# *Full-Scale Aircraft Fire Tests*

A comparison of Aluminium and Composite Burn-Through

Chief François Jacquet, OIAA ERS  
Ron Gould, NRC Aerospace (Retired)  
Simon Hind, NRC Aerospace

LTR-SMM-2015-0414

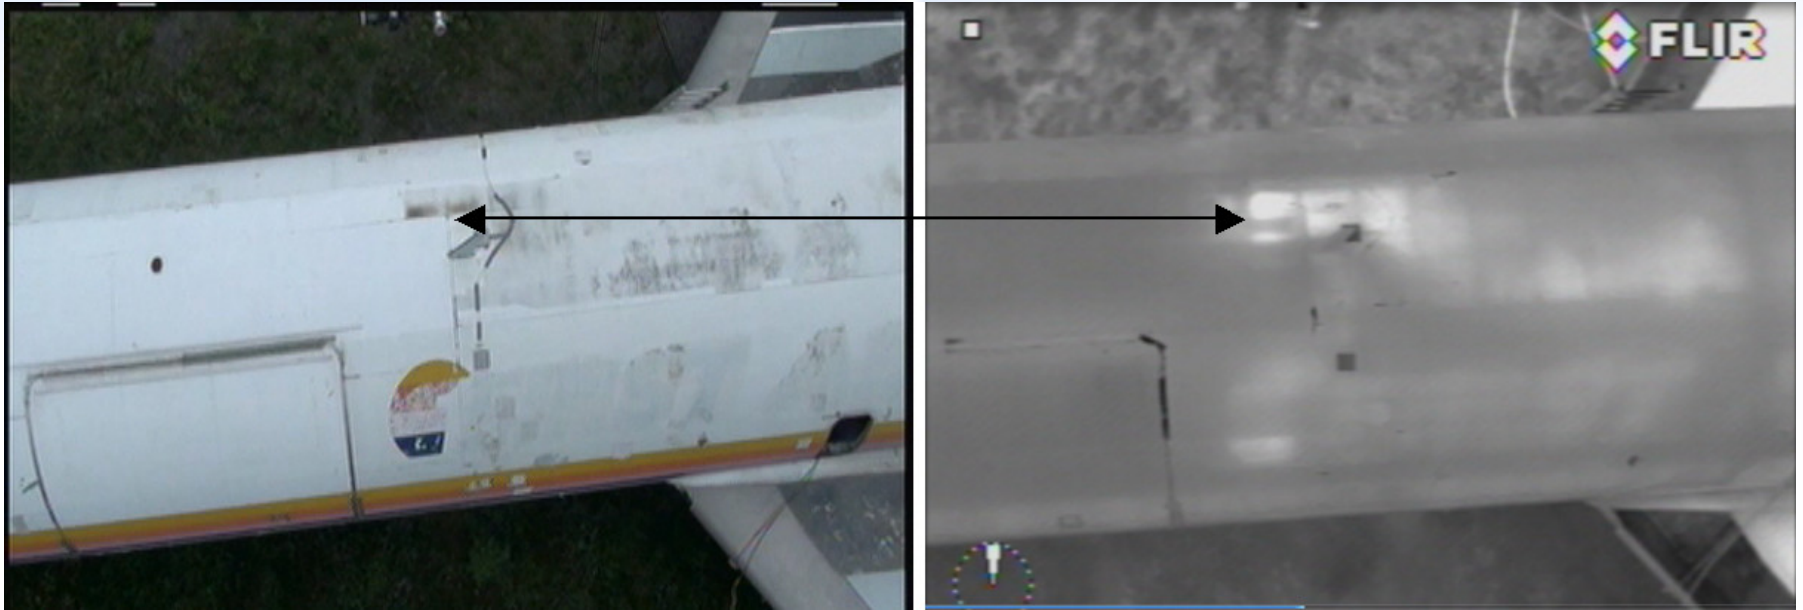
The first indication of fire (arrow) is in the region of solar heating.

If this was the first view upon arriving at the scene there could be some confusion as to the extent of internal heating.

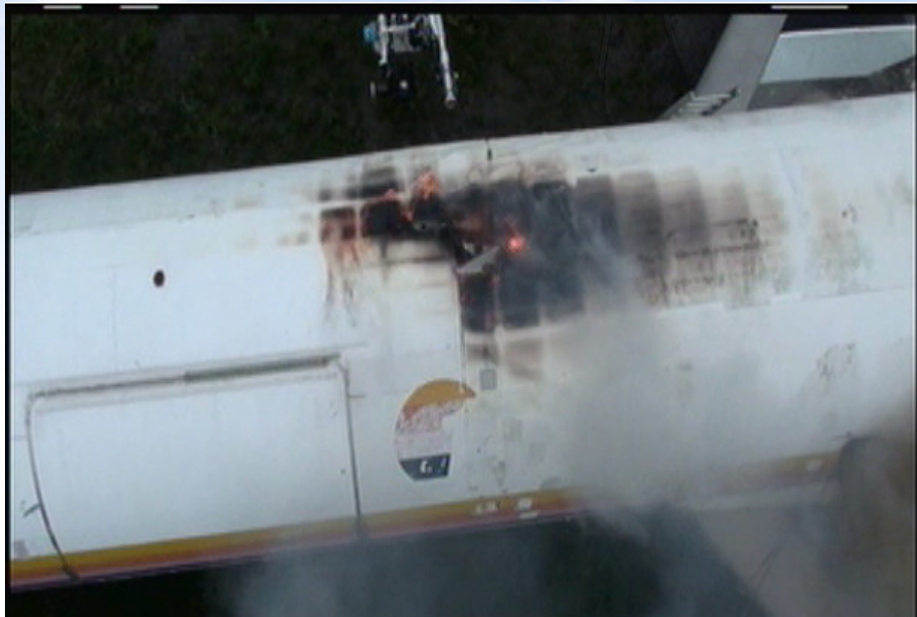
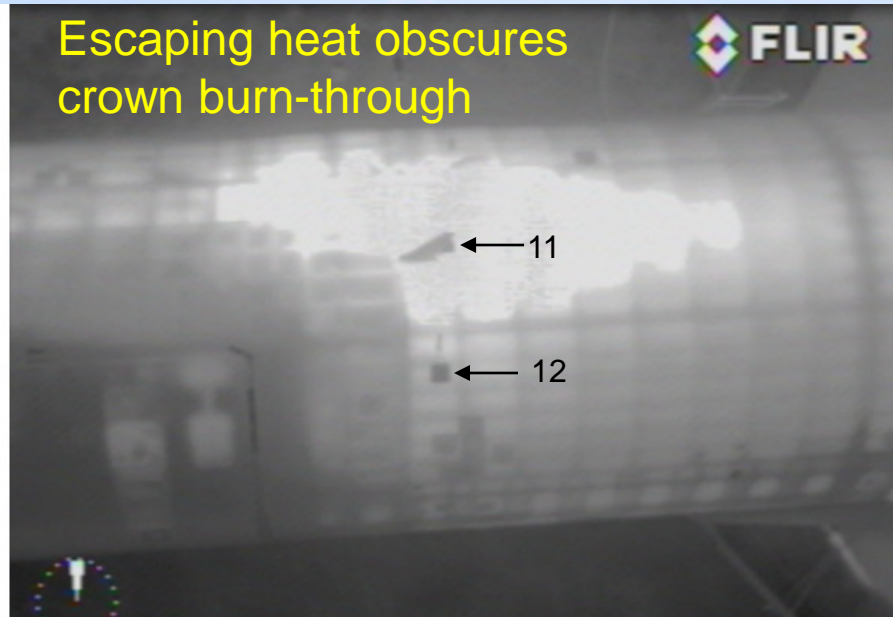
TC#11 falls into the aircraft when the crown burns through

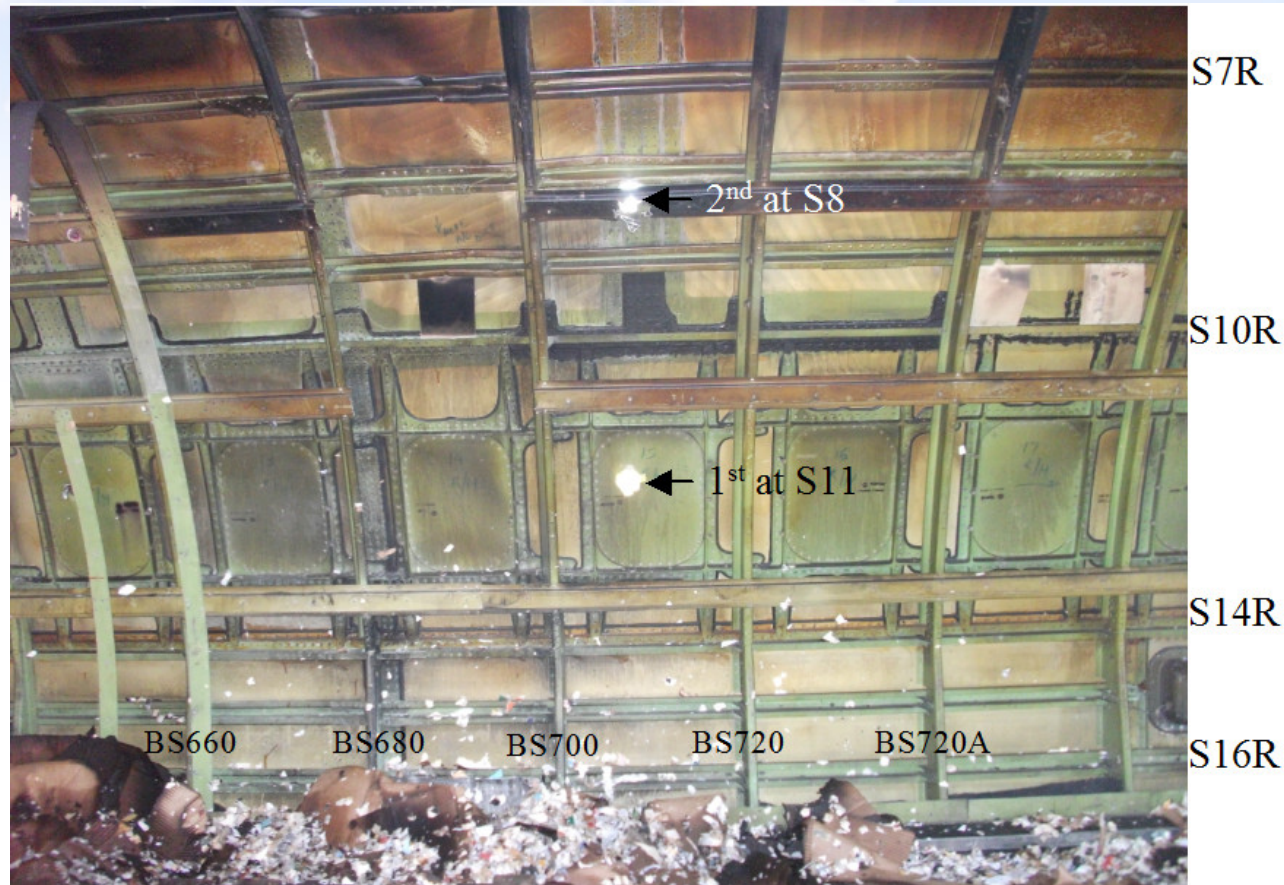
# Post Test 1

Little heat damage or sooting below S7 as evidenced by this typical view.

The two Stinger piercing locations are noted.

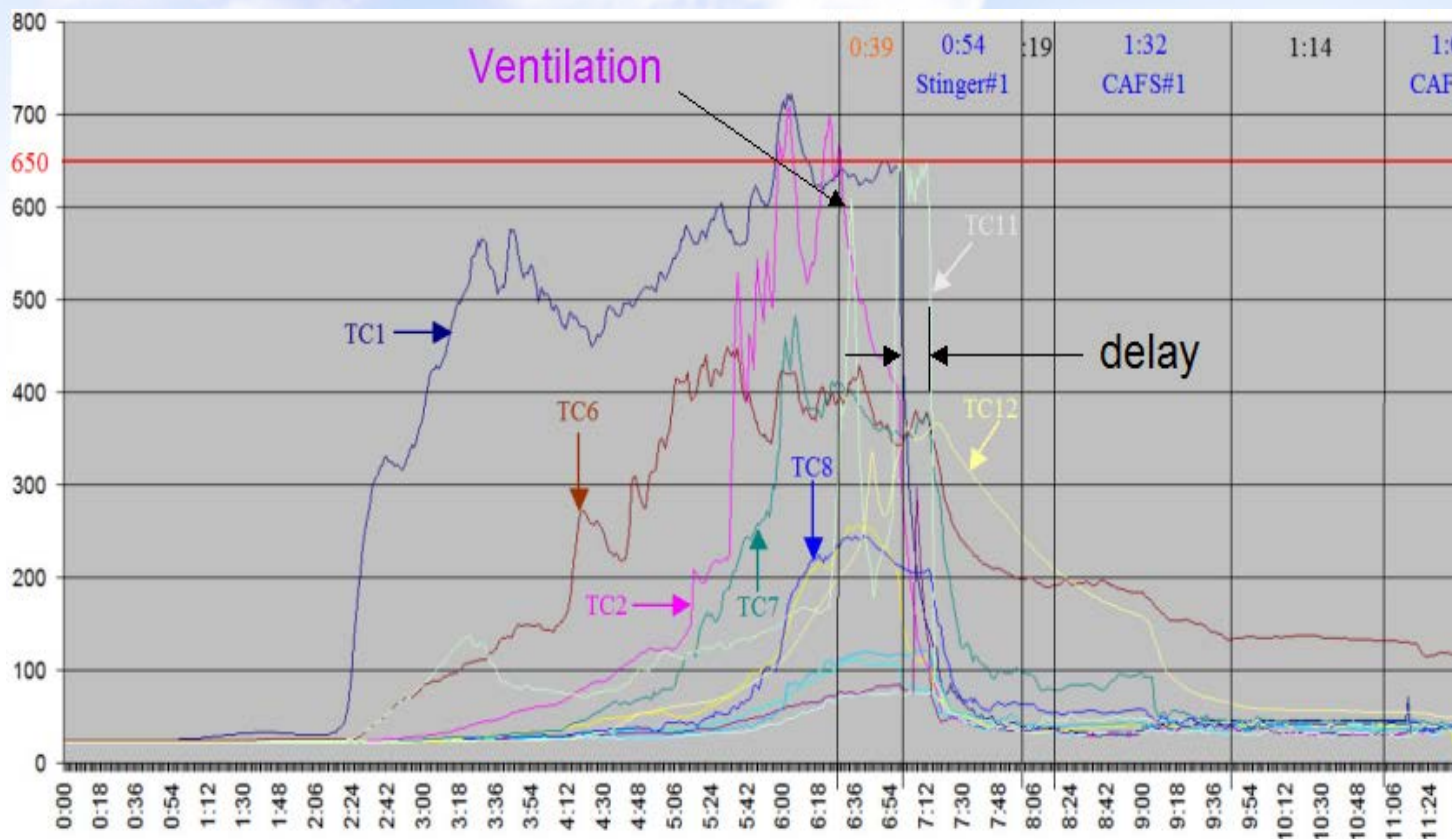
# Test 1 Temperature Profile & Initial Extinguishments

TC#1	1330°F (721°C)
TC#2	1308°F (709°C)
TC#3	488°F (353°C)
TC#4	226°F (108°C)
TC#5	177°F (80°C)
TC#6	831°F (444°C)
TC#7	900°F (482°C)
TC#8	473°F (245°C)
TC#9	248°F (120°C)
TC#10	169°F (76°C)
TC#11	1198°F (648°C)
TC#12	687°F (364°C)

Stinger water cooling effect delayed by distance from TC trees.

Red line is melting temperature of aluminium.

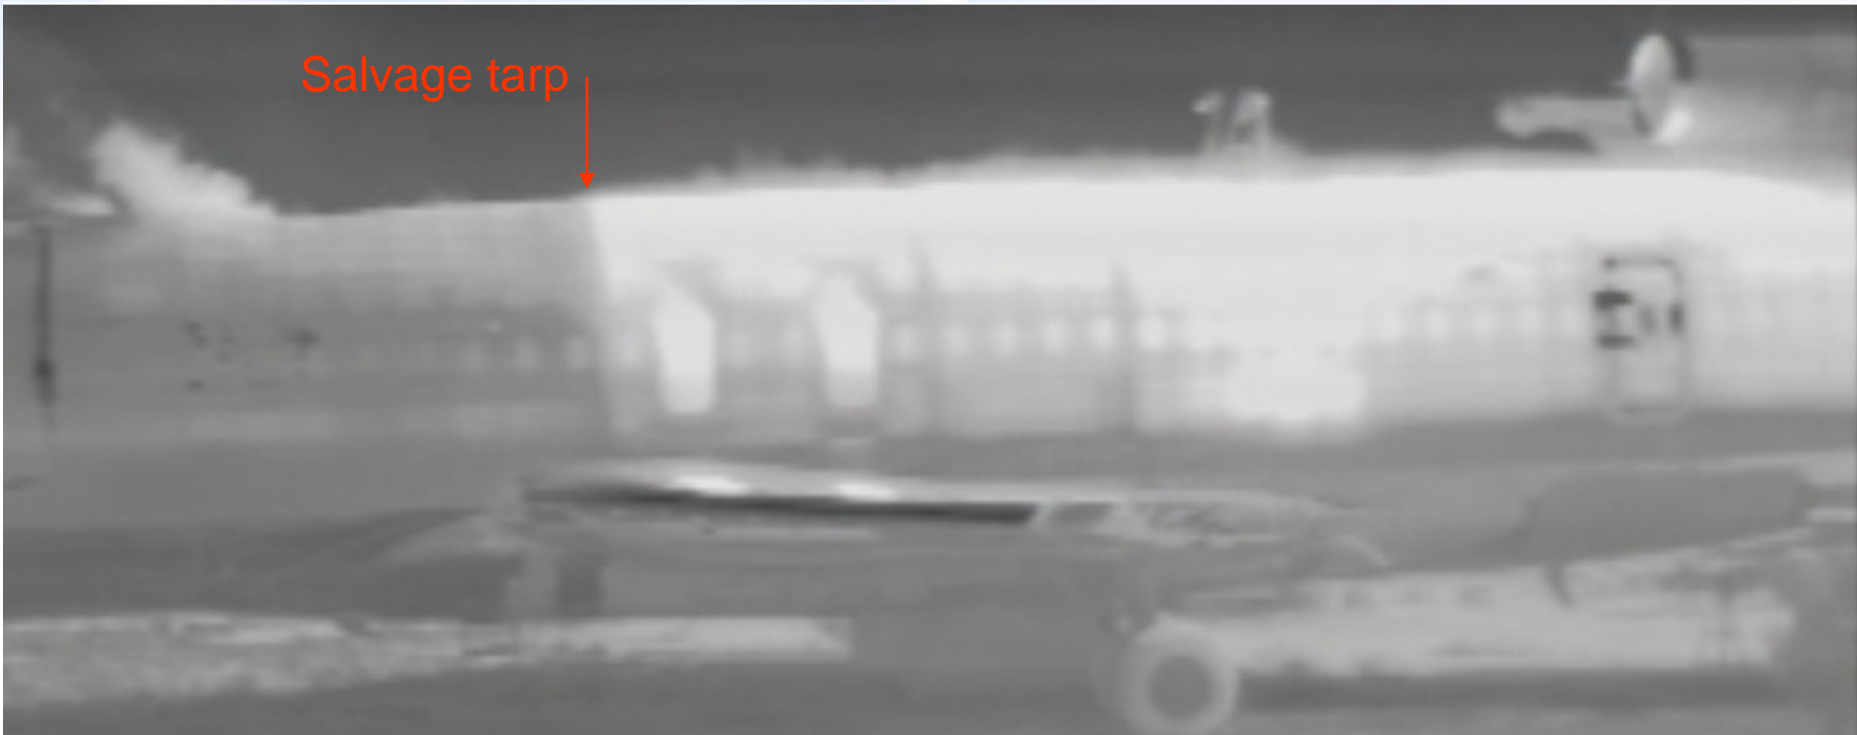
## Test 2 PORT Side TIC

No evidence of Stinger application on PORT side. Heat haze obscures 3B1.

[Salvage tarp failed at 7:45](#) as evidenced by heat escaping Test 1 crown burn-through.

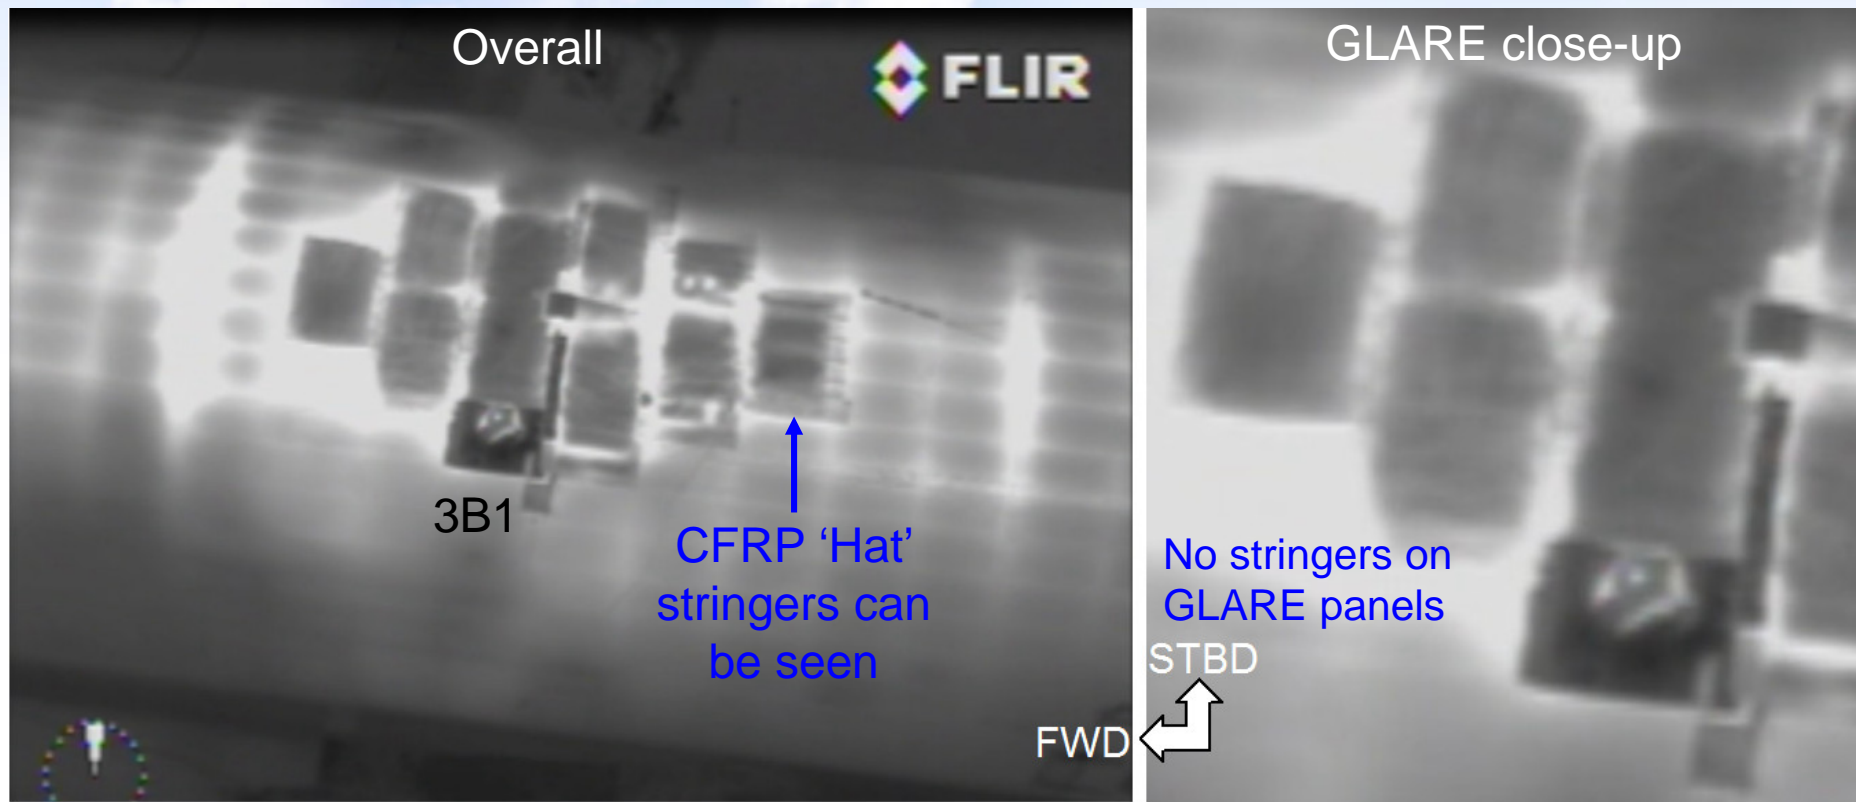
## Test 2 Overhead TIC

Fire damaged GLARE & CFRP panels do not transmit heat well.

Panel 3B1 has been partially burned through.

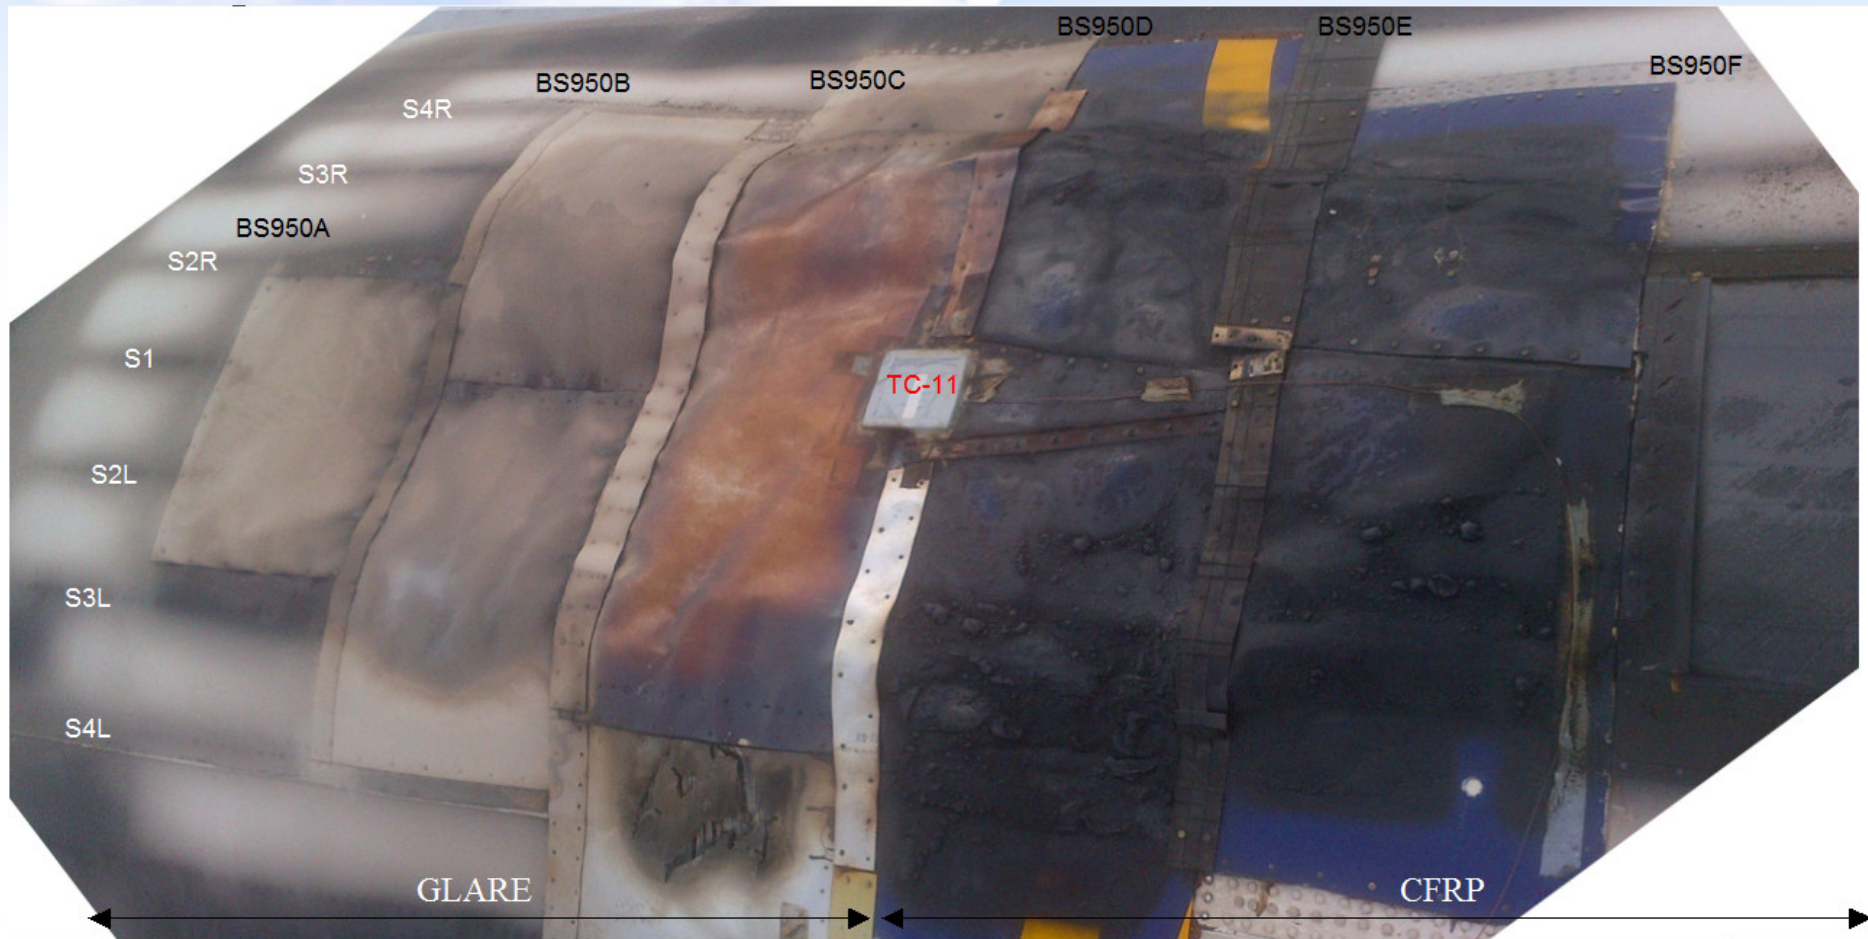
## Test 2 Damage to Composites, Exterior

Note refractory insulation protected skin between stringers from heat damage.

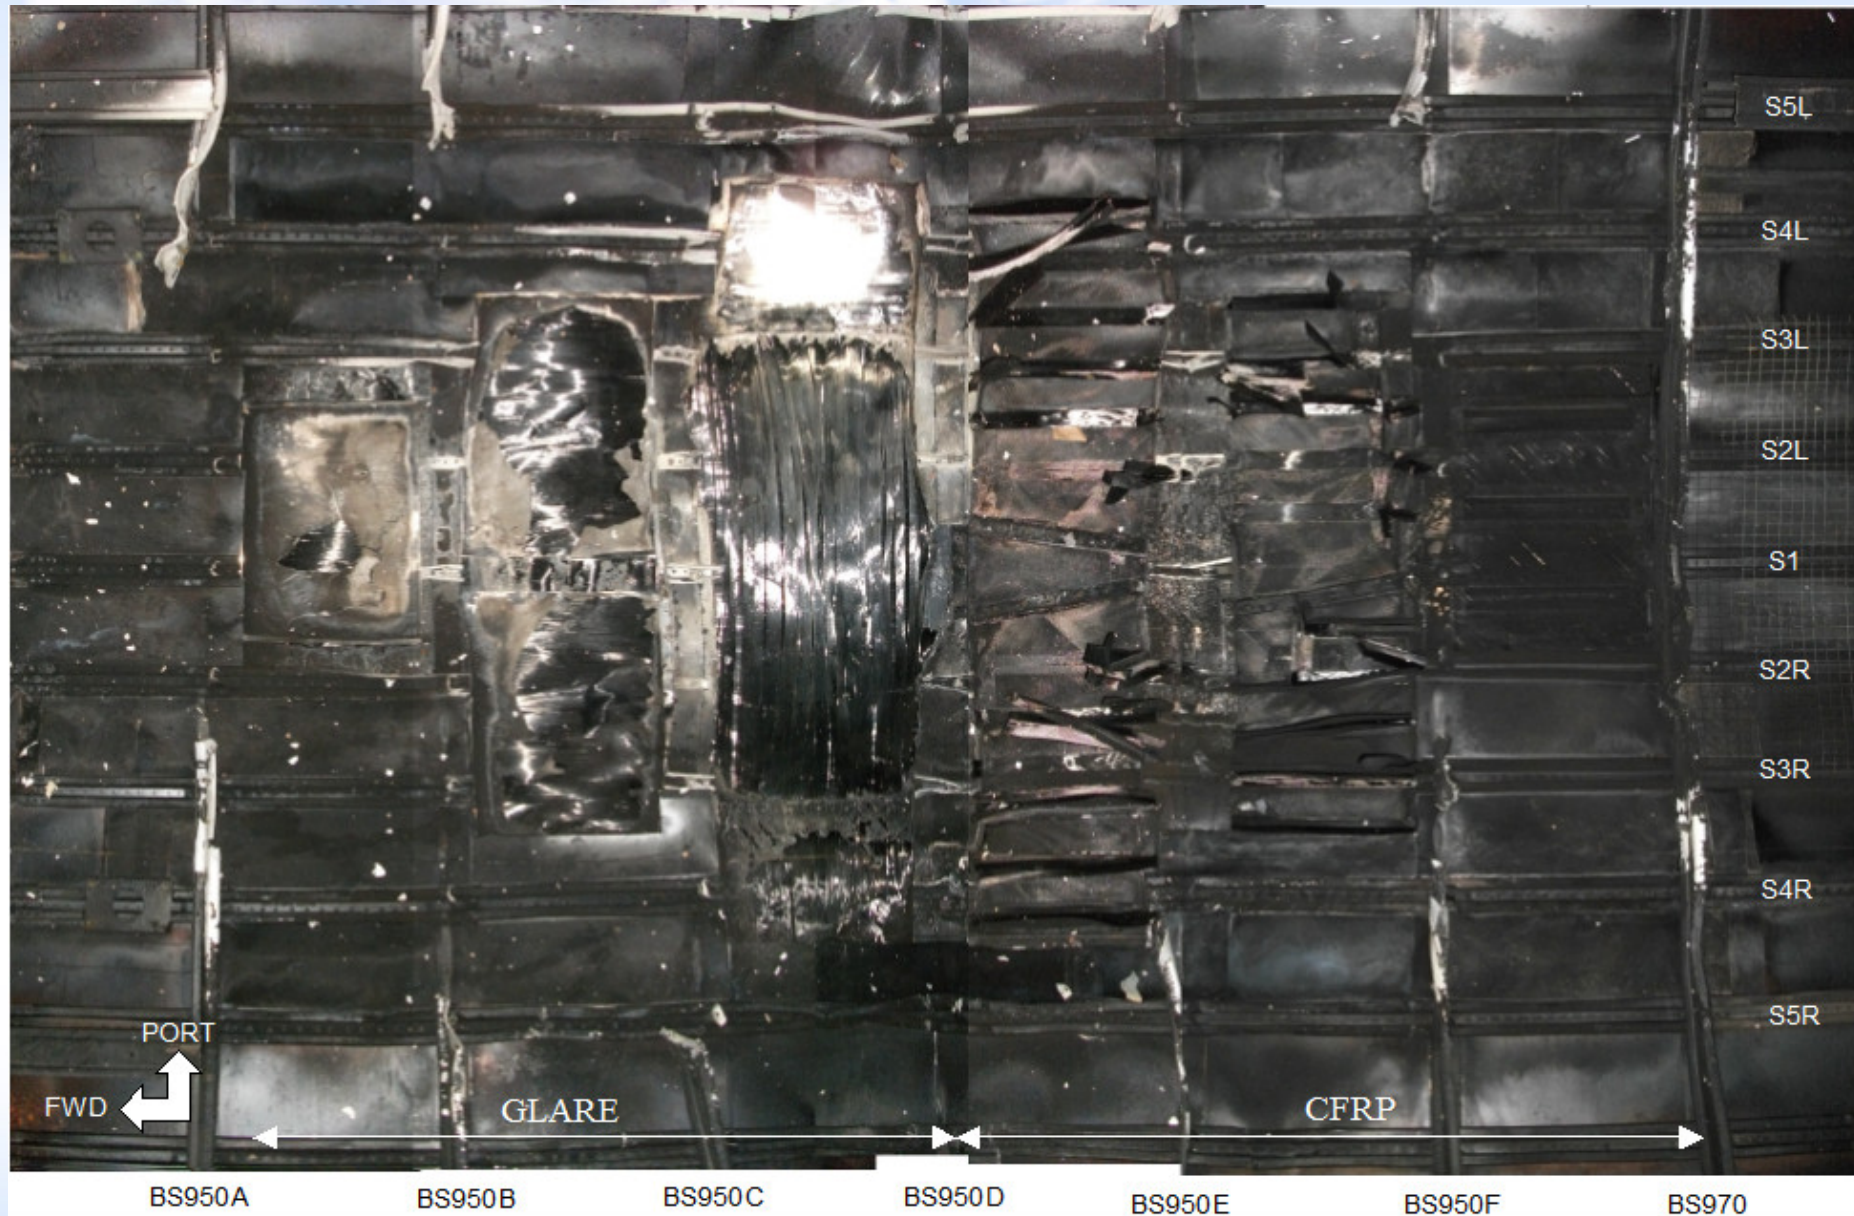
## Test 2 Damage to Composites, Interior, Overall

No burn-through of CFRP but significant loss of structural integrity.

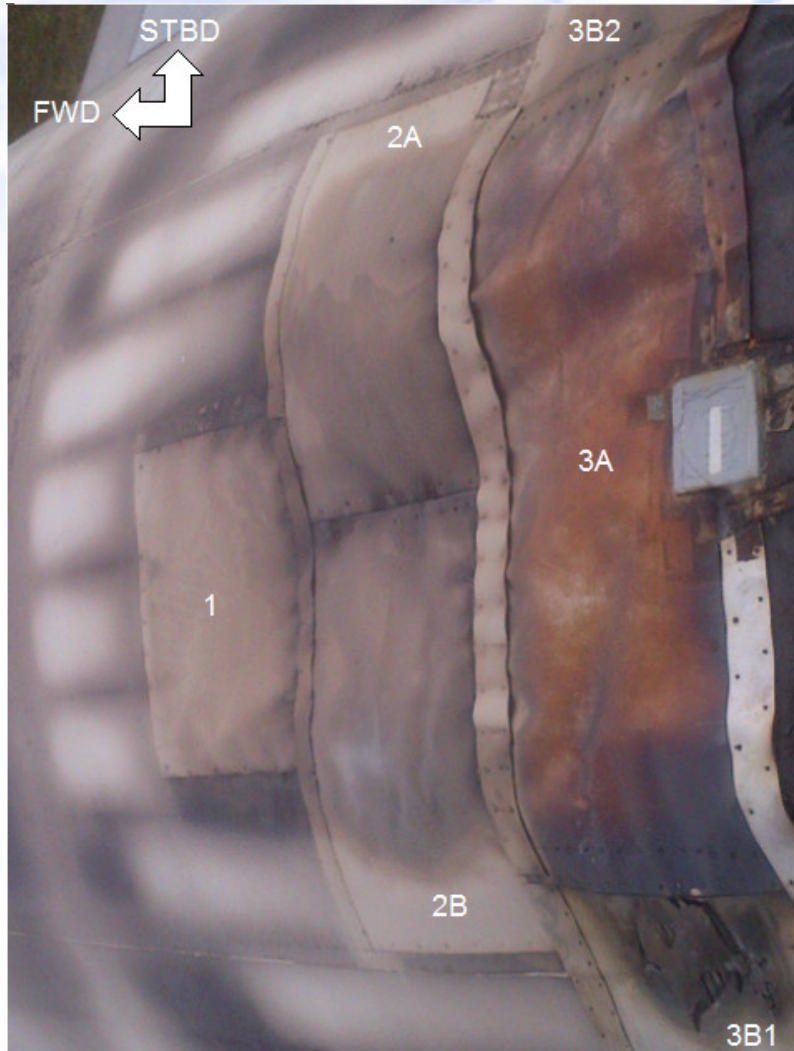
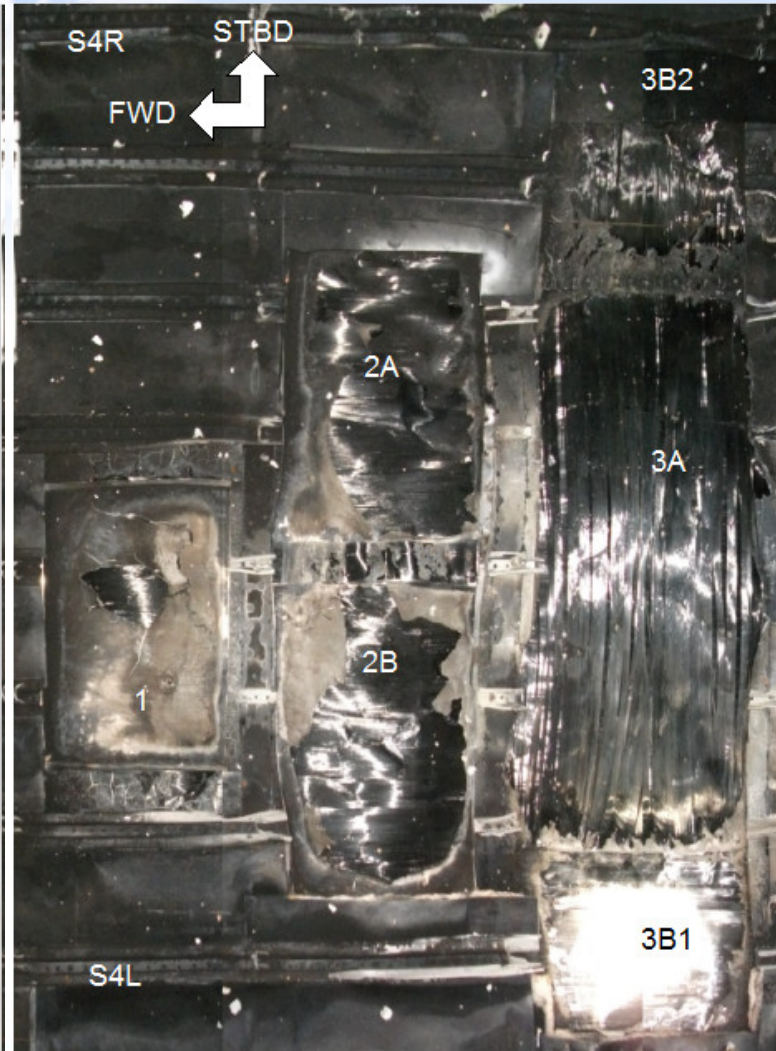
# Post Test 2 GLARE

Minor burn-through of aluminium skins in two GLARE panels but limited vertical ventilation occurred due to intact fibre layers.

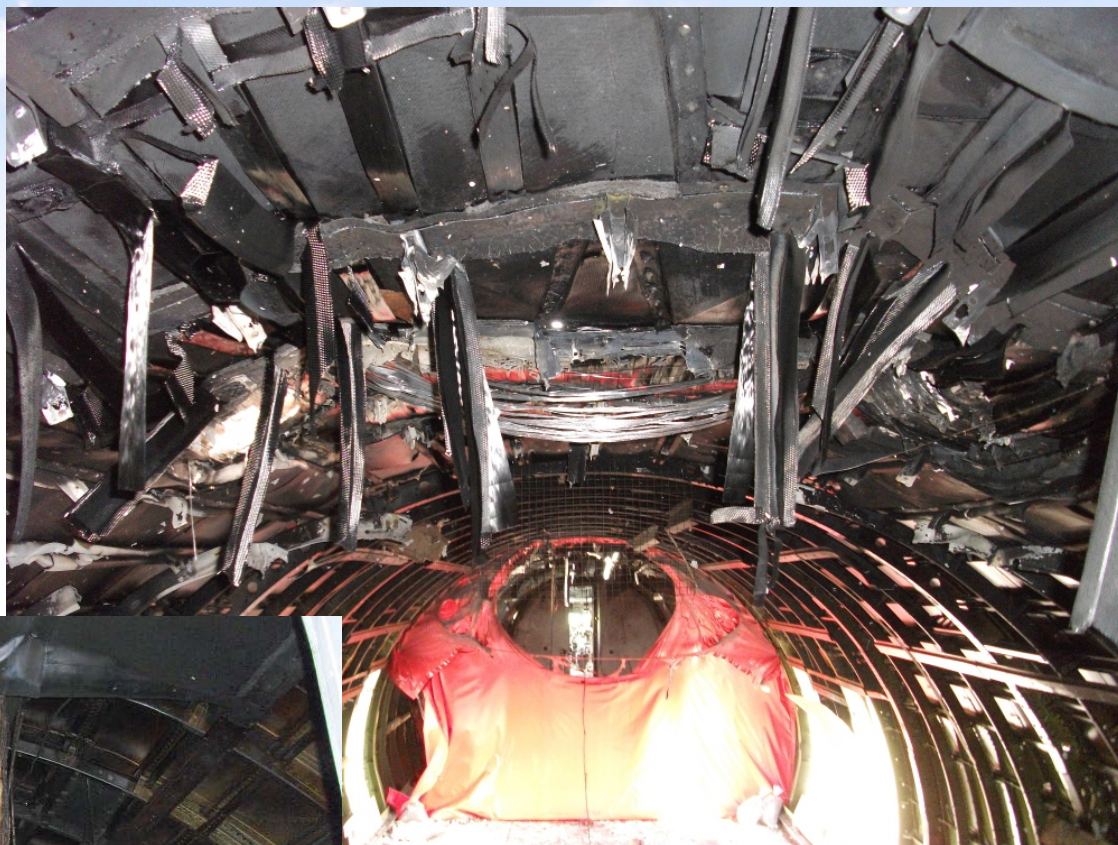
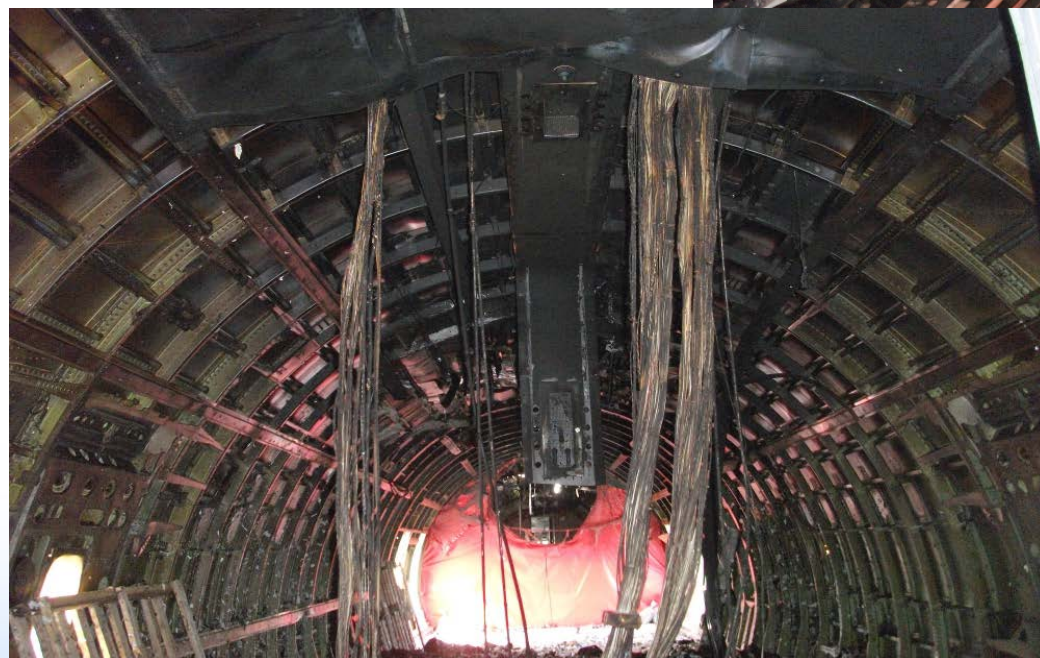
Add a forest of hanging CFRP plies to the existing entanglement hazard of displaced wiring bundles.

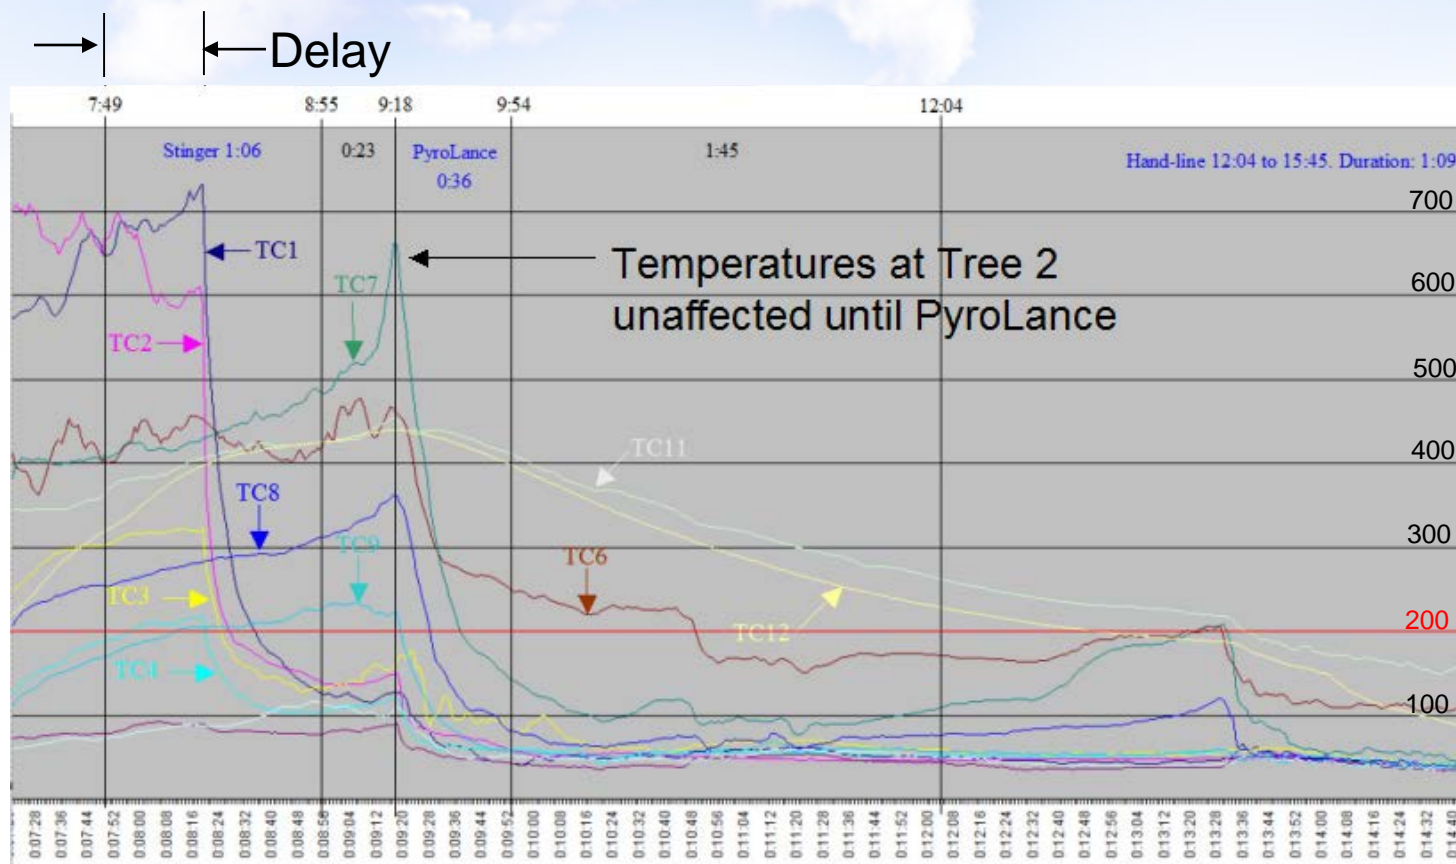
# Test 2 Temperature Profile for Initial Extinguishments

TC#1	1348°F (711°C)
TC#2	1301°F (705°C)
TC#3	608°F (320°C)
TC#4	415°F (213°C)
TC#5	176°F (80°C)
TC#6	900°F (482°C)
TC#7	1222°F (661°C)
TC#8	682°F (361°C)
TC#9	450°F (232°C)
TC#10	239°F (115°C)
TC#11	441°F (245°C)
TC#12	455°F (235°C)

Note delayed response to Stinger application.

Upper cabin exceeds CFRP  $T_g$  for 10 minutes
