# **Full-Scale Aircraft Fire Tests - A Comparison of Aluminium and Composite Burn-Through**

Report No: LTR-SMM-2015-0414

Date: May 2015

<b>Classification :</b>	Unclassified	<b>Distribution :</b>	Limited
<b>For:</b>	Ottawa International Airport Authority, Emergency Rescue Services		
<b>Reference:</b>			
<b>Submitted by:</b>	S. Beland, Director R&D (Aerospace - SMM)		
<b>Approved by:</b>	J. Komorowski, Director General (IAR)

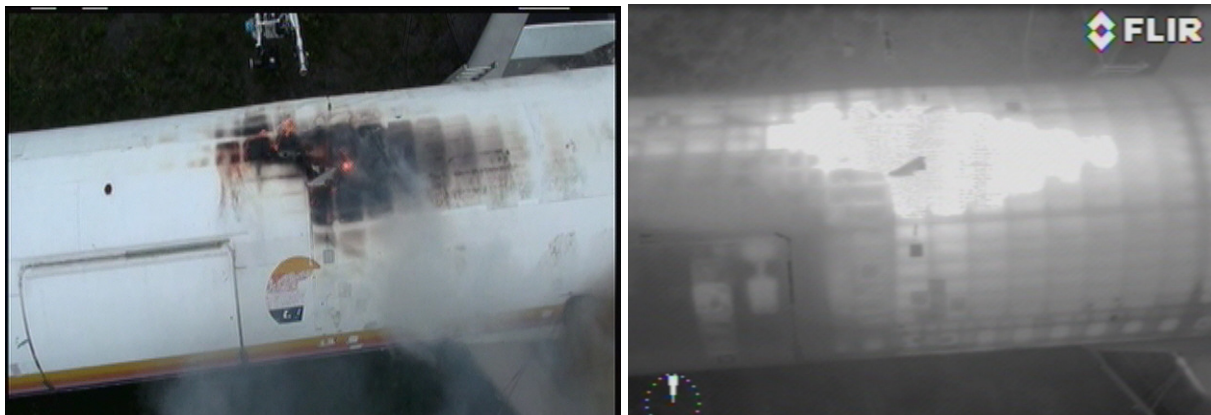
c) First flames visible at beginning of fuselage crown burn-through.

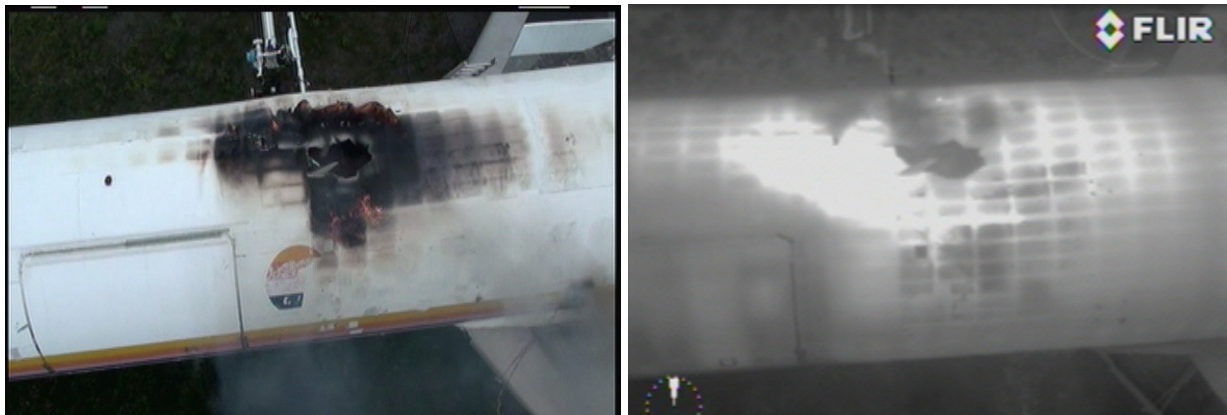
d) Just prior to first extinguishment with Stinger. Area of crown with TC#11 attached has melted.

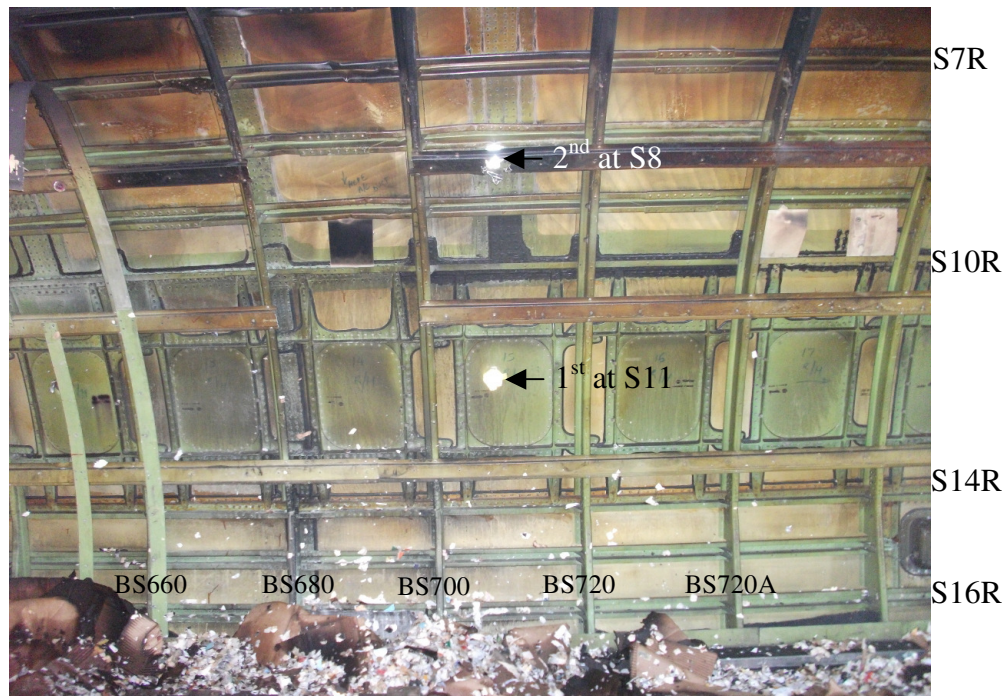
Figure 20 shows the interior view of the lower STBD side post-test including, Stinger piercings and clearly shows the lack of heat/soot damage at the seat of the fire. There is little heat damage below S6 or sooting below S8 on either side. The figure partially illustrates the unburnt fuel (paper) remaining.

Figure 20. Interior view of lower STBD side.

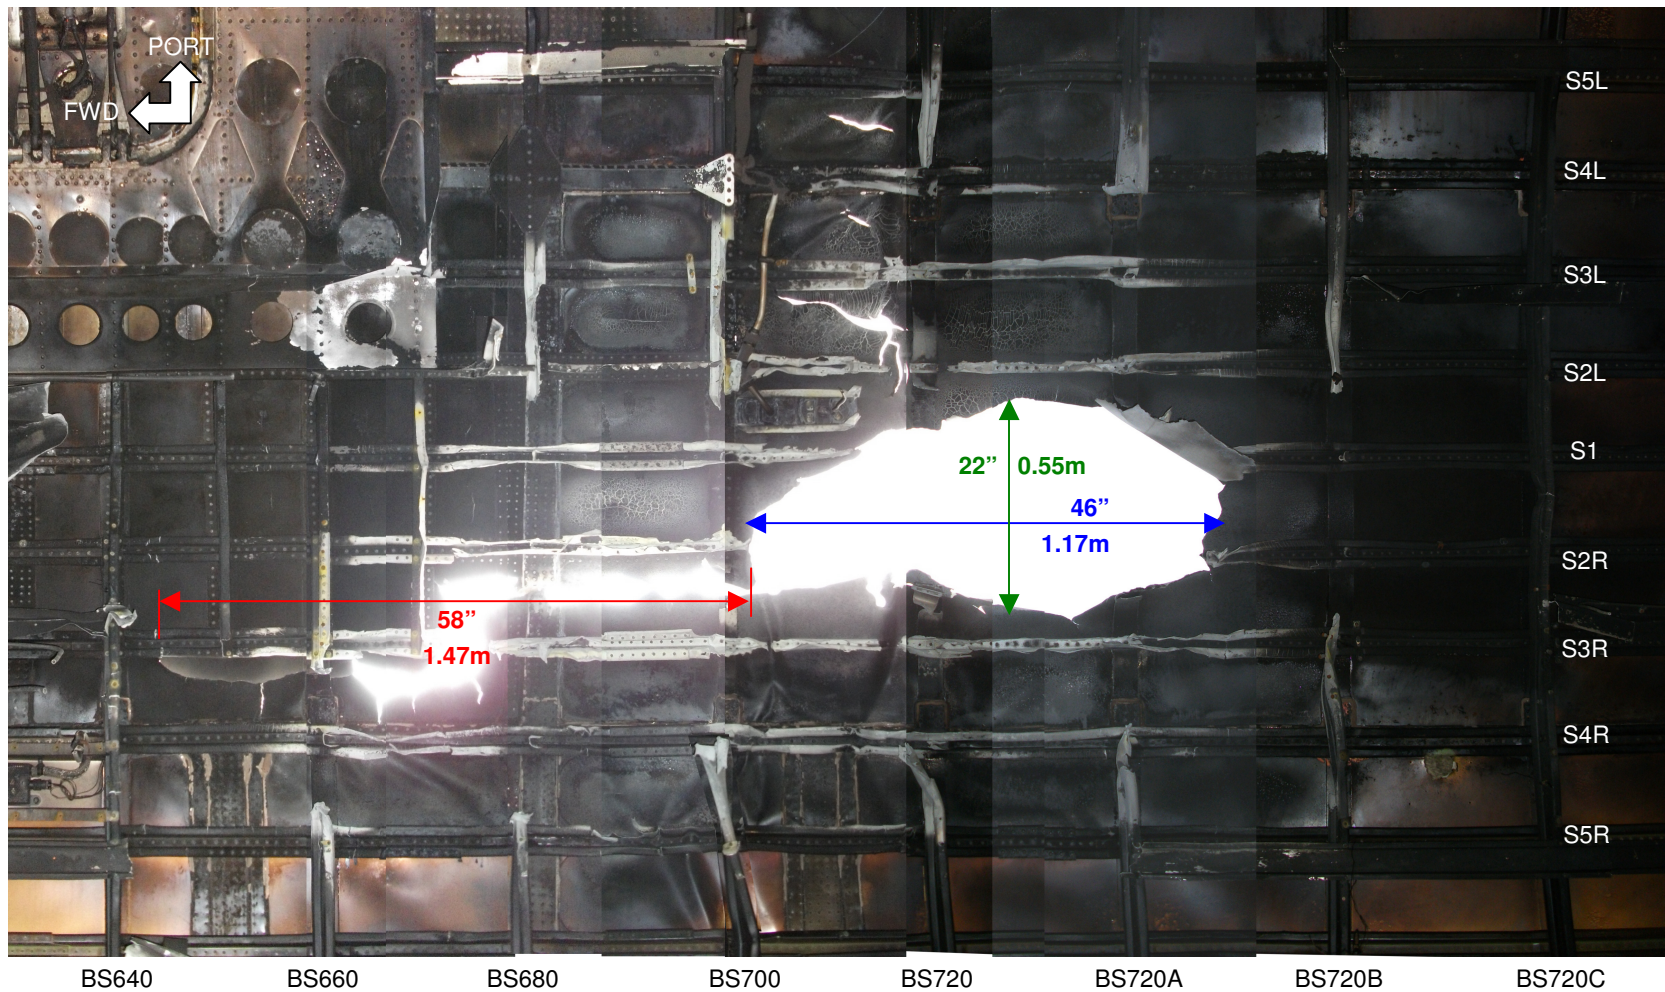
Figure 23: Test 1 fuselage crown, post-test damage.

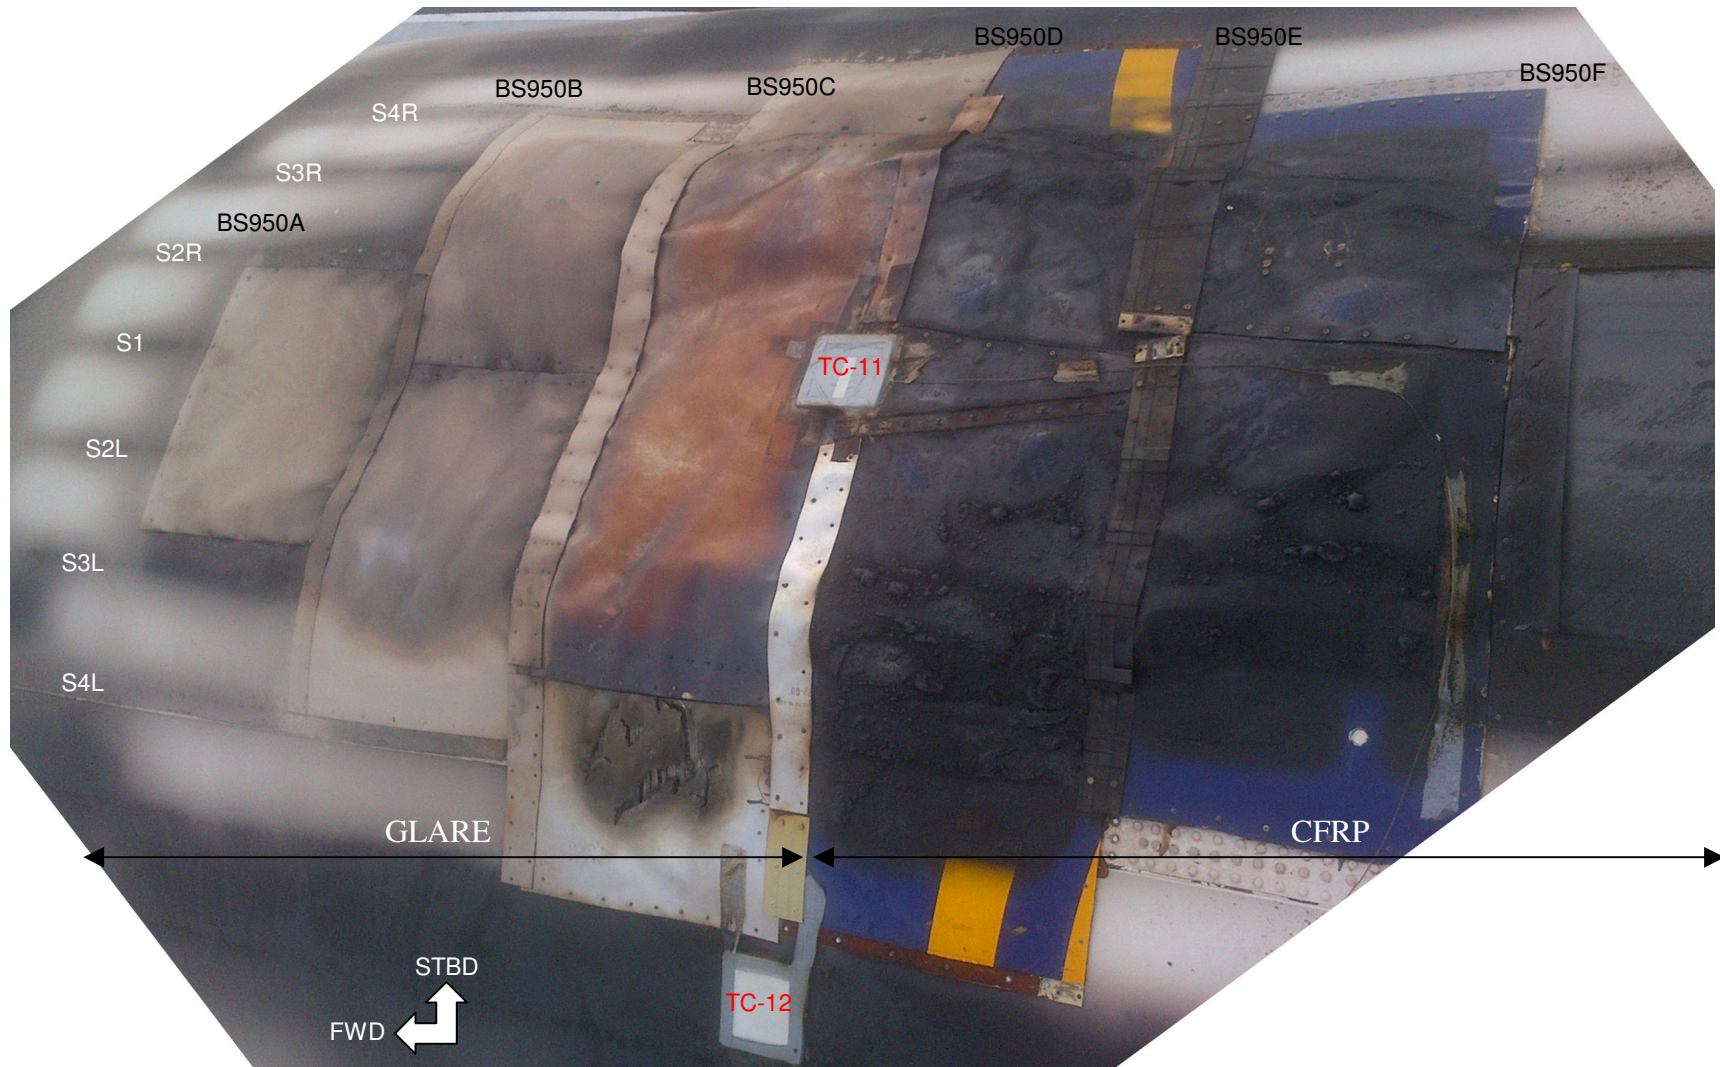
Figure 28. Test 2. Overall exterior view of the fuselage crown, post-test.

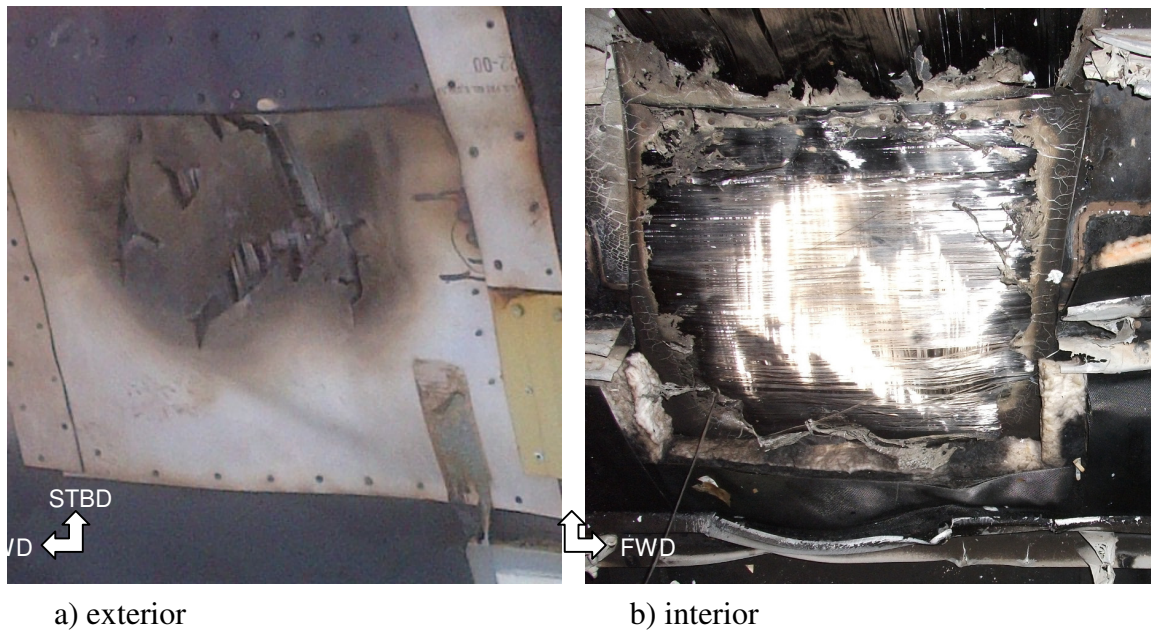
Figure 30. Burn through on panel 3B1.

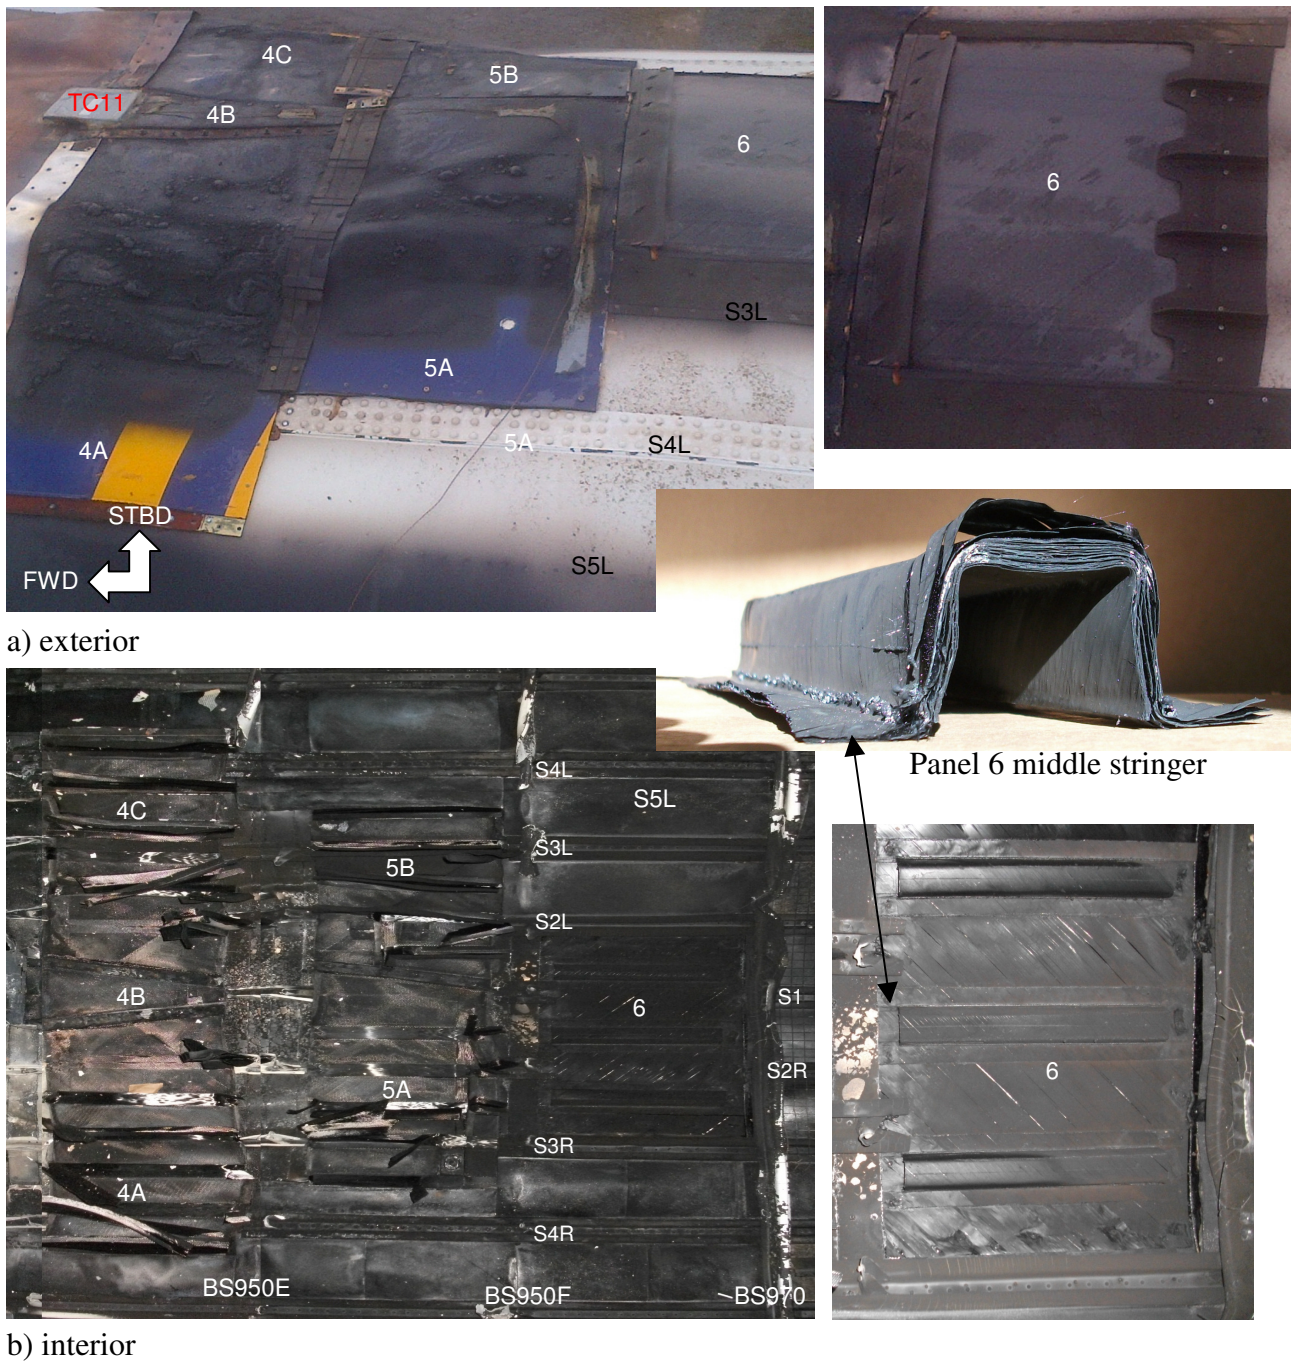
Figure 32. CFRP panels 4, 5 & 6 (with close-ups).

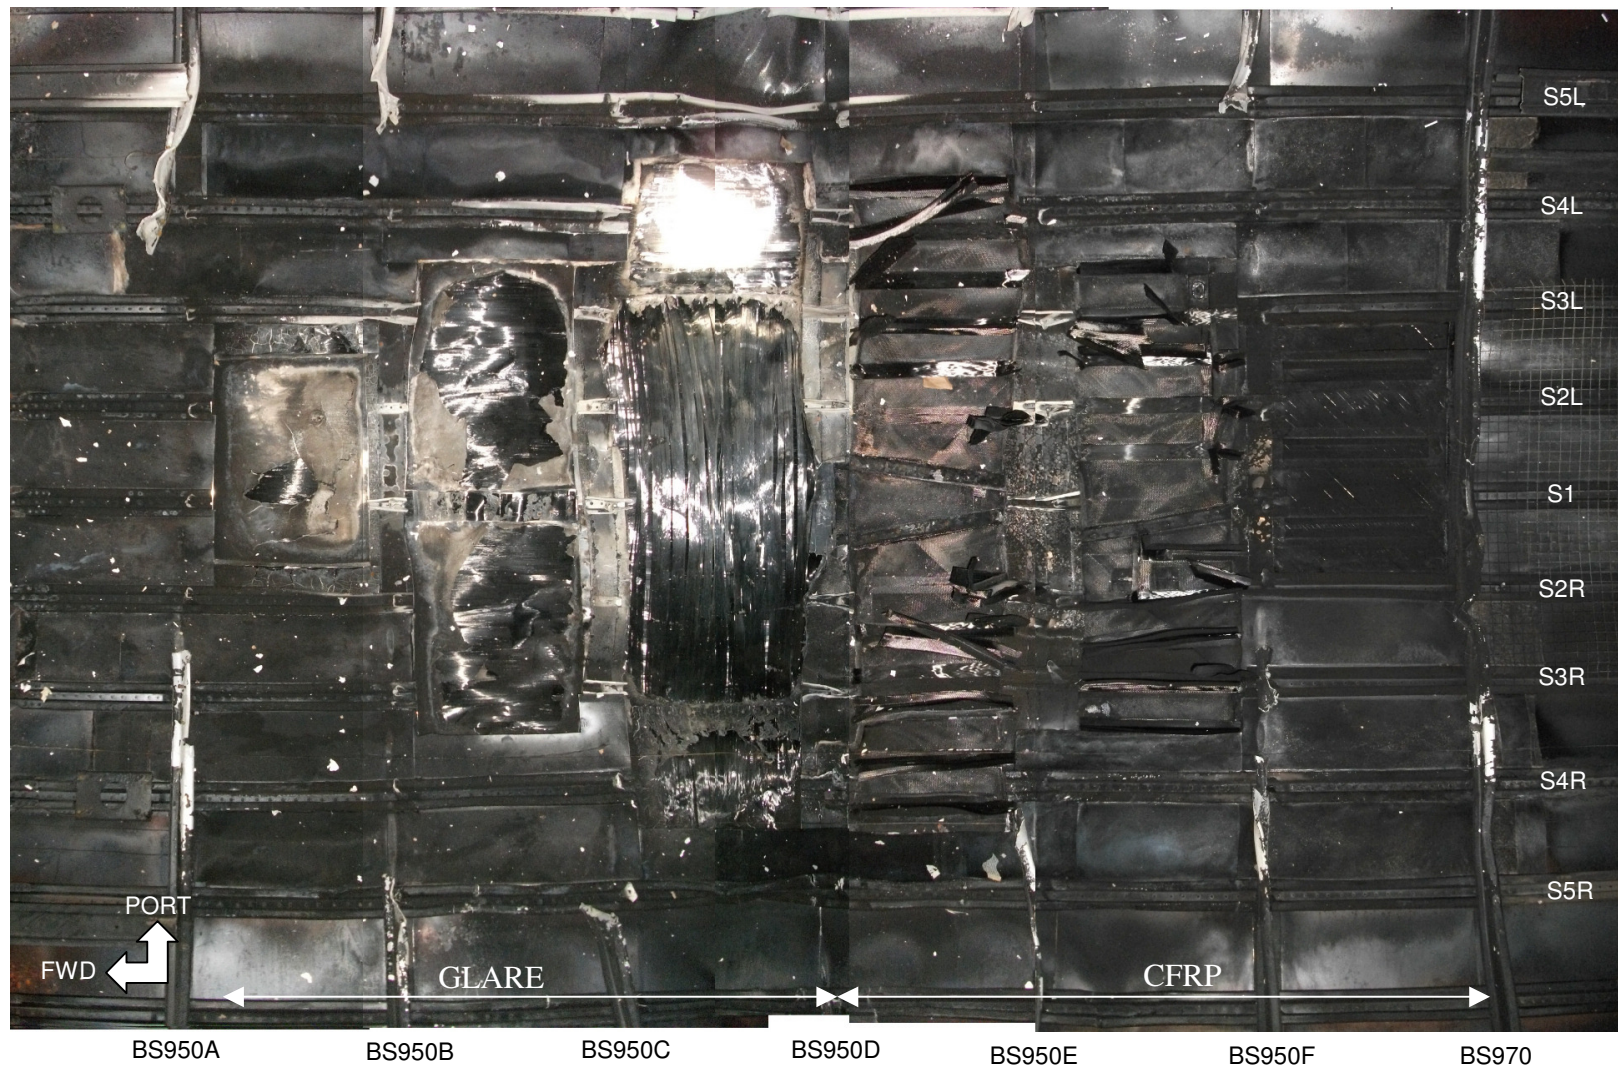
Figure 33. Test 2 fuselage crown, post-test damage.

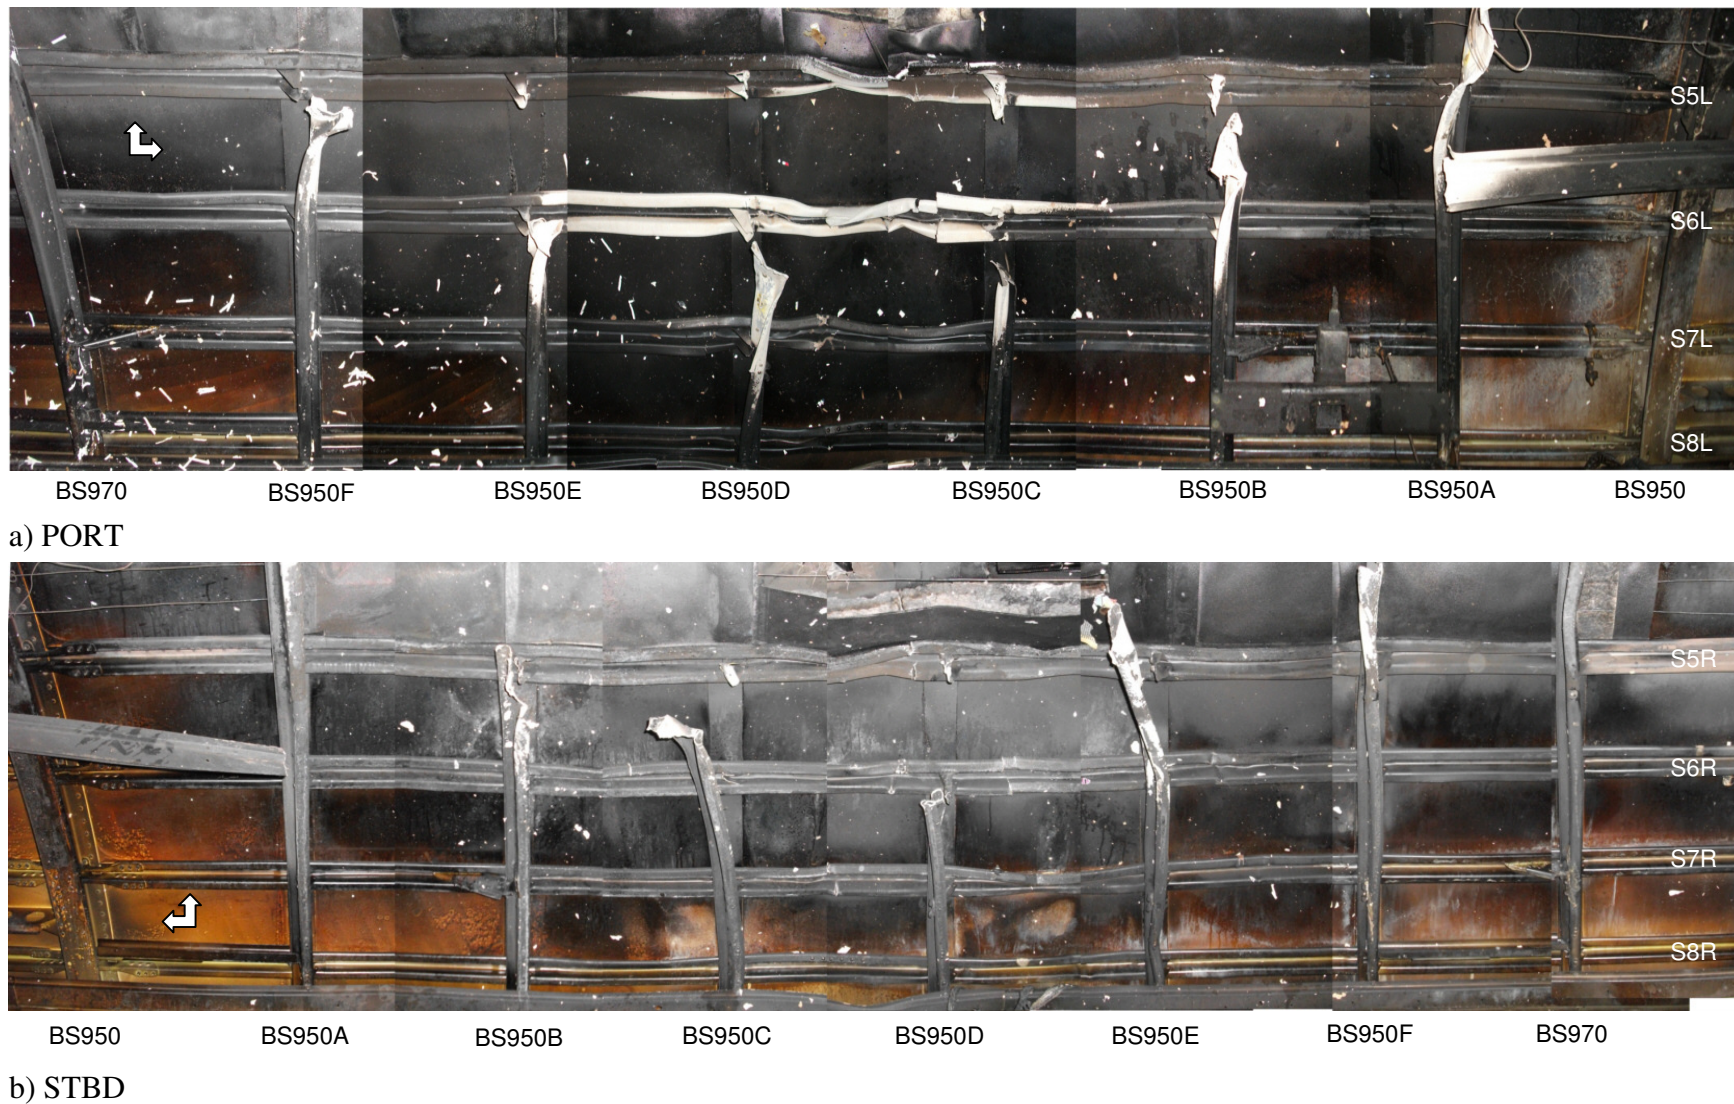
Figure 34. Test 2 fuselage sidewalls, post-test damage.

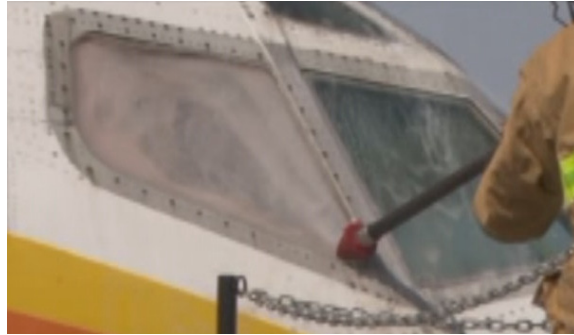
c) Quit without full penetration at 10:47:04. Plies were delaminated and water filled cavity.

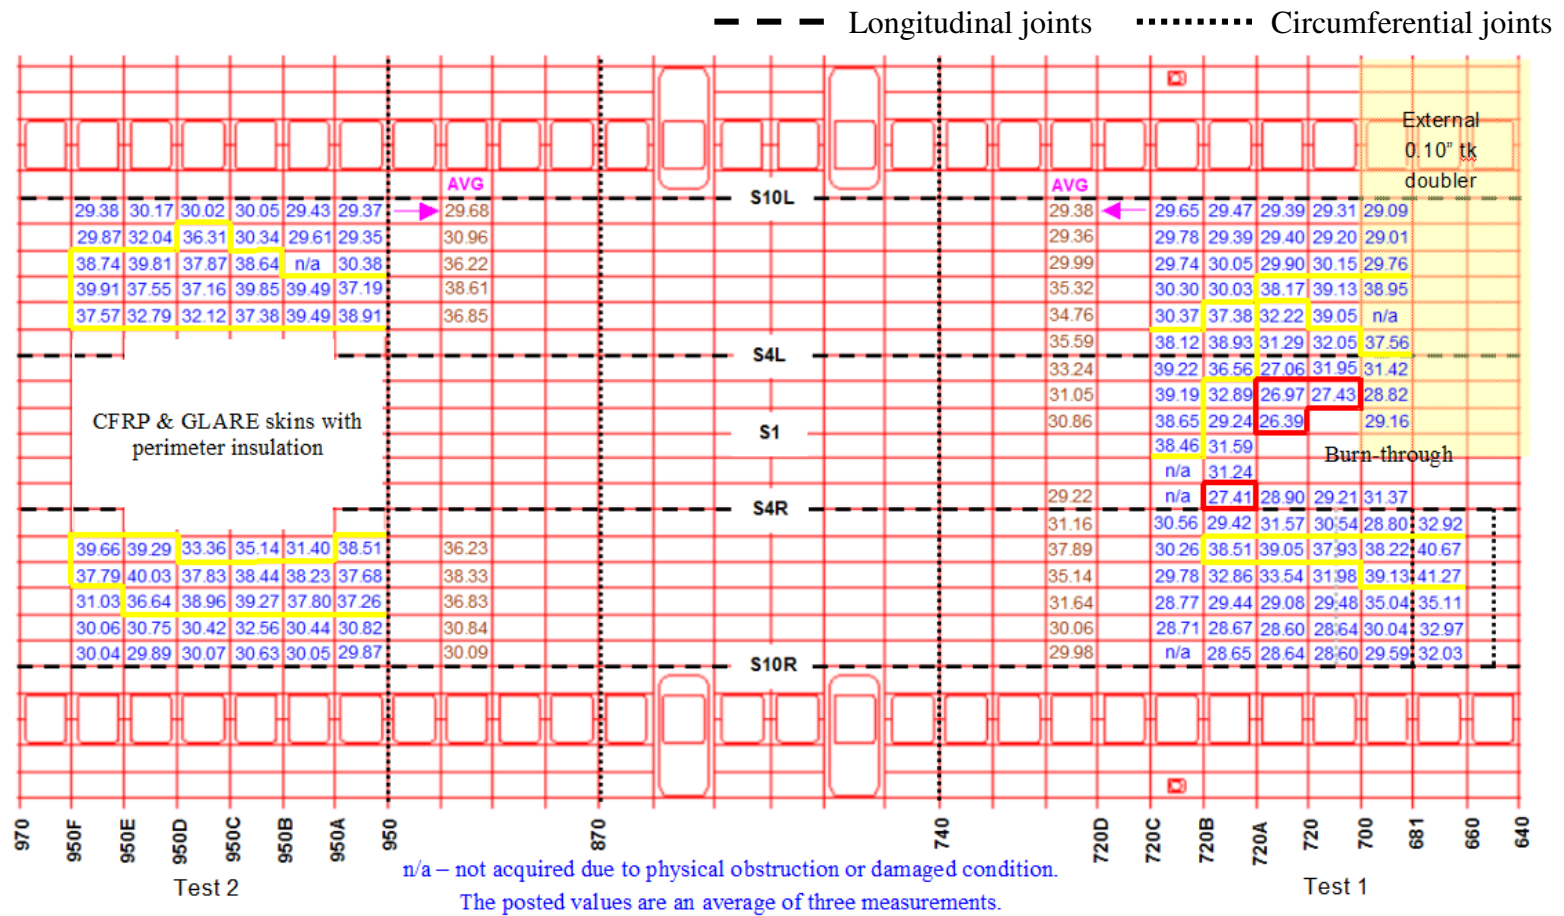
Fig. A.IV-1 Post-test 2024-T3 aluminium skin conductivity (% ICAS) measurements and average values (horizontally).

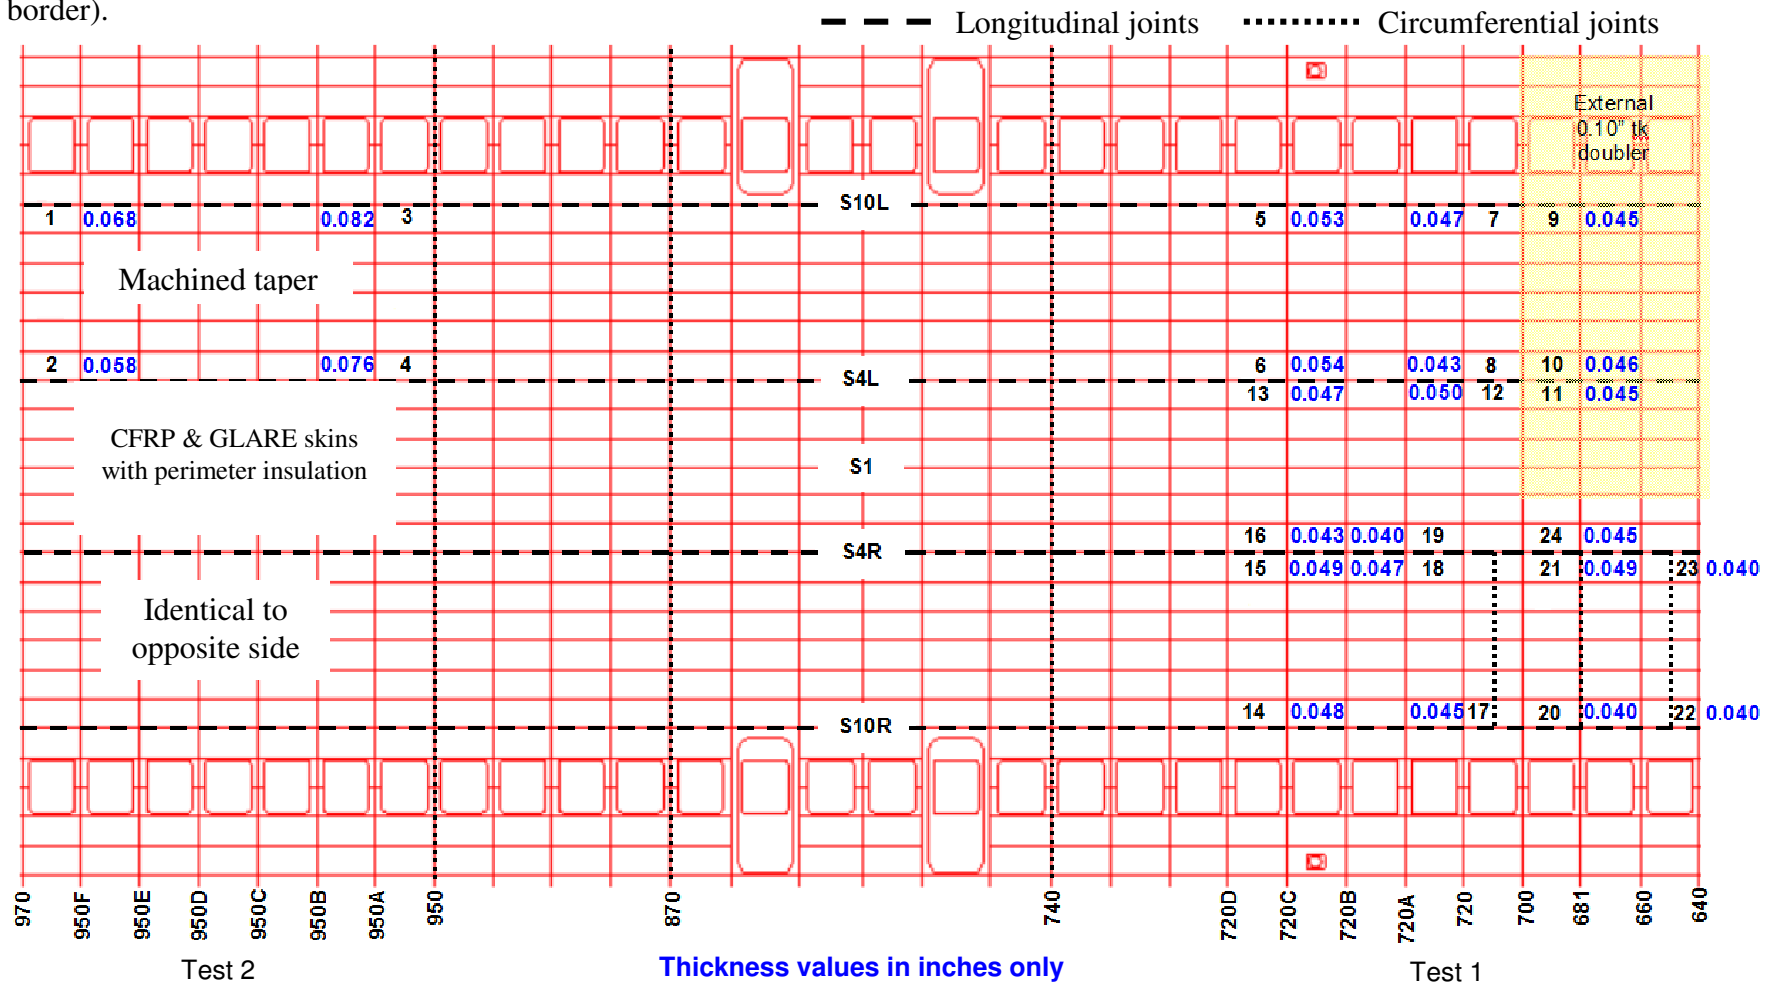
Fig. A.IV-2. Post-test aluminium skin sample locations (black) and skin thickness (blue).
