# *Full-Scale Aircraft Fire Tests*

A comparison of Aluminium and Composite Burn-Through

Chief François Jacquet, OIAA ERS  
Ron Gould, NRC Aerospace (Retired)  
Simon Hind, NRC Aerospace

LTR-SMM-2015-0414

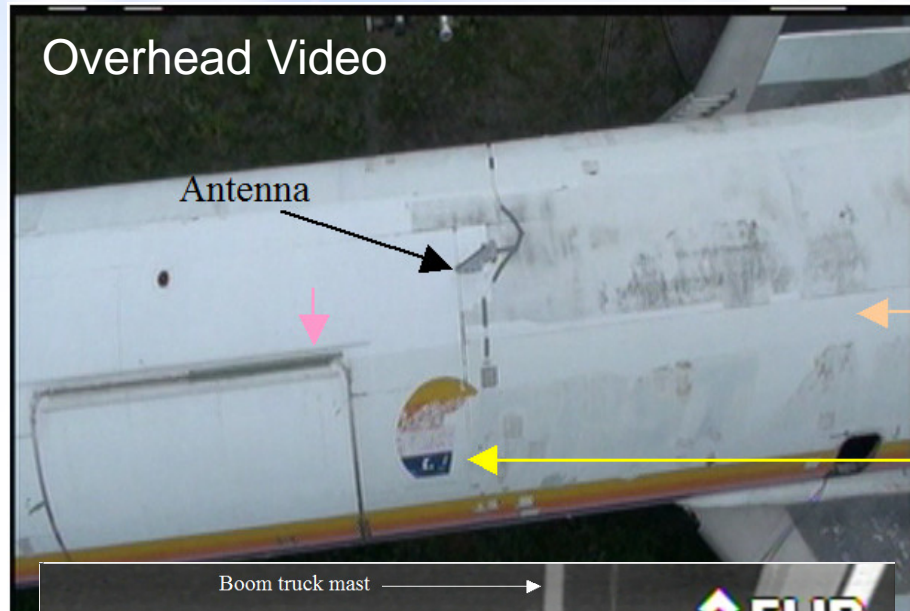
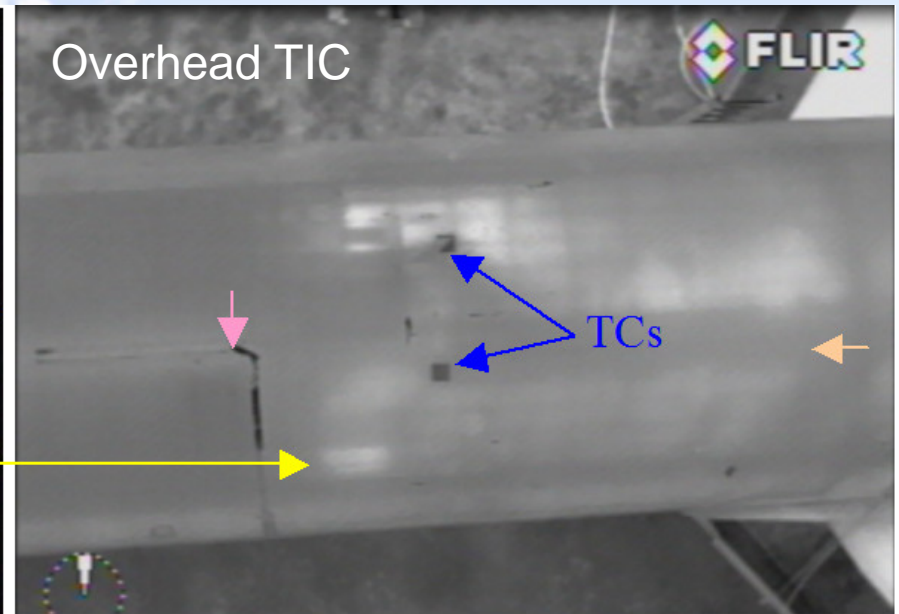
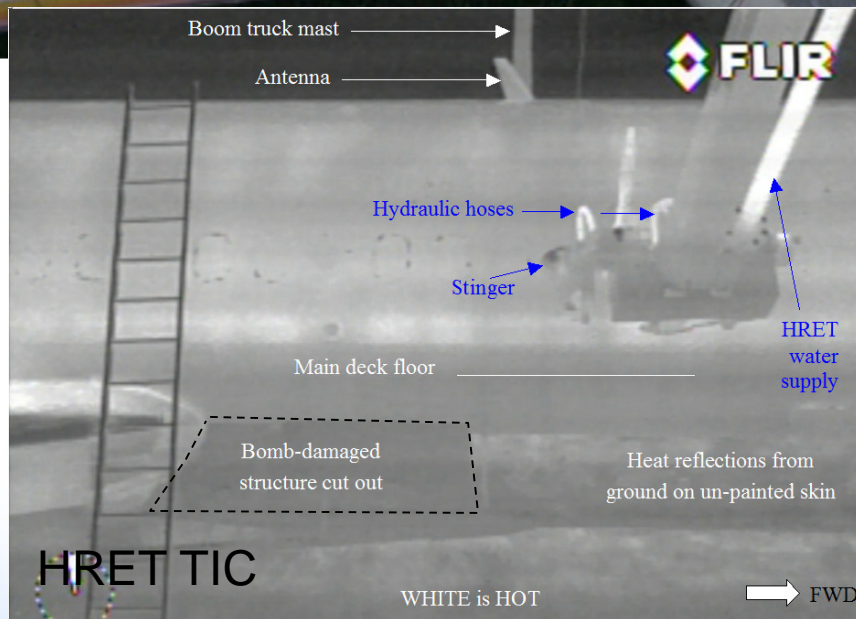
Note solar heating of fuselage skin and differences in surface emissivity of paint (←→) and metal tape at cargo door (↓).

TCs covered with ceramic insulation blocks. Duct tape doesn't show.

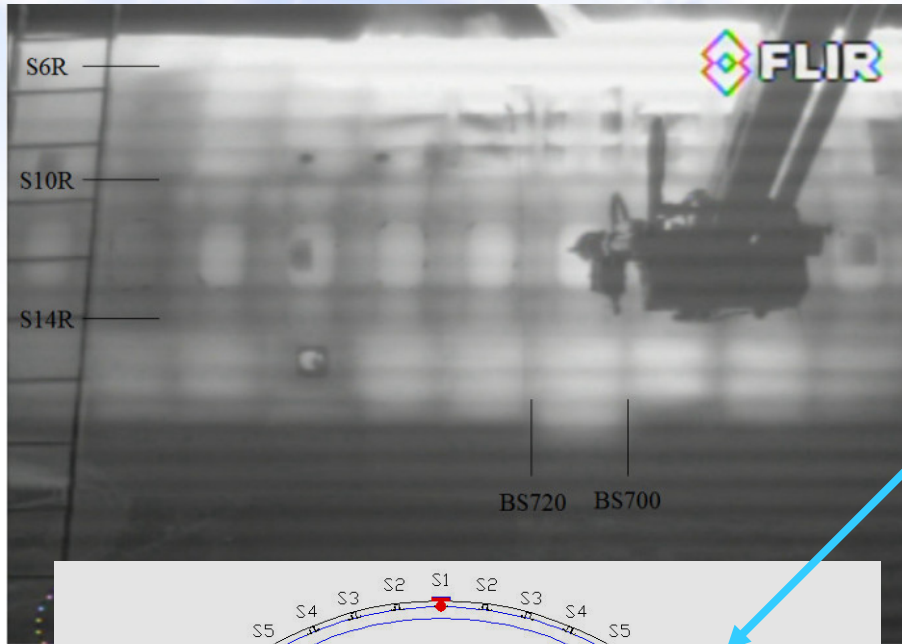
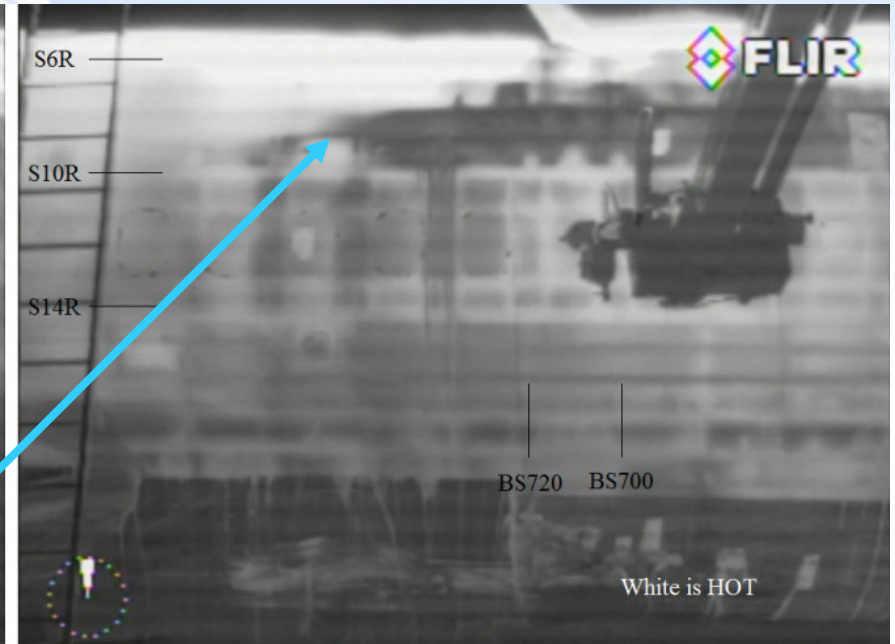
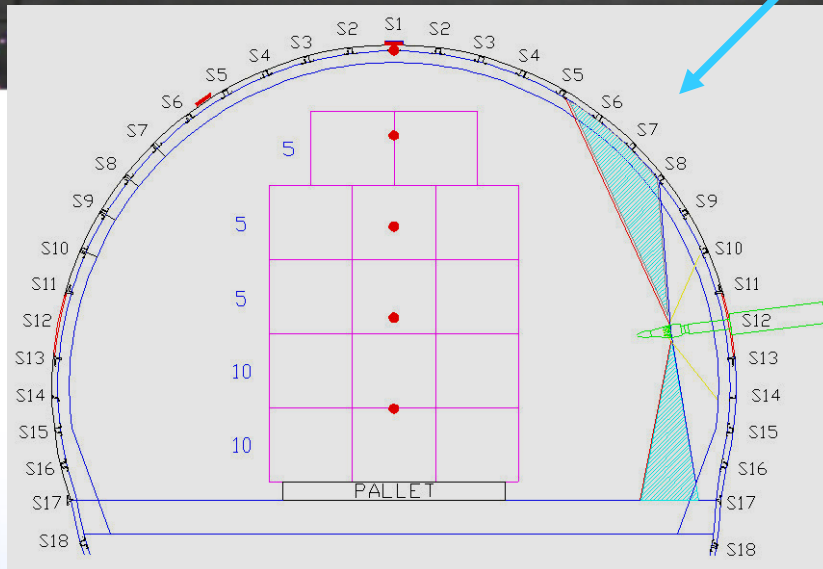
Stinger chisel tip fan-shaped water spray distribution pattern is confined by the fuselage curvature as shown by thermal images taken before and after first application.

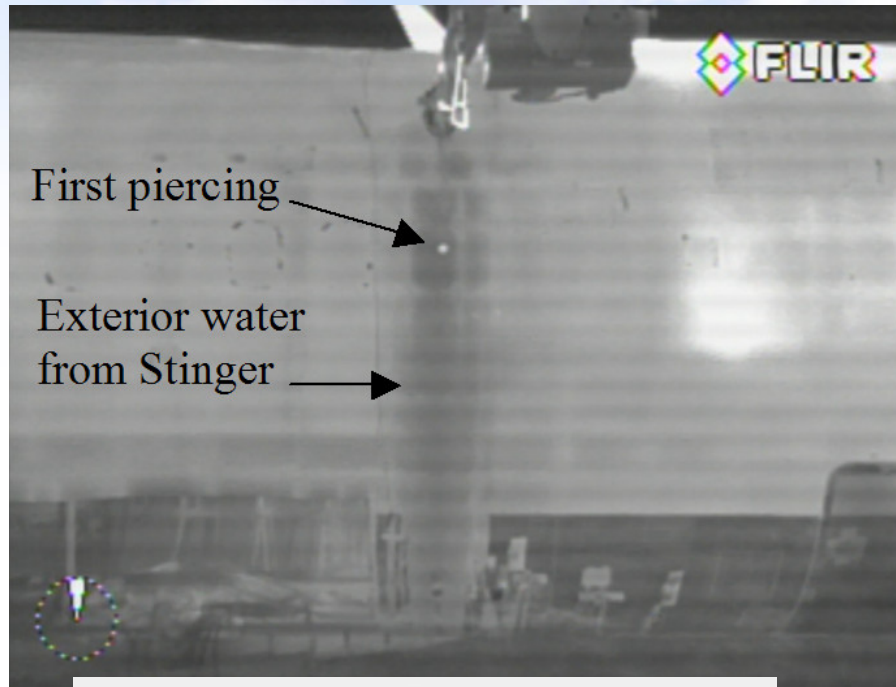
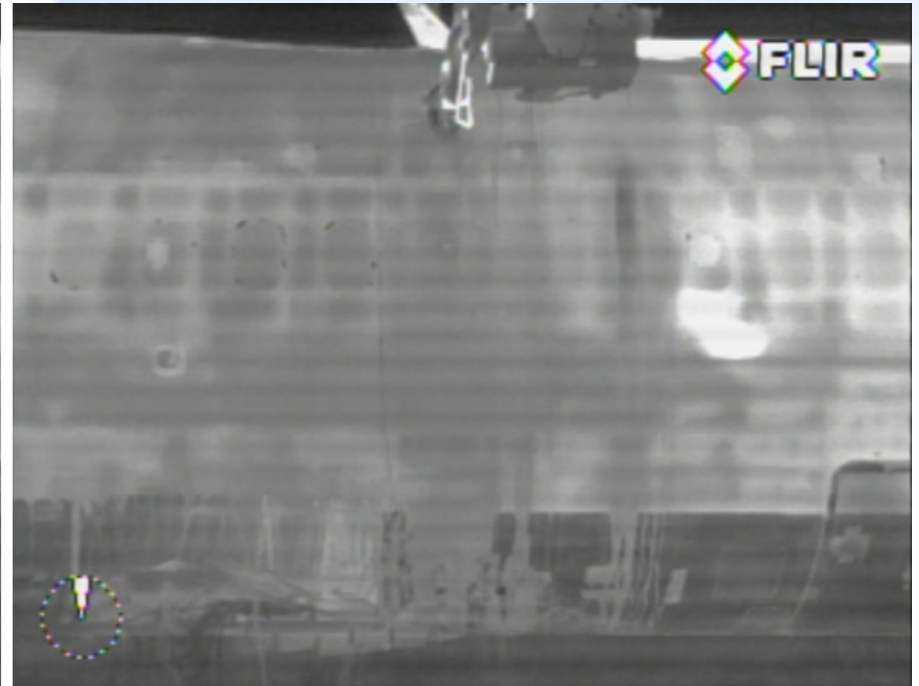
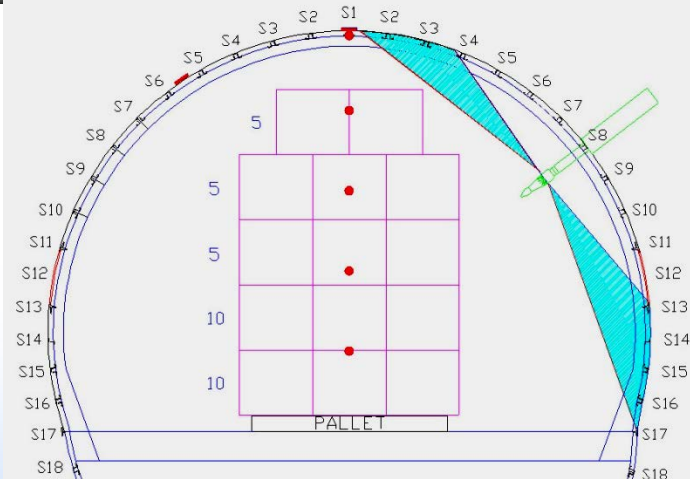
Stinger chisel tip water spray distribution pattern is improved by piercing higher on the fuselage as shown in thermal images taken before and after second application...but this is a cargo aircraft with no O/H bins.

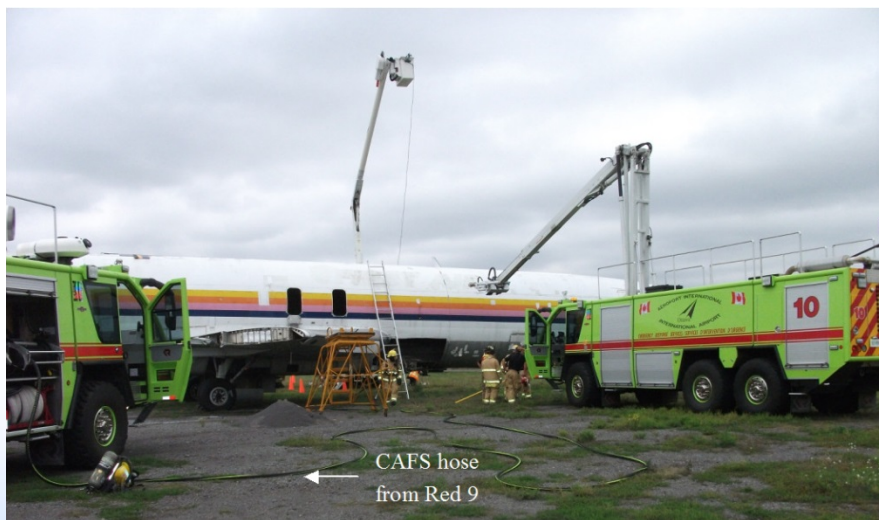
The CAFS foam persists even though 386 US Gal or 1,461 L of water was applied afterwards from the hand-line and second Stinger applications.

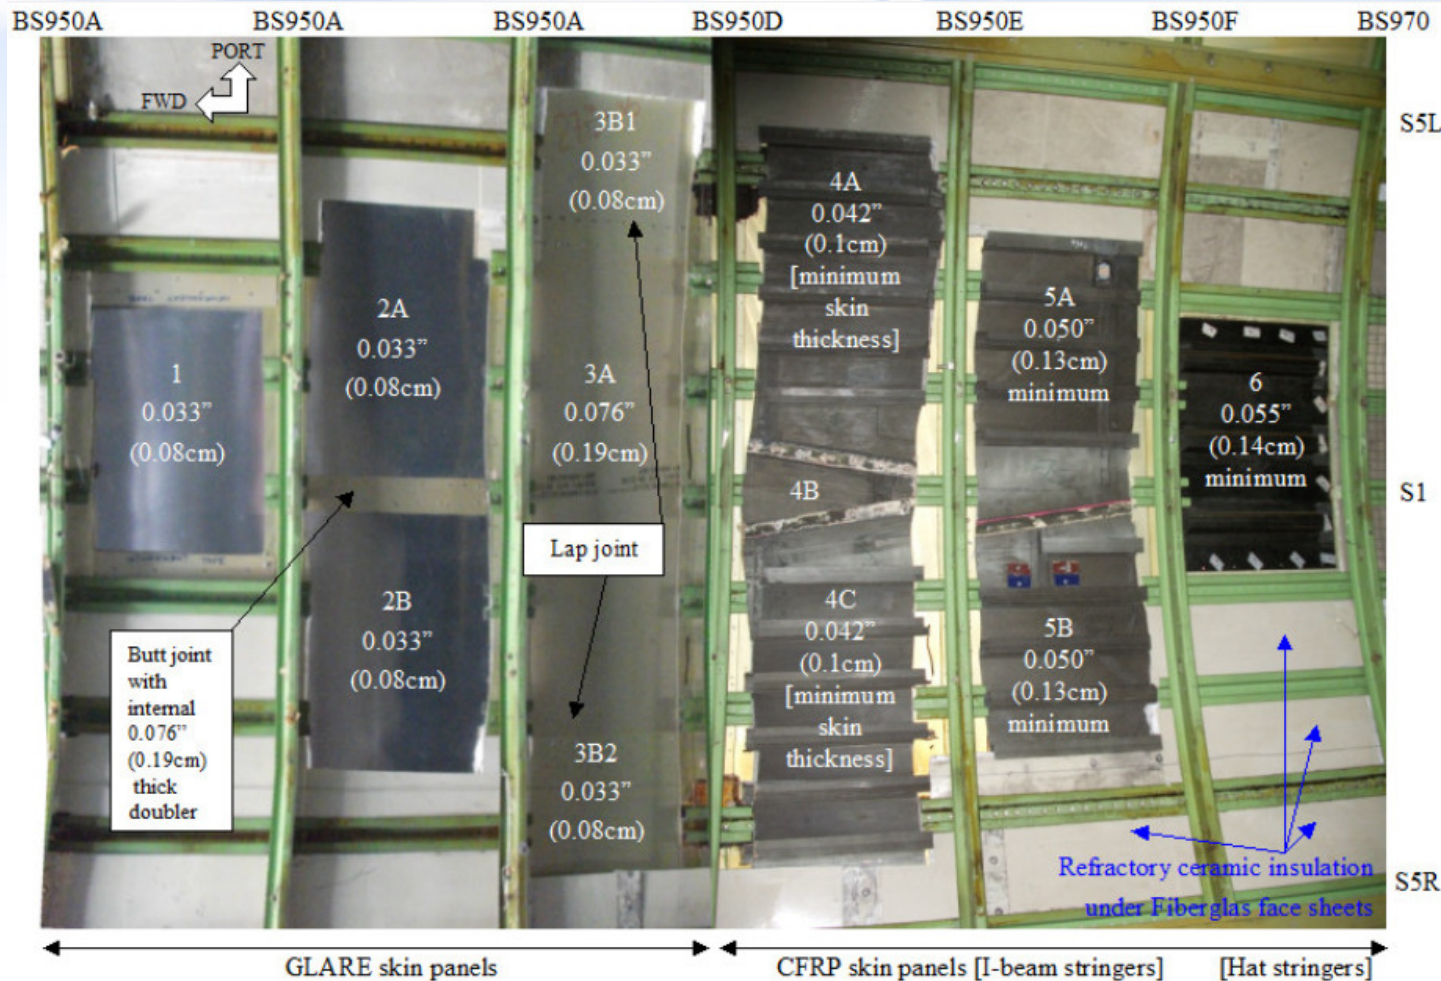
Area with composite skins: ~26ft<sup>2</sup> (2.4m<sup>2</sup>).

Composites skins ranged between 0.033 and 0.076" tk (0.08-0.19 cm).

GLARE 40% thinner than Al skin (except 3A). CFRP equal to or 15% thinner than original Al skin which tapered from 0.050-0.060" (0.127-0.152 cm)

Refractory ceramic insulation used to protect the perimeter aluminium from burn-through.

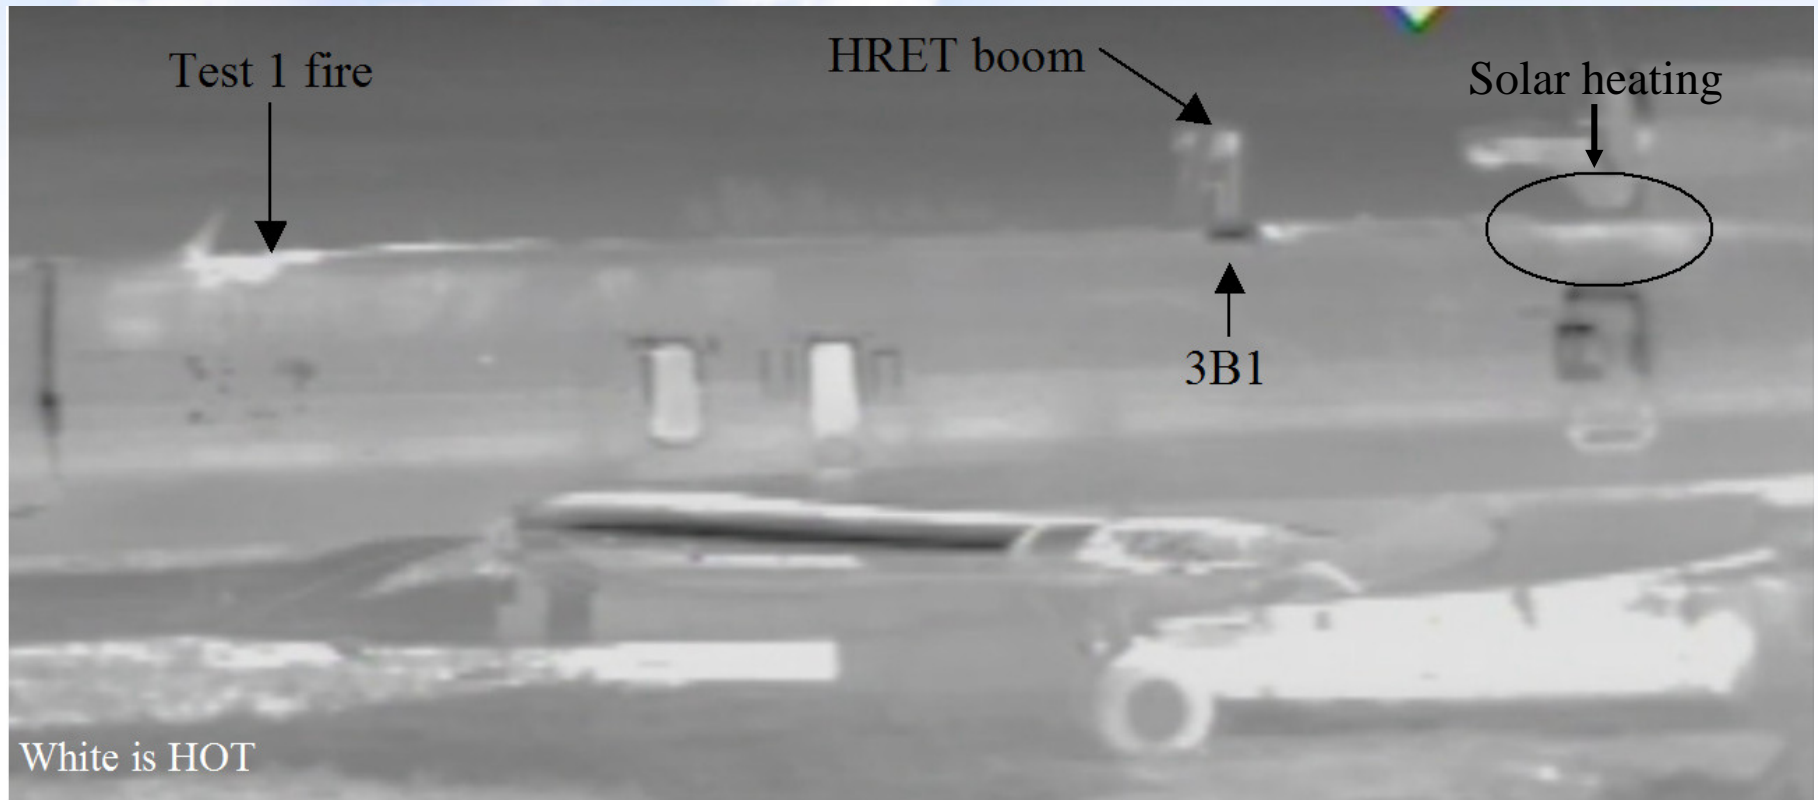
NRC built GLARE panel 3B1 in primer shows black throughout test. Commercial Panel 3A also in primer does respond to heating as do the painted panels. NRC has IR stealth primer?

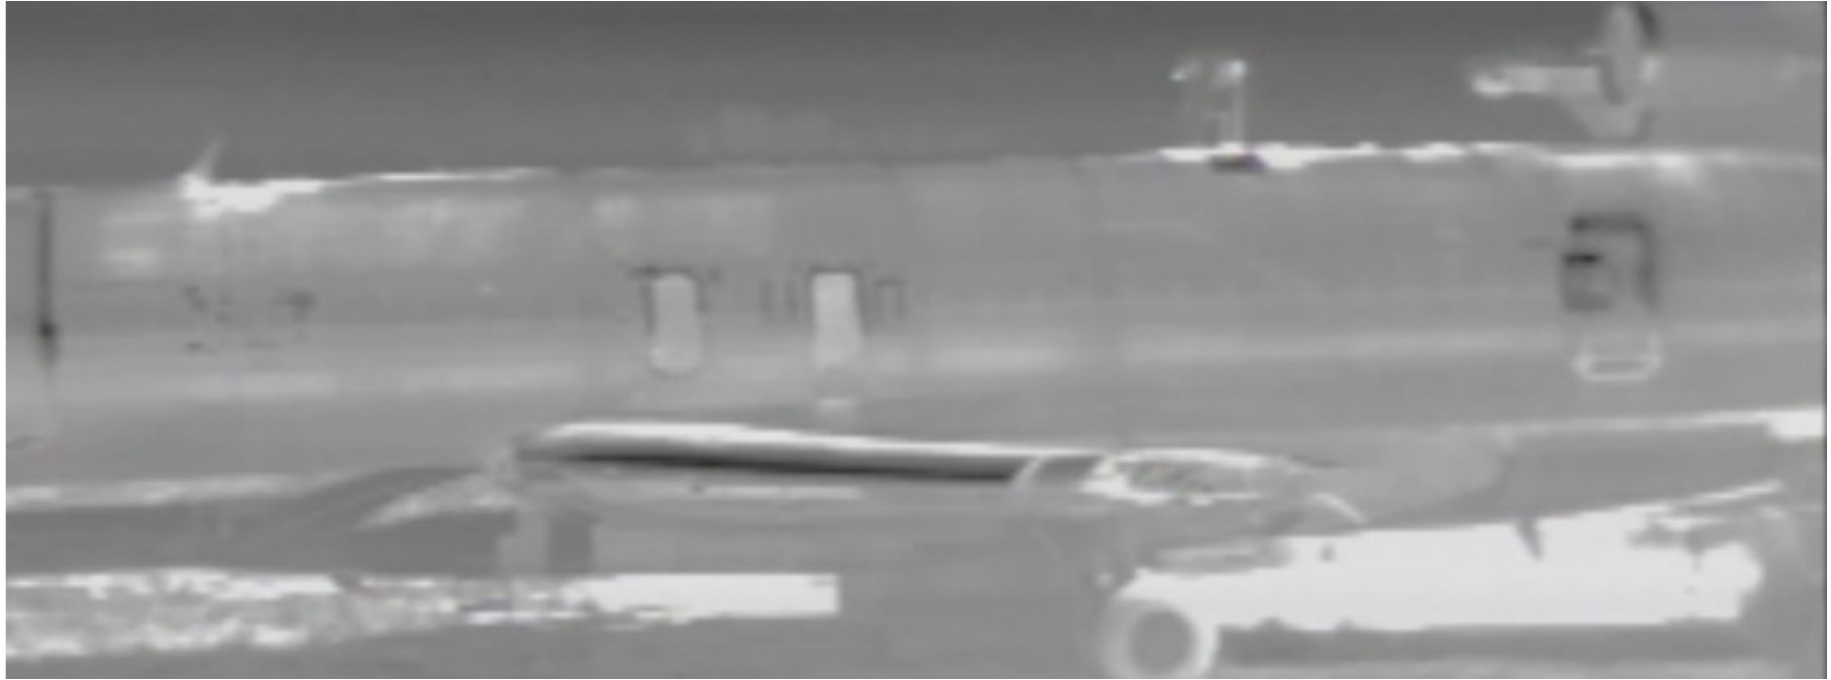
First indication of fire heating crown. Note that 3B1 is still black.

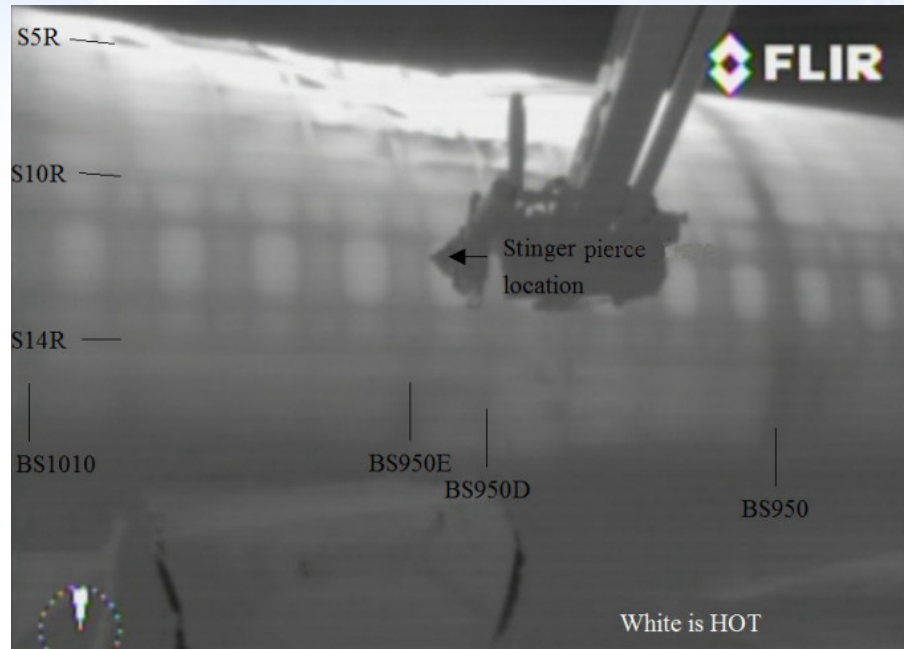
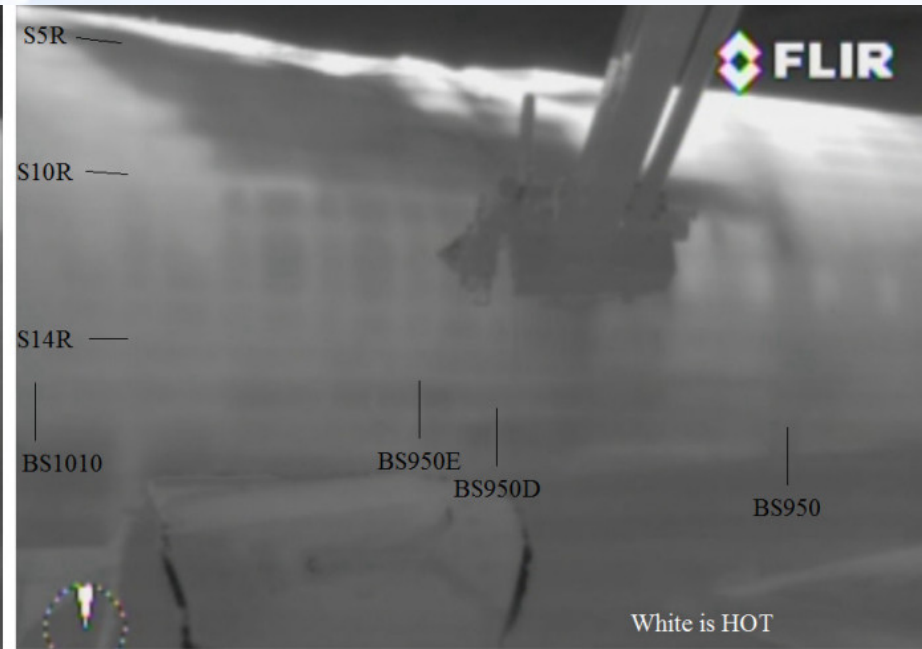
As in Test 1, the Stinger chisel tip water spray distribution pattern is confined by the fuselage curvature as shown by thermal images taken before and after the first application.

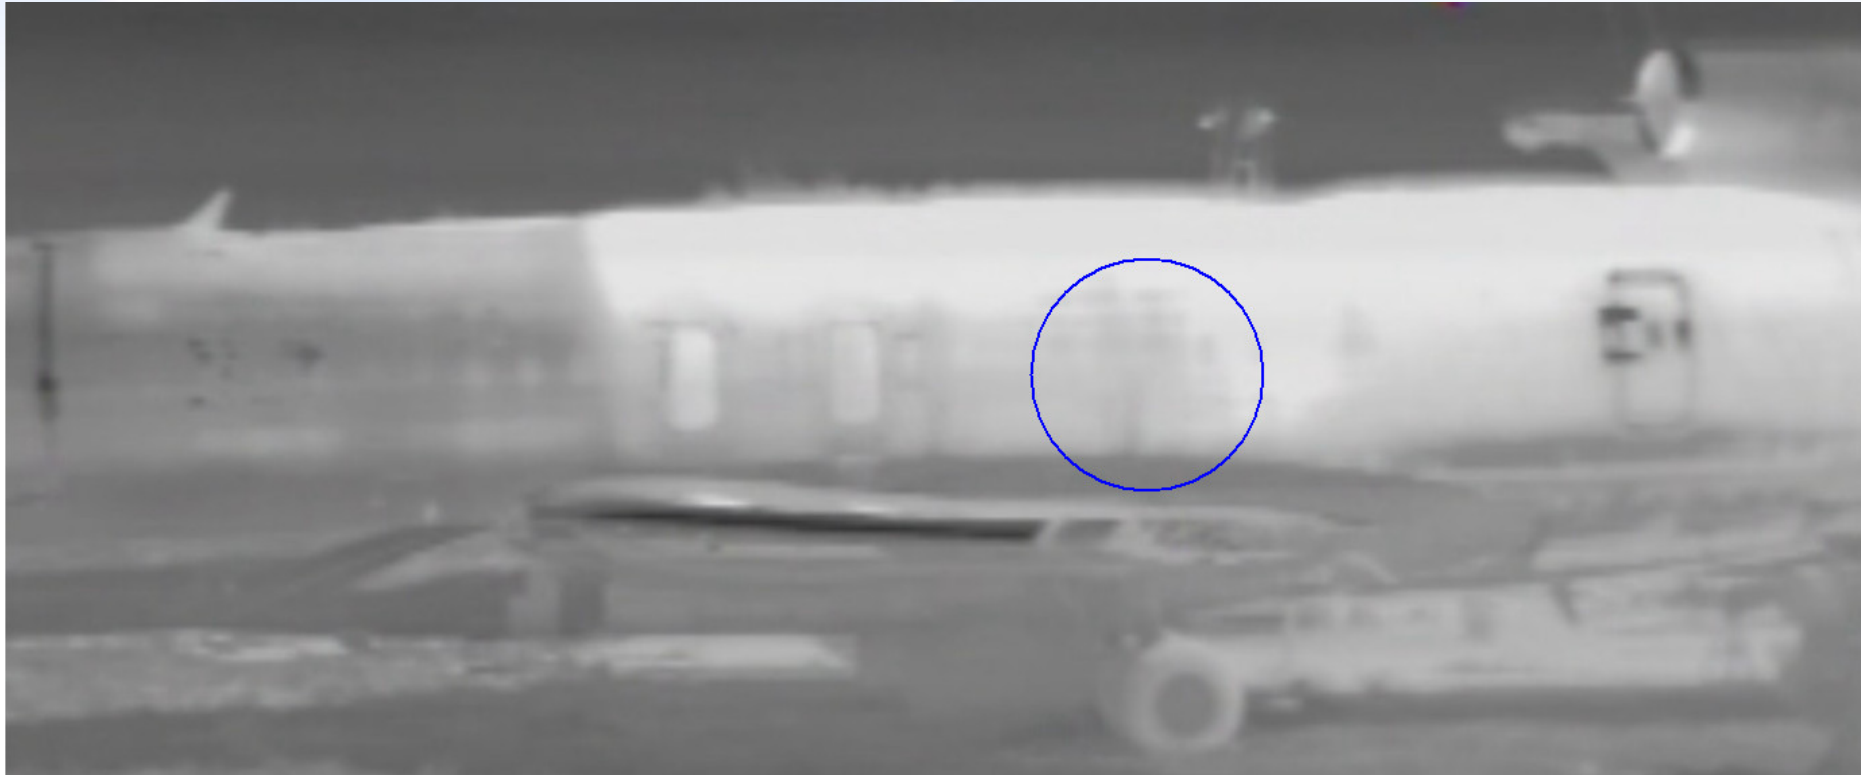
Things looked like this during [PyroLance application 9:13 to 9:54](#)

PyroLance application cools PORT fuselage skin for entire duration of application. PyroLance stream was between TC trees and caused immediate cooling.

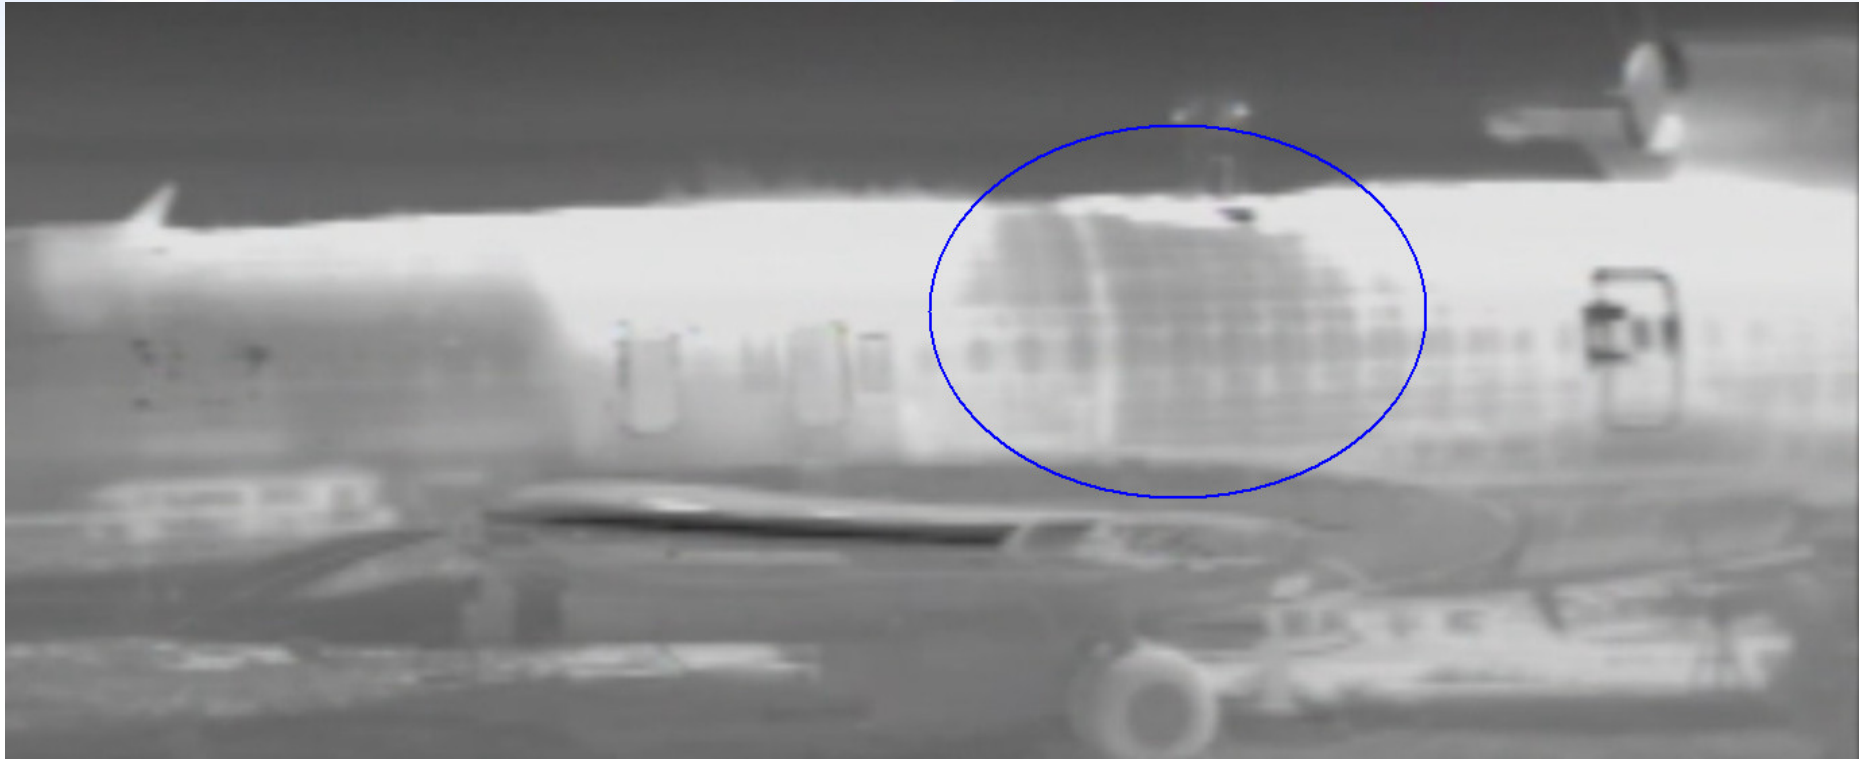
Things looked like this at start of [Hand line application](#) 12:45 to 15:45

Hand-line application cools PORT fuselage. Note that GLARE panel 3B1 is still black.

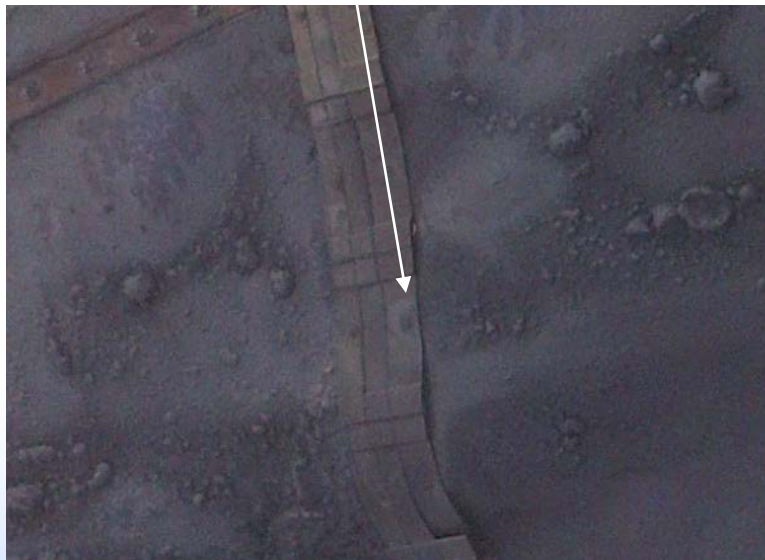
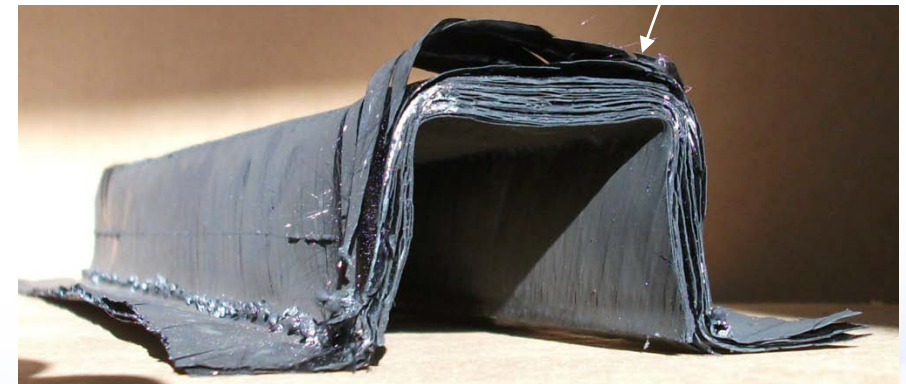
## Post Test 2 CFRP

Add a forest of hanging CFRP plies to the existing entanglement hazard of displaced wiring bundles.

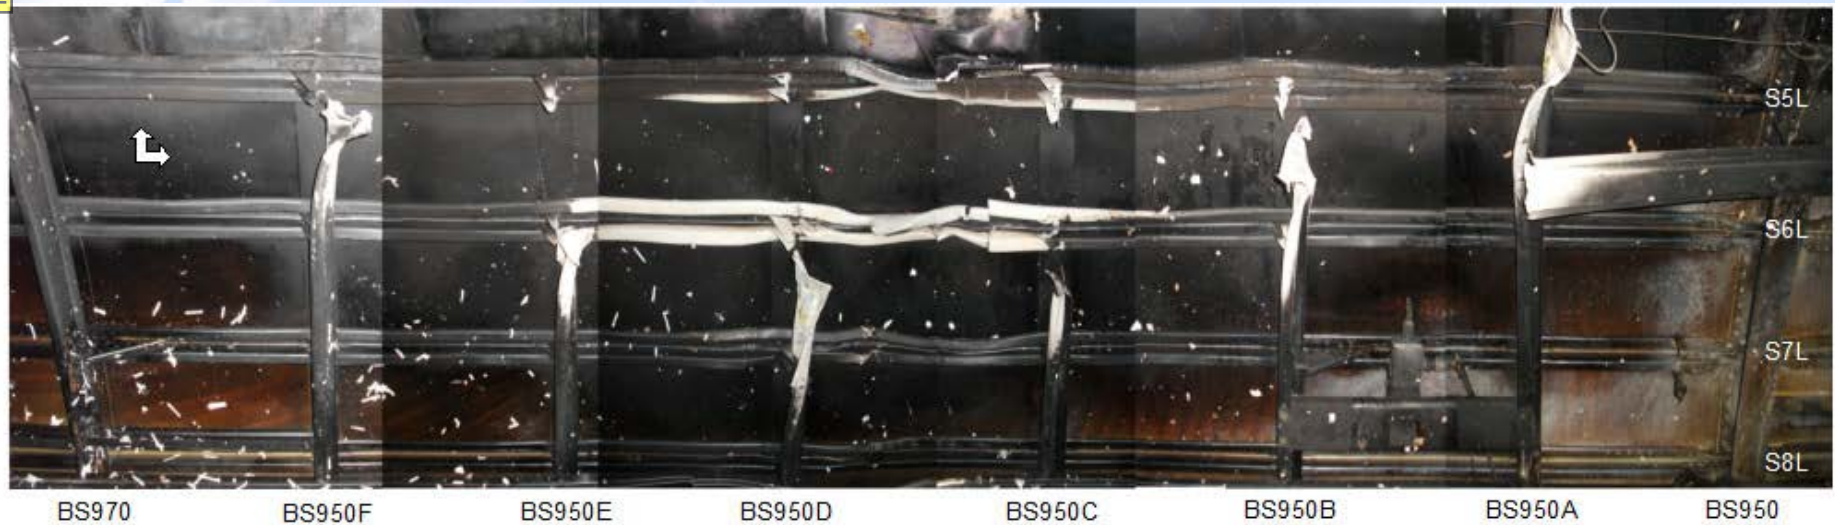
a) PORT

## Test 2 Interior below S6

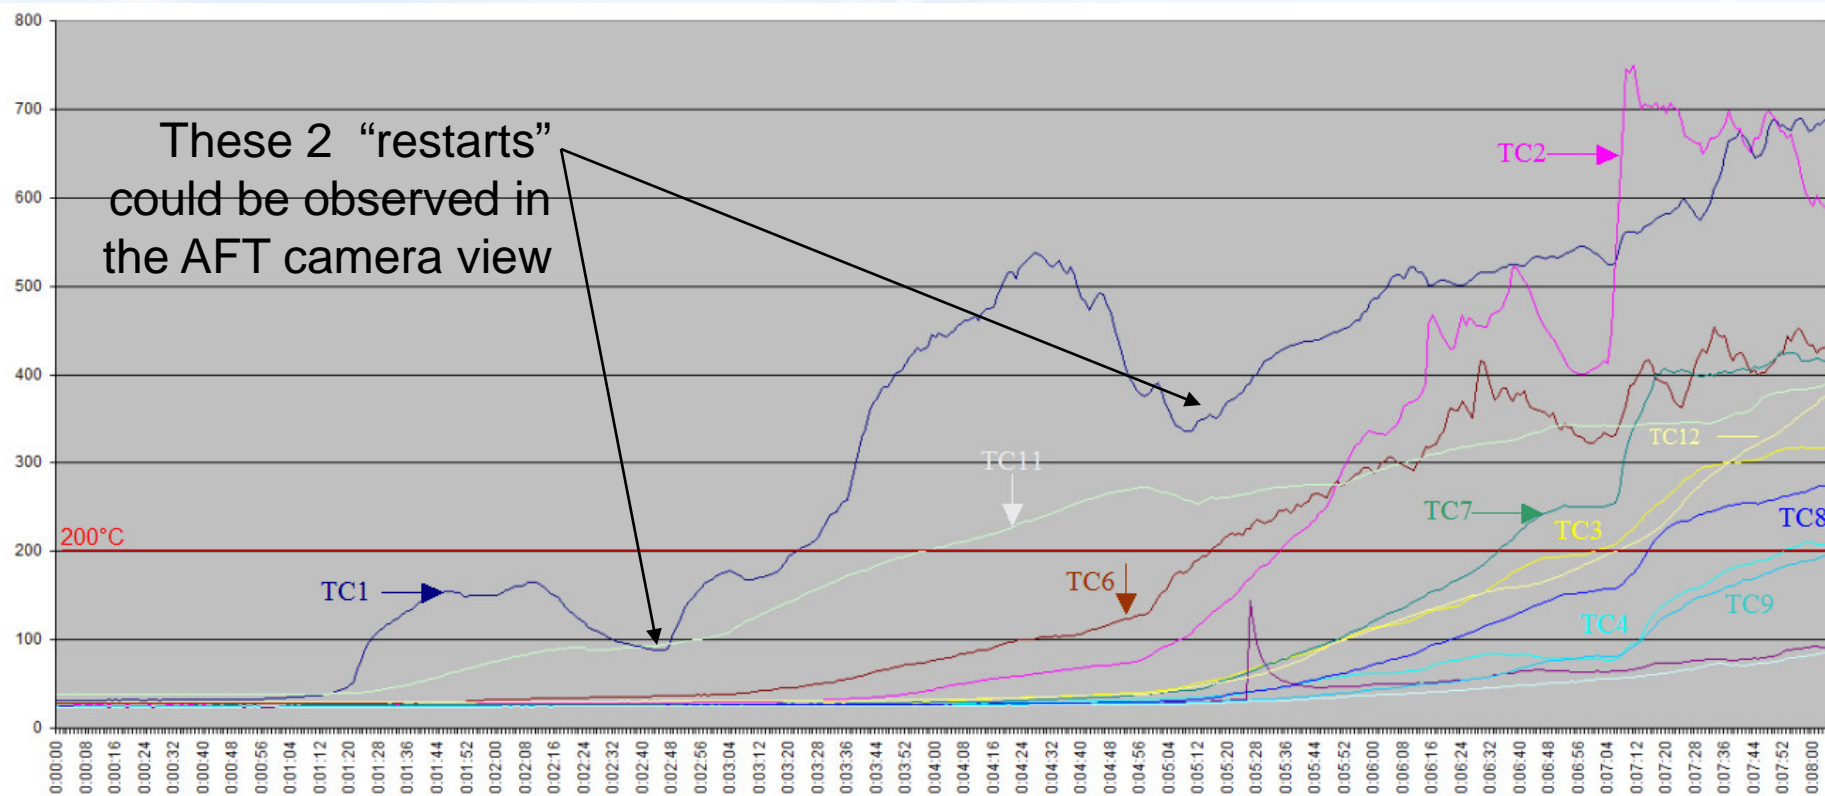
# Test 2 Temperature Profile Prior to Extinguishments

Upper cabin exceeds CFRP  $T_g$  for 10 minutes

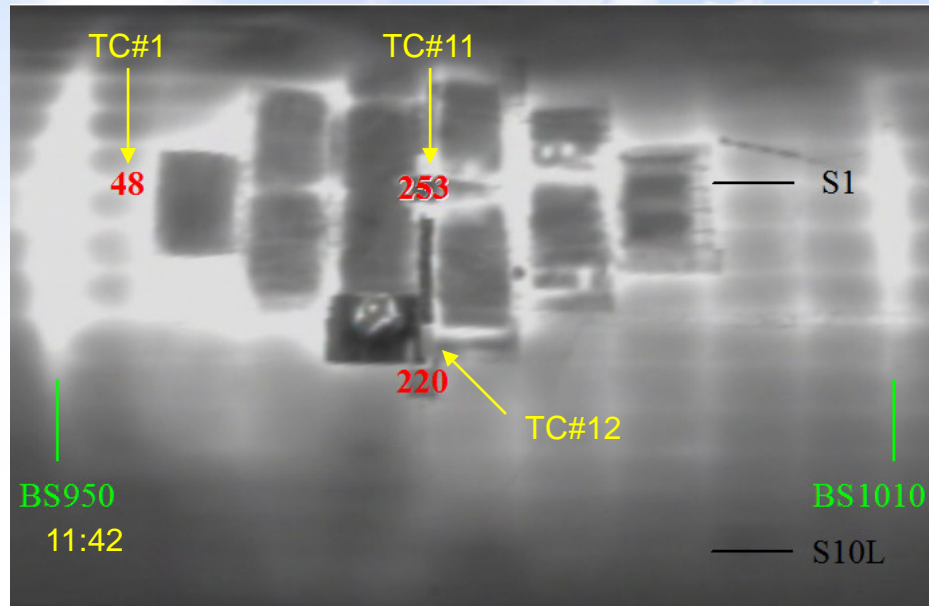
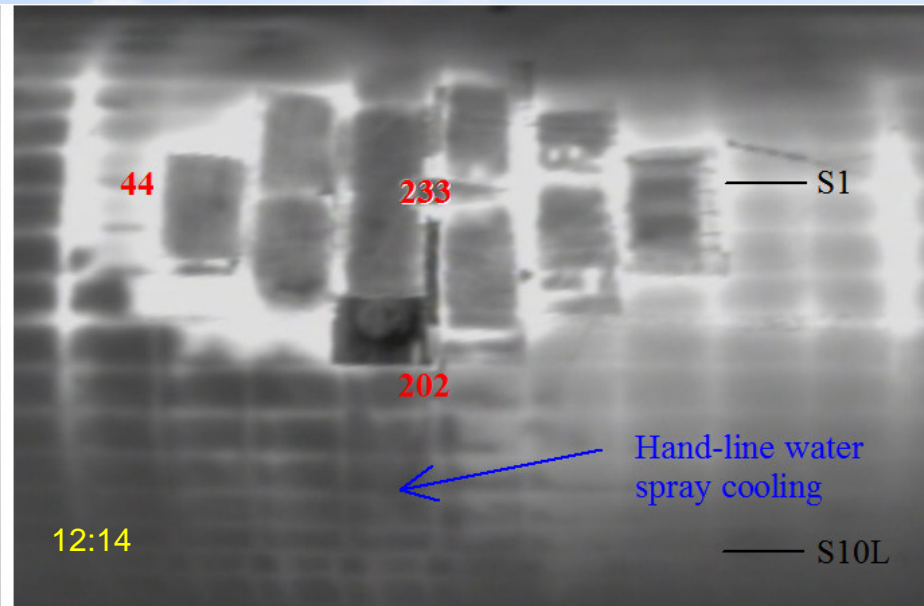
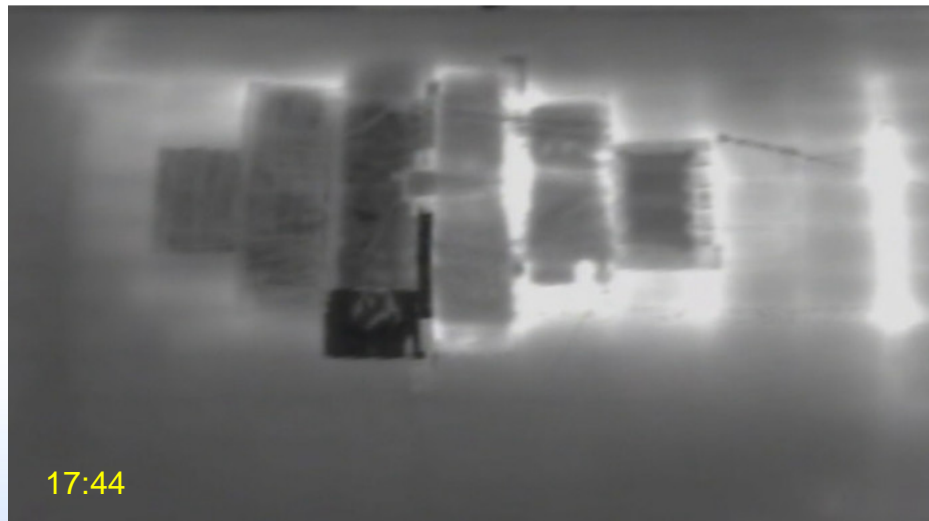
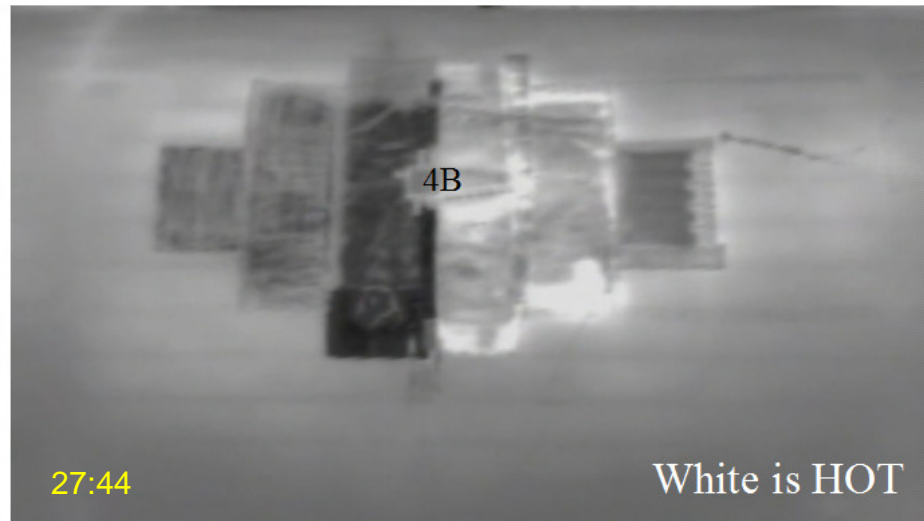
# Does the CFRP retain heat longer or continue to smoulder?

Over-wing hand-line 12:04 to 15:45.

Rear air-stair overhaul 17:43 to 27:00.

TC#1: 48°C = 118°F, 44°C = 111°F

TC#11: 253°C = 487°F, 233°C = 451°F

TC#12: 220°C = 428°F, 202°C = 396°F

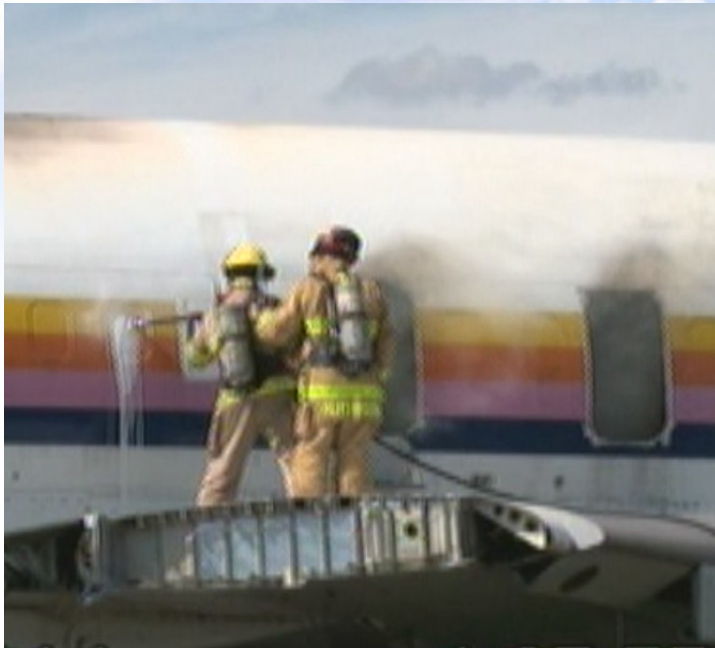
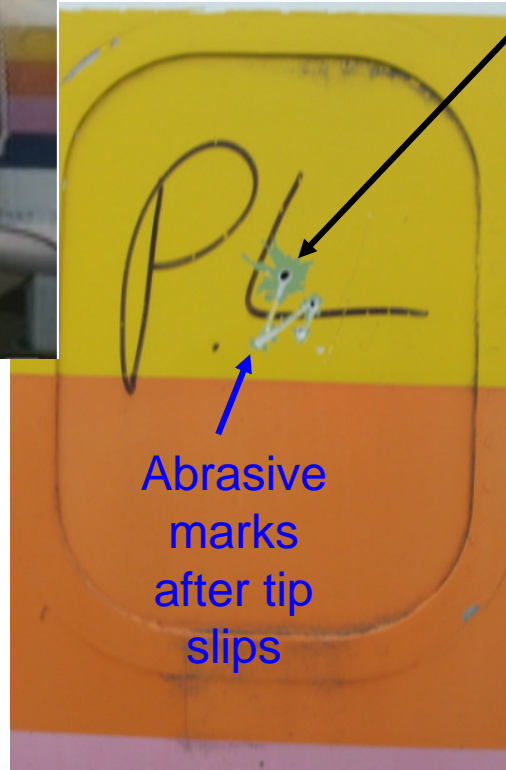
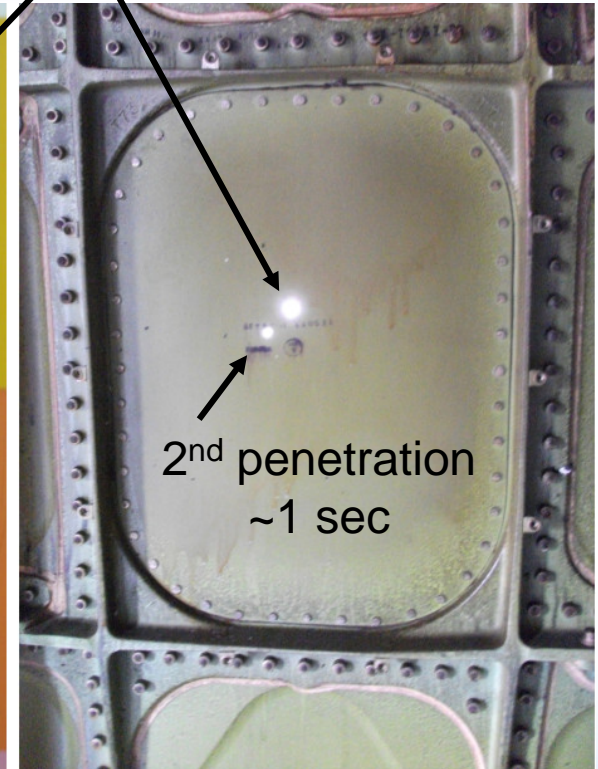
# PyroLance Piercing

Skin pierced and water flows for 36 seconds.

PyroLance attack lasted 1:06

Approximately 6.8 US Gal  
(25.7 L) of water introduced  
into fuselage.

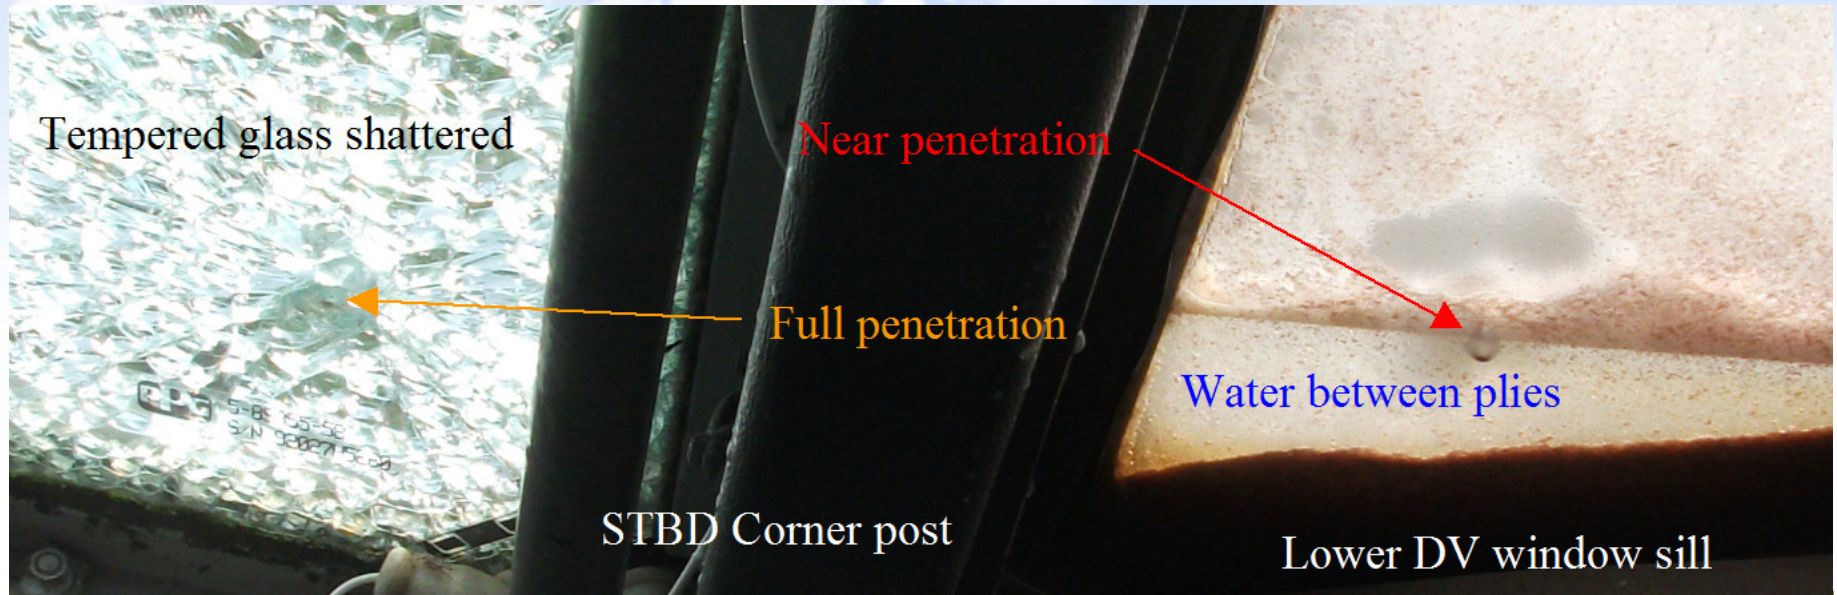
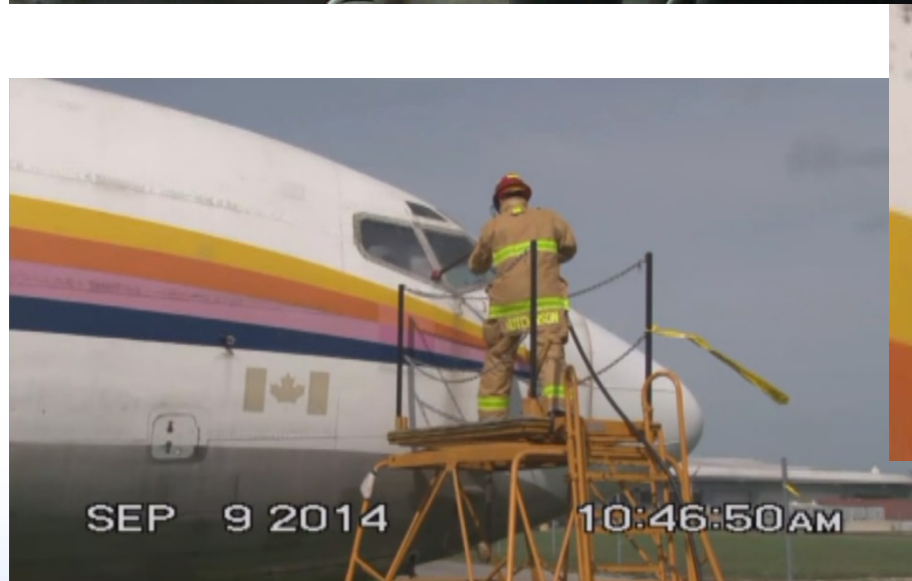
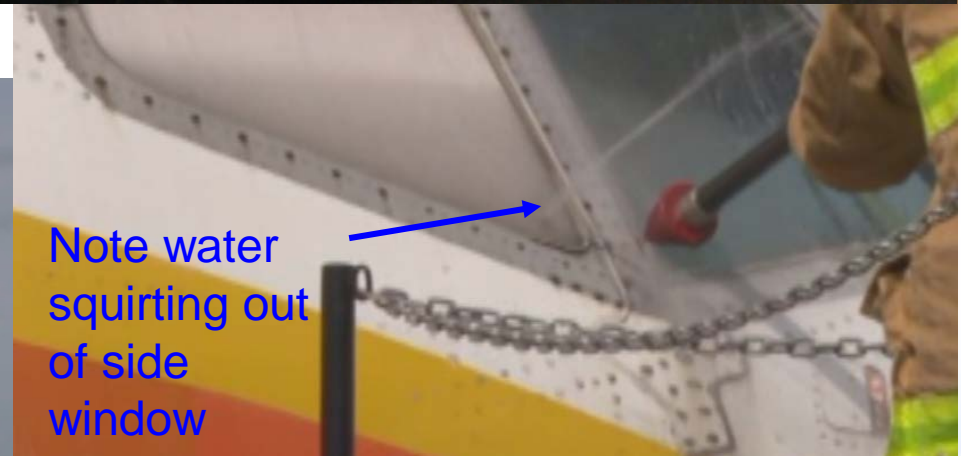
# PyroLance & Cockpit Windshields

PyroLance quickly pierced laminated cockpit windshield and introduced agent – not otherwise easily or quickly accomplished.
