# **Full-Scale Aircraft Fire Tests - A Comparison of Aluminium and Composite Burn-Through**

Report No: LTR-SMM-2015-0414

Date: May 2015

<b>Classification :</b>	Unclassified	<b>Distribution :</b>	Limited
<b>For:</b>	Ottawa International Airport Authority, Emergency Rescue Services		
<b>Reference:</b>			
<b>Submitted by:</b>	S. Beland, Director R&D (Aerospace - SMM)		
<b>Approved by:</b>	J. Komorowski, Director General (IAR)

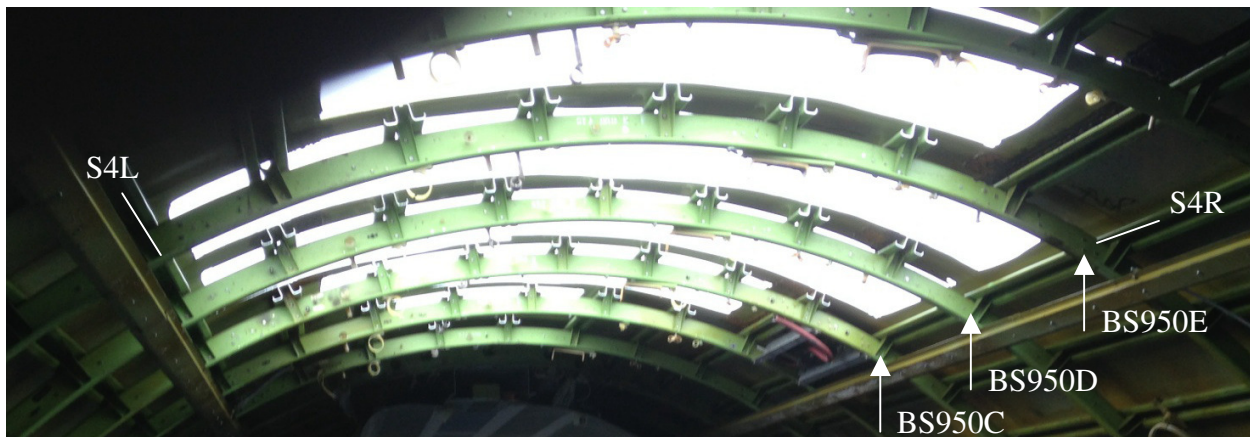
For the composite fire test, rectangular sections of the aluminium skin were cut out between frames at six bays in the crown of the aircraft (BS950A to 970) leaving narrow strips of aluminium skin to attach the replacement composite sheet material (Figure 11). Between the stated body stations the crown aluminium skin was machined to a taper in thickness from 0.060 to 0.050 (1.52 to 1.27 mm).

Figure 11: Skin sections and stringers removed.

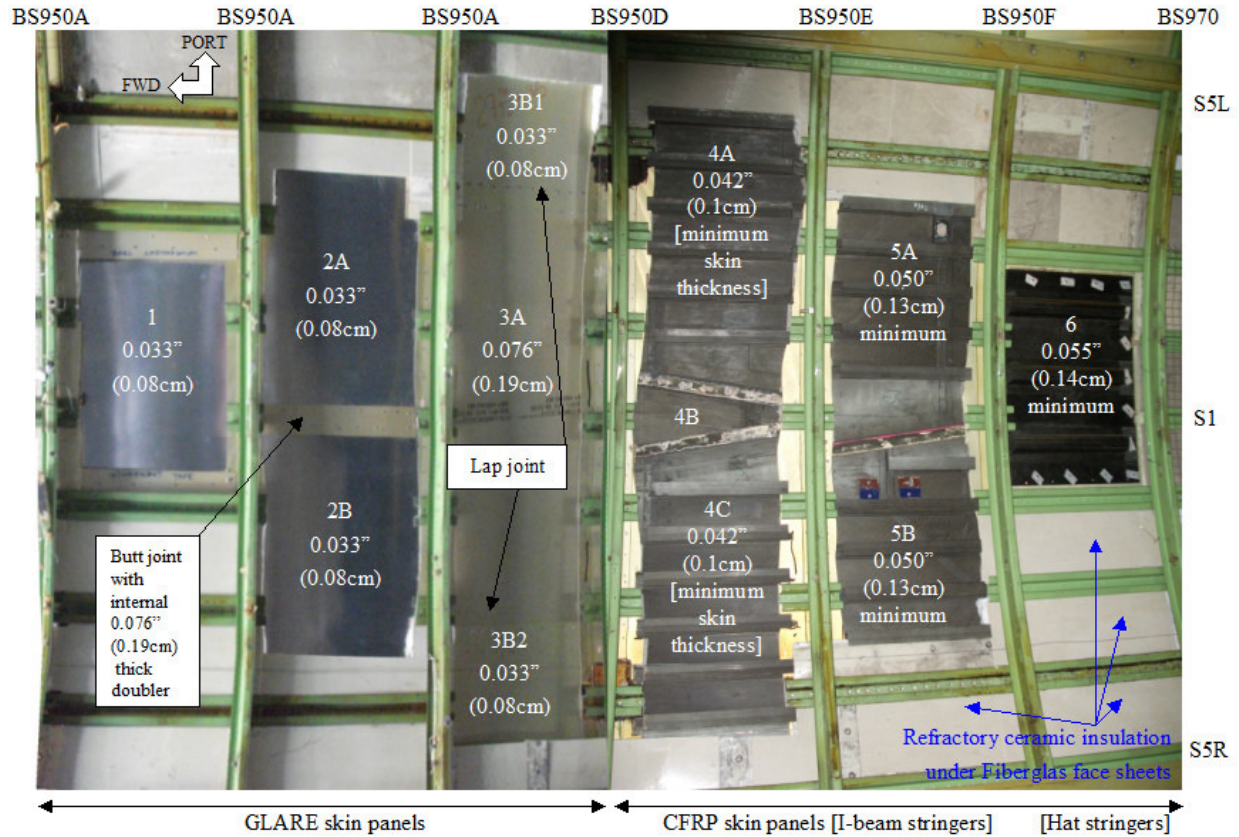
One-inch thick fibrous refractory ceramic insulation was installed inside the aircraft between the stringers in a perimeter around the composite panels to mitigate burn-through of the aluminium supporting the composites. The insulating material was held in place by 0.050 inch (50mm) thick sheets of fibreglass panel, salvaged from the original cargo liner, which were tucked under the stringer flanges (Figure 14).

Figure 14: Interior view of Test 2 composite skin panels.

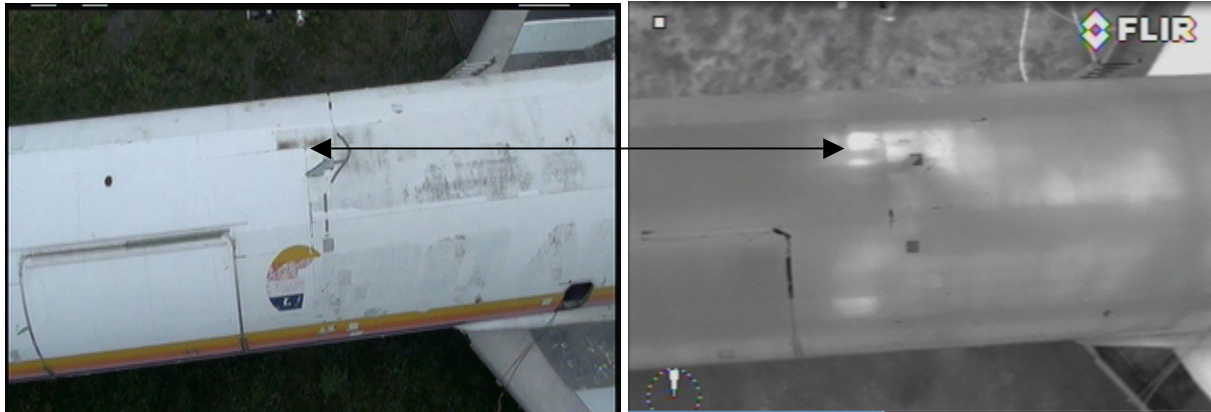
b) First exterior indication of fire (arrow) is in the region of solar heating.

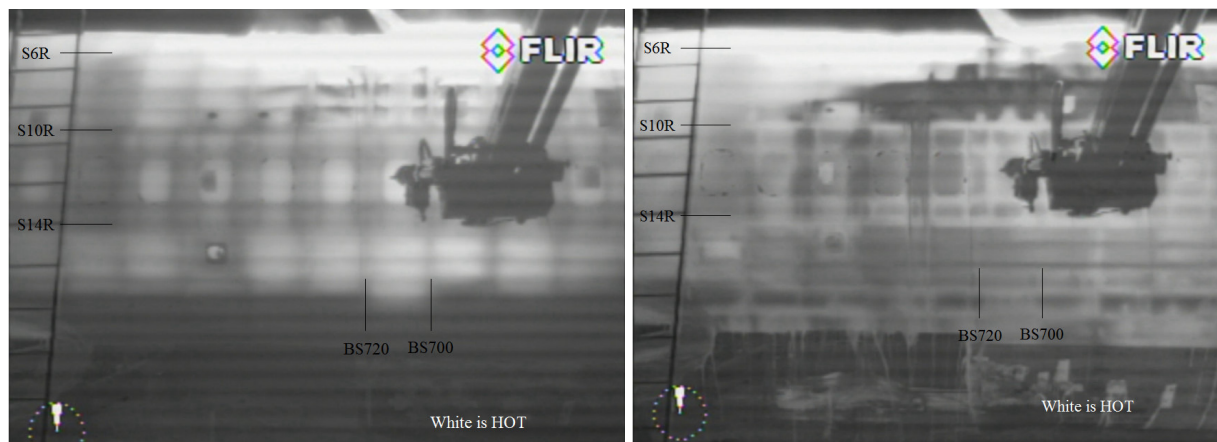
Figure 18. Red 10 TIC views at the beginning and end of the first Stinger extinguishment.

The first extinguishment with the HRET Stinger at 6:57 affected the outer skin of the aircraft as shown in the Red 10 TIC views, Figure 18. By the end of the extinguishment (7:55) water has cooled an area from just above S8R and down to the main deck floor. Heated water can be seen draining from the aircraft. The area cooled by the Stinger will be discussed further in Test 2.

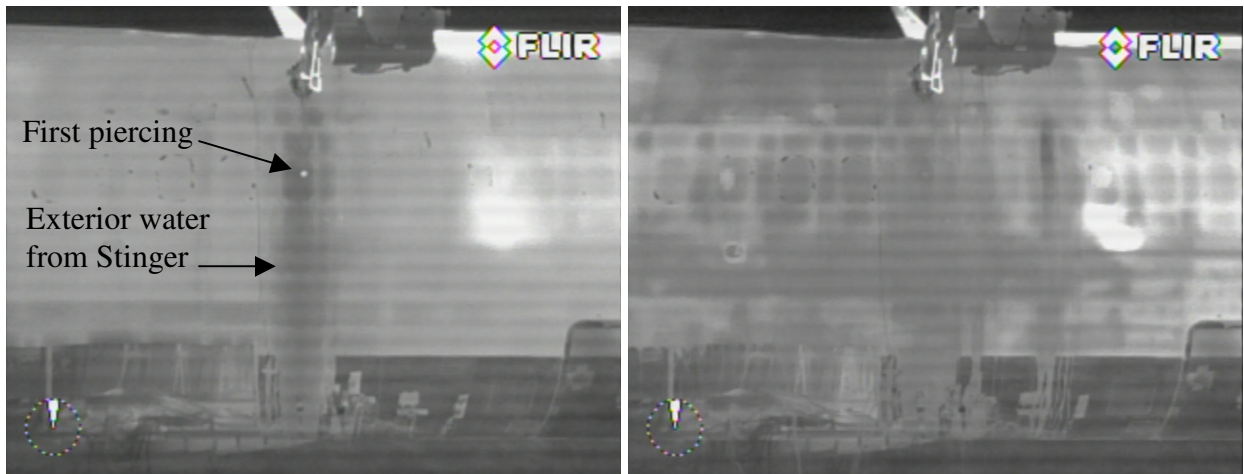
The second HRET Stinger application at 16:27 was higher on the fuselage side and lasted for 57 seconds, Figure 19. A larger area was seen to be cooled but note that a hot spot remains.

Figure 19. Red 10 TIC views just before and after second Stinger extinguishment.

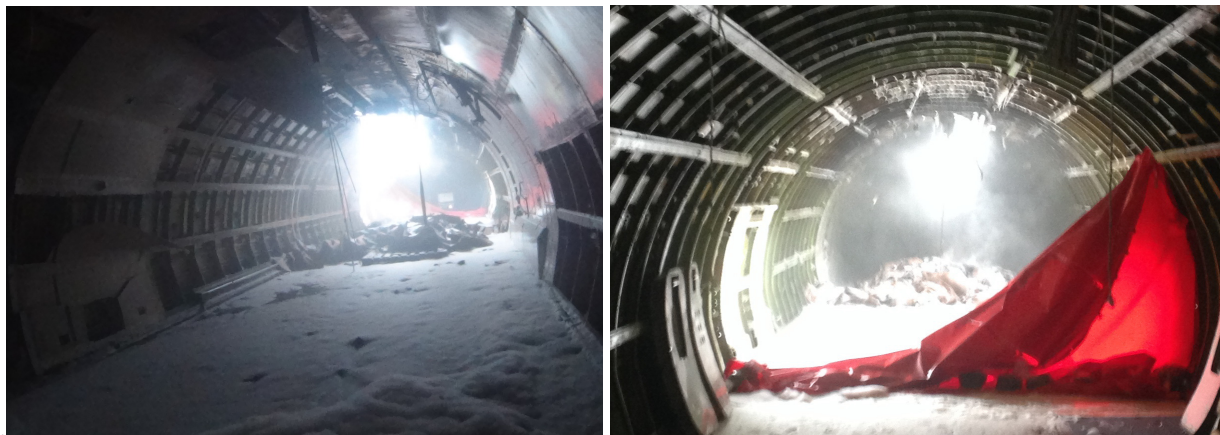
Images of the main deck after the CAFS applications, second Stinger and hand-line work show a blanket of foam remaining and the un-burnt pile of boxes which was reported to be 18-inches deep (45.7 cm) when firefighters entered the zone, Figure 21.

Figure 21. Post-Test 1 overhaul. Foam and remains of fuel load.

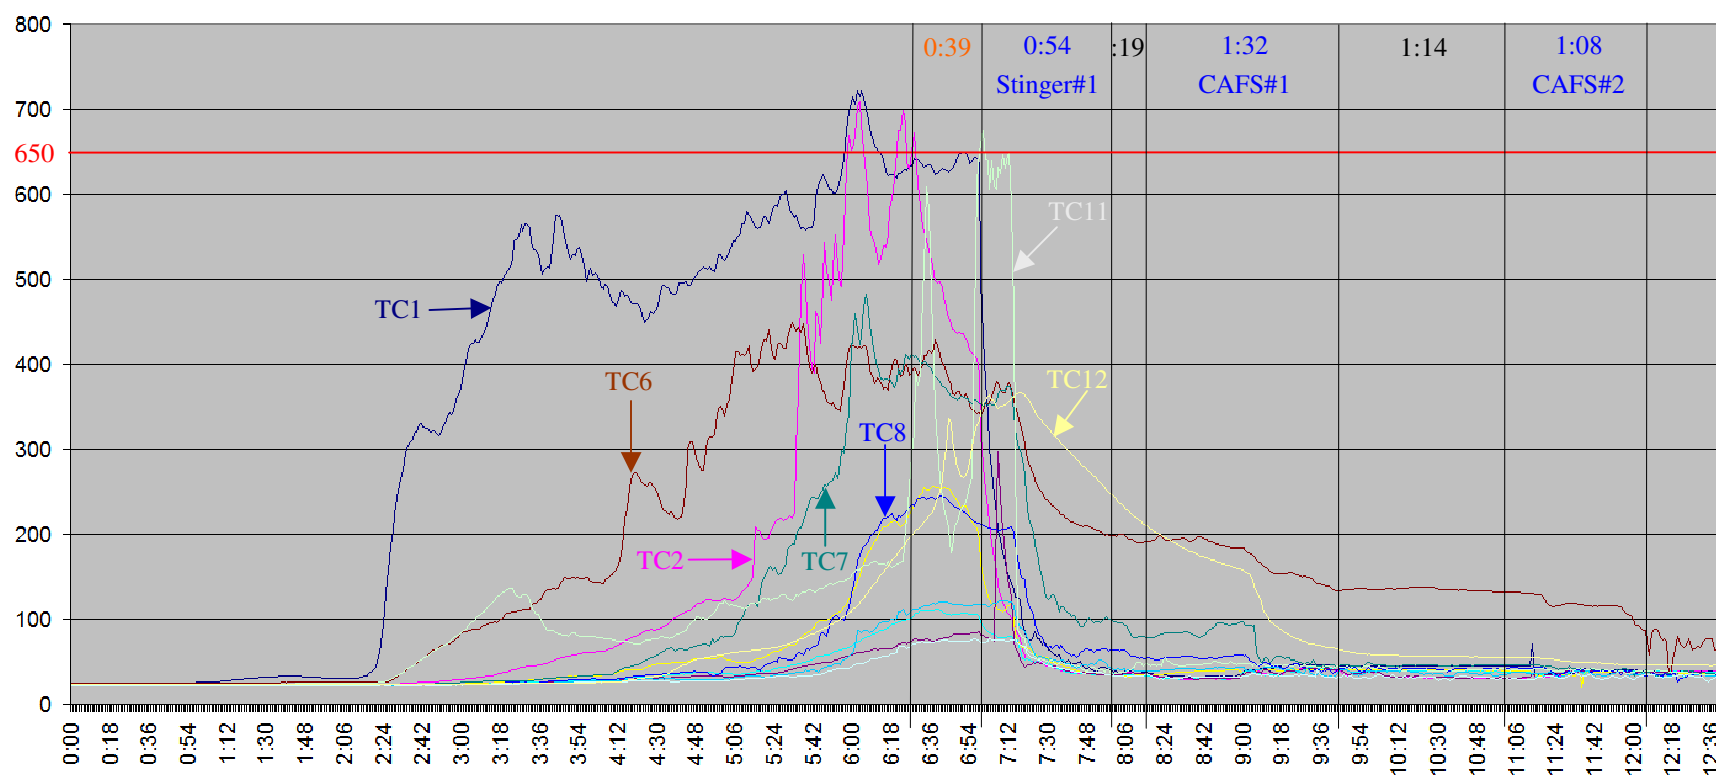
The temperature data from the 12 TCs were collected at one second intervals. The data for Test 1 is presented graphically in Figure 22. Note that according to Matweb.com, the reported melting point of 2024 T3 aluminium ranges from 935-1180°F (502-638°C) and for 7075 T6 aluminium ranges from 890-1175°F (477-635°C).

From analysis of the overhead video there is a 39 second period following the crown first being breached by fire before the first Stinger extinguishment starts. TC#11 fell into the top of the fuselage during those 39 seconds when the crown melted away. TC#1 and #2 at the top of thermocouple tree #1 read above 650°C (1200°F) a minute before TC#11 reached this temperature and this was after it had fallen into the fire when its readings drop dramatically and then recovered rapidly. Some of the TC#11 wire insulation was found to be burned off leaving the two wire conductors exposed. These wires may have come in contact during or after their fall into the fuselage affecting the data during this period.

Other than TC#1, all of the other upper level thermocouple readings declined between the start of the crown burn-through until the start of the first HRET Stinger extinguishment. TC#2 had the most rapid temperature decrease, dropping 570°F (300°C). TC#6, at the top of thermocouple tree #2 and 160 inches (4.6 m) away from the crown breach, dropped 188°F (87°C) in the same period. This is evidence of the heat released by vertical ventilation as a result of the crown burn-through. All of the temperature readings fall soon after the first Stinger extinguishment starts.

Figure 22. Thermocouple data (°C) for Test 1 with initial extinguishments annotated.

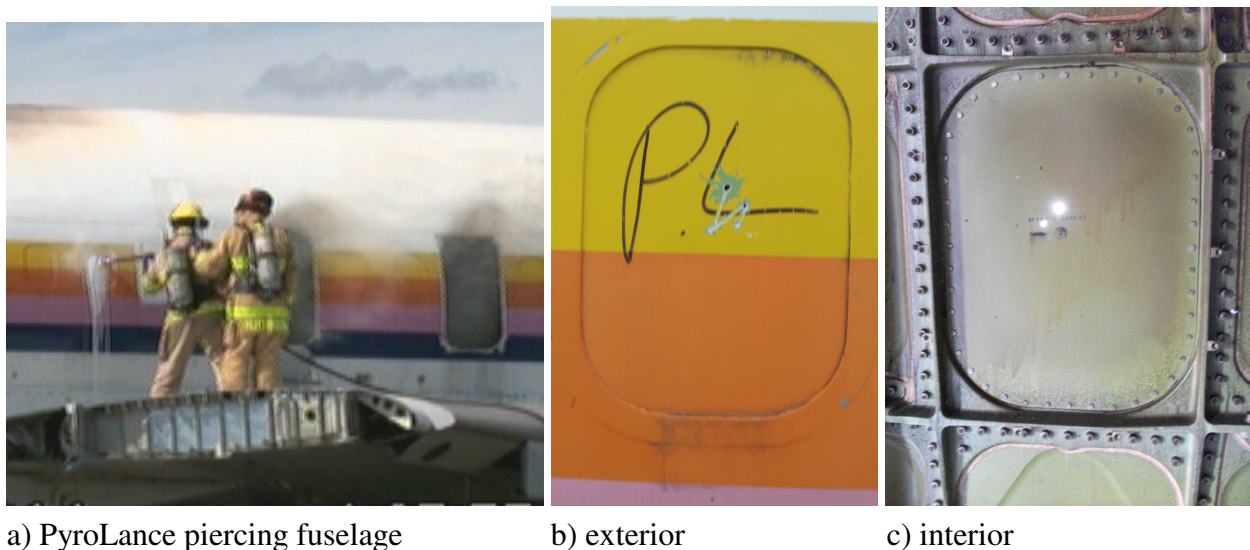
Figure 27. PyroLance piercing fuselage, Test 2.

The PyroLance piercing is shown in Figure 27 with a view after the fuselage has been pierced and while agent is being delivered inside the fuselage. The exterior and interior surfaces of the two-ply aluminium window blank are shown post-test. The upper and larger hole was the first piercing and agent flowed through this hole for 41 seconds. The exterior view also shows the track after the operator slipped and the operator triggered for abrasive media to try and pierce through again. The panel was pierced a second time at the very end of the action but no significant amount of agent was delivered through this hole.

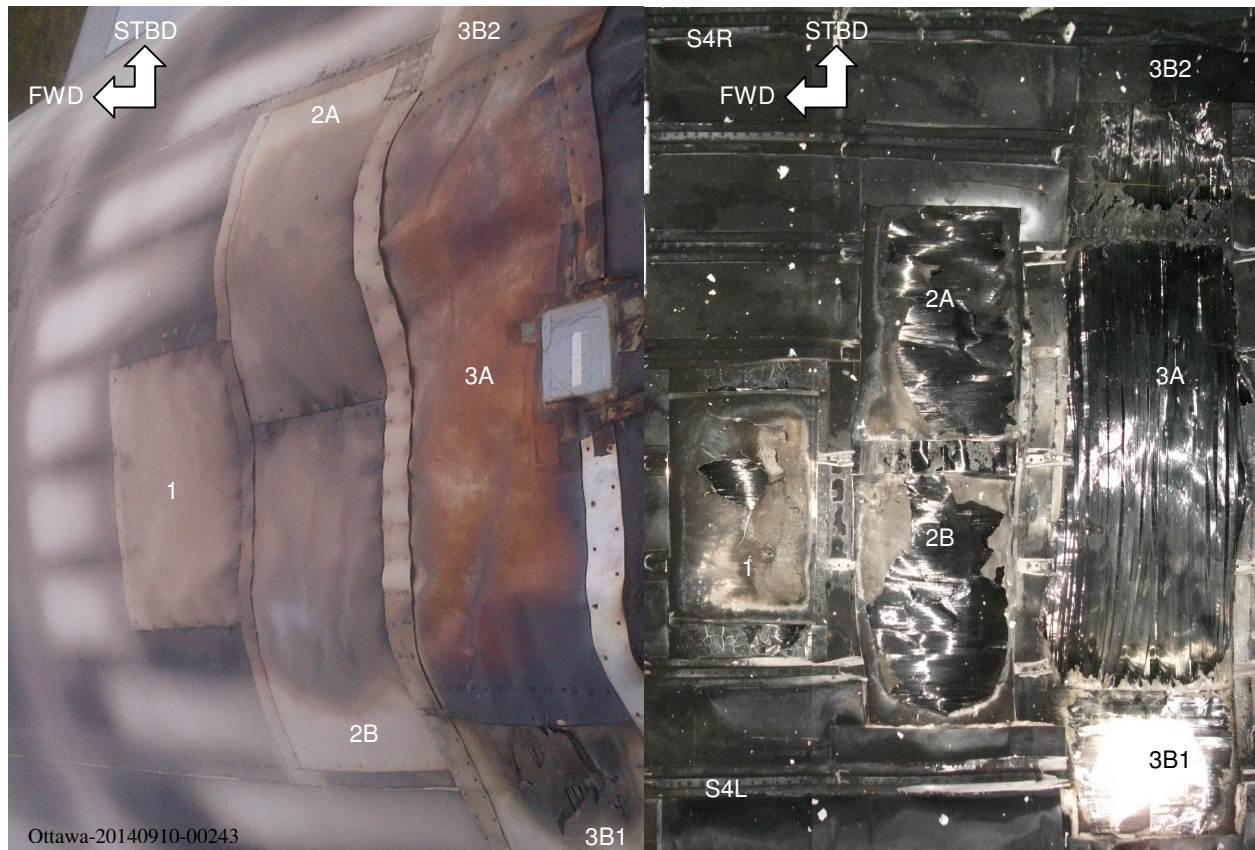
Internal inspection of the GLARE panels, Figure 29, revealed that all of them had suffered disassociation (delamination) of the layers and loss of some or all of the inner aluminium sheets as well as the epoxy adhesive. In effect, only the outer aluminium sheets remained intact except for panels 3B1 and B2 which both suffered some degree of burn-through. The burn-through area (breach of the outer aluminium ply) was largest on Panel 3B1. Smoke was observed escaping the fuselage from these breaches.

The GLARE panels would have normally been attached to aluminium stringers. As seen in Test 1, the stringers would have burned away or been damaged. The fibres seen hanging loose, such as those of panel 3A in Figure 29b, would be the realistic result of fire damage for this type of construction. A closer view of the burn-through to panel 3B1 is shown in Figure 30. The inner sheet of aluminium has melted or burned away with material remaining only around the perimeter where it was attached to other structure. The outer aluminium sheet had just been breached by the end of the test and the fibres within can be seen in these areas. The glass fibres remain in place and act as a restriction to the escape of smoke and heat.

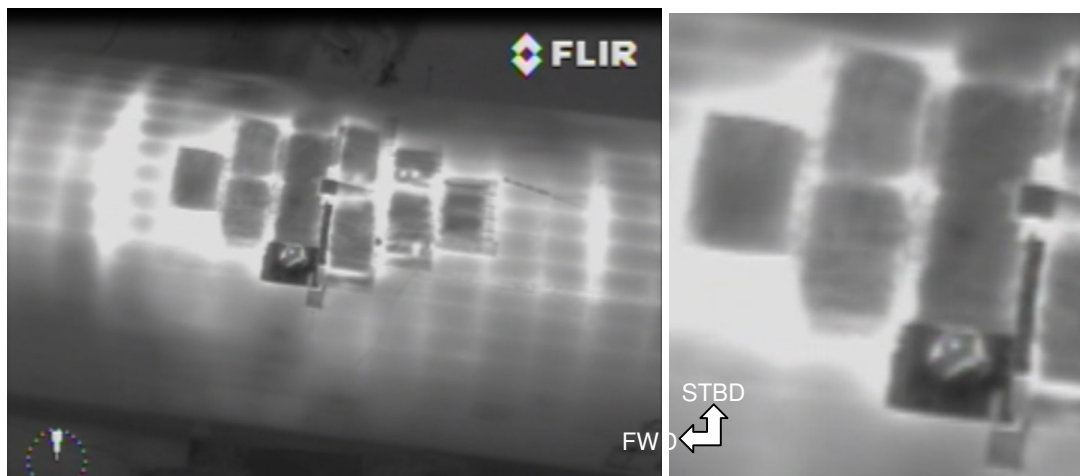
Figure 31. Overhead TIC image at 11:44 (after Stinger and PyroLance extinguishments).

Figure 31 shows an overall view from the overhead TIC camera after burn-through as well as a close-up of the GLARE panels. The camera setting was “white is hot”. Panel 3B1 was not painted white and the emissivity of its outer surface caused this panel to show as black throughout the test. The heat escaping through the breach in panel 3B1 is being detected as hotter (white) as can be seen in the images.

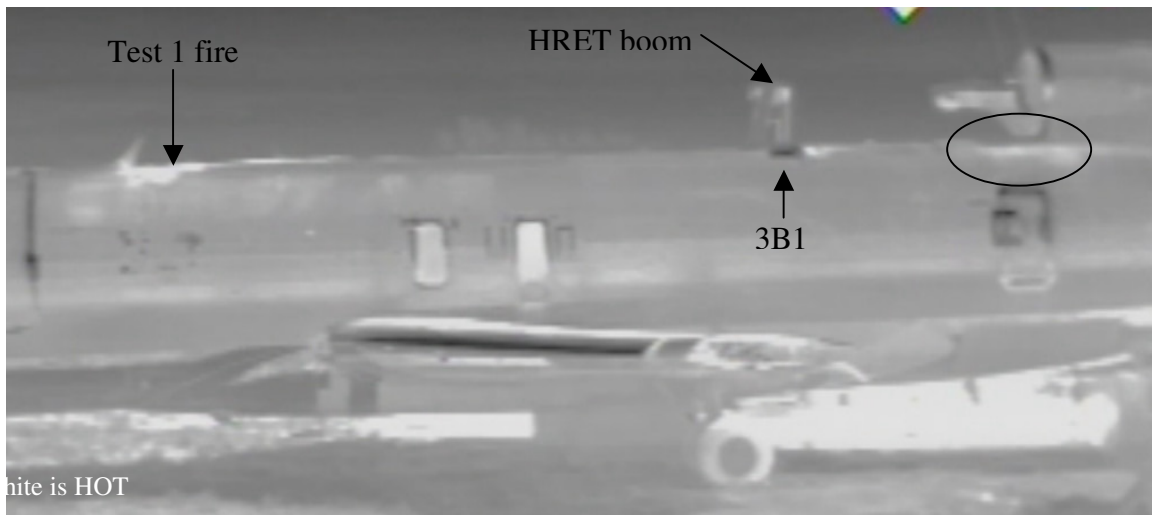
Figure 35. Prior to Test 2 fire start the Red 9 TIC side view shows panel 3B1 as 'black'.

With reference to the Red 9 TIC side-view in Figure 35: it can be assumed that solar heating has raised the temperature of the blackened skin around the Test 1 fire site. In both the overhead and side TIC camera views the exterior surface of GLARE panel 3B1 reports as black. Panels 3A and 3B1 were in the as-received condition with only a primer coating yet 3A did not report as black. All other GLARE panels were painted white. The source of the white (hotter) area just aft of 3B1 is unknown. It is interesting that the dark blue paint system on panels 4 and 5 and the unpainted black CFRP panel 6 are not being reported as hotter (by solar heating) than the surrounding aluminium although the Red 9 TIC side-view of these panels is minimal. The crown skin area forward of the V Stab and between S4L&R (circled in Figure 36 and shown in Figure 37) is painted black which may account for the reported heating or it may be an emissivity difference. The overhead TIC view did not include the area AFT of BS1010.

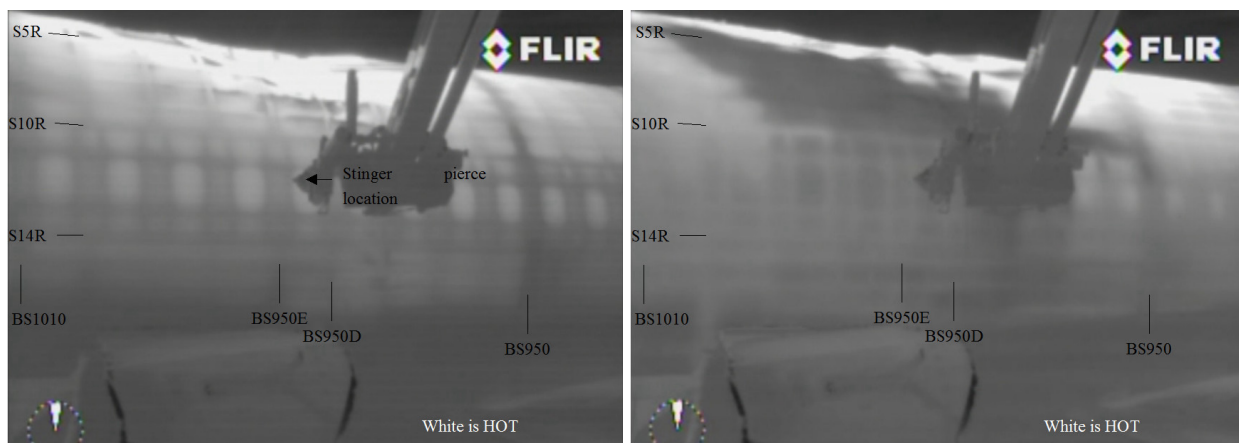
Figure 38. Extent of Stinger water spray cooling effect on STBD fuselage between 7:49 and 8:55.

The fibreglass cargo liner had been completely removed from the fuselage sidewall and as such there was no impediment to the water spray contacting the STBD fuselage skin and substructure. The piercing was carried out through the window blanking plate between BS950D and 950E. The maximum fuselage skin area cooled by the water spray is shown in Figure 38 and extends from BS950 to 1010 between S4 and S10R.

Based on the Red 10 TIC video stills in Figure 38 and the CAD sketch in Figure 40, the first water spray cooling is seen along S8R with a little impinging slightly above up to S5, (upper red and blue lines from Stinger in sketch). There isn't as definitive a cooling effect visible on the fuselage STBD side below the Stinger (reciprocal angle). By the end of the water spray event the cooling effect is seen to extend from S5R down to S10R. The cooling from S8R down to S10R is apparently not from direct spray but must be from gravity, otherwise water spray would also show from S14R down (Yellow lines in sketch) but it doesn't. No cooling was visible on the PORT side, Figure 41.

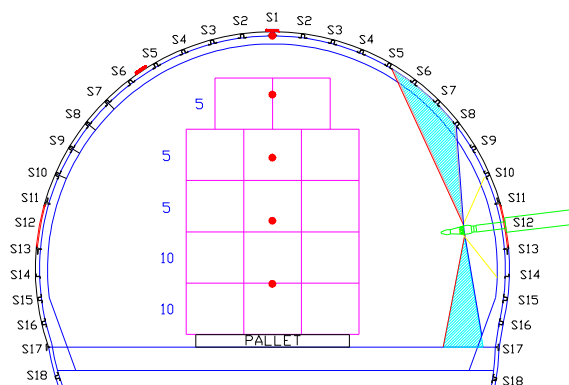
Figure 40. Water spray from Stinger.

There are 32 orifices in the piercing tip arranged in four rings of 8 each. The rear two rows are large and project water radially. The front two rows are small orifices that are angled forward. The water spray from the small, forward-projecting orifices are not shown in the sketch.

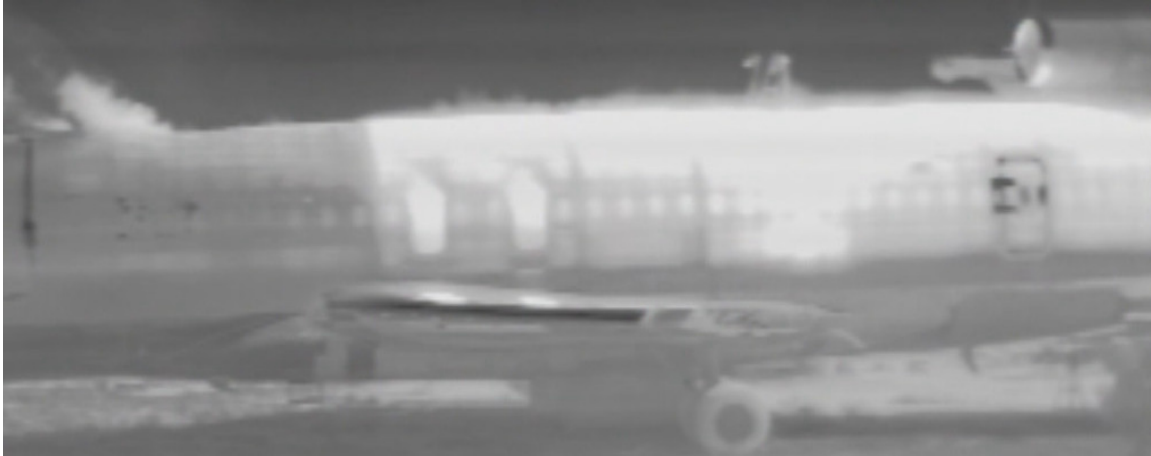
Figure 41. Red 9 TIC at 8:00. No Stinger water spray cooling on PORT fuselage skin.

The salvage tarp failed at 7:45. The Stinger pierced at 7:40 and water flowed from 7:49 to 8:55 (1:06 duration). Figure 41 shows that the water does not cross the fuselage and cool the opposite sidewall. This is because some portion of the fuel package may still be in-between and the flat-fan spray pattern of the chisel-style tip does not project very much water forward.

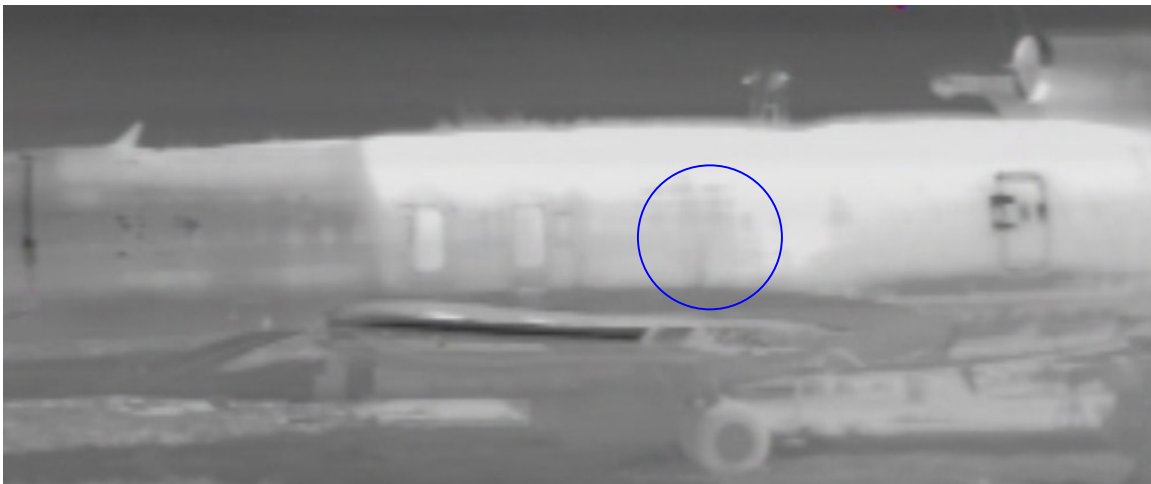
Figure 42. Red 9 TIC at 10:00. Evidence of PyroLance cooling PORT fuselage skin (circled).

As shown in Figure 42 and Figure 43, the water spray cooling effect of both the PyroLance and hand-line extinguishments could be witnessed by observing the Red 9 TIC side-view of the PORT side. The effect of water impinging on the PORT fuselage skin from the PyroLance being operated from the STBD side was observed to cool the PORT side, circled in Figure 42, starting at 9:27 and persisted throughout the 1:06 application. The cooled fuselage area caused by the initial hand-line water spray is circled in Figure 43.

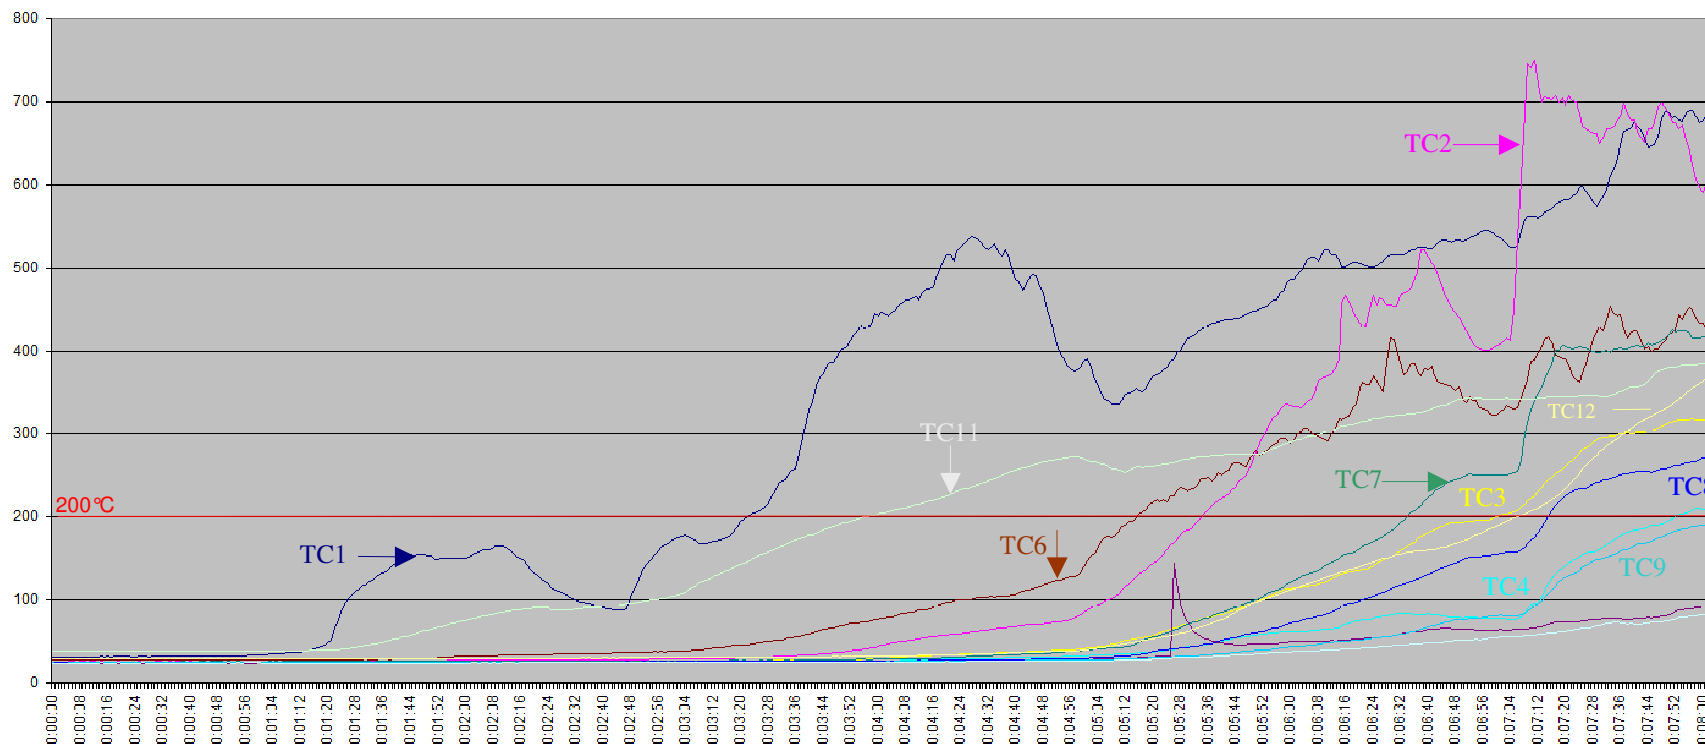
Figure 44. Test 2 fire temperatures (°C) prior to extinguishments.

As evidenced by the TC#1 data the fire suffered two periods where the fire dampened. This is mirrored to a lesser extent in the TC#11 data. In both cases re-ignition could be seen as a flash through the smoke in the forward-looking interior camera views. TC#2 exceeded 650°C (1202°F) approximately 28 seconds before TC#1.

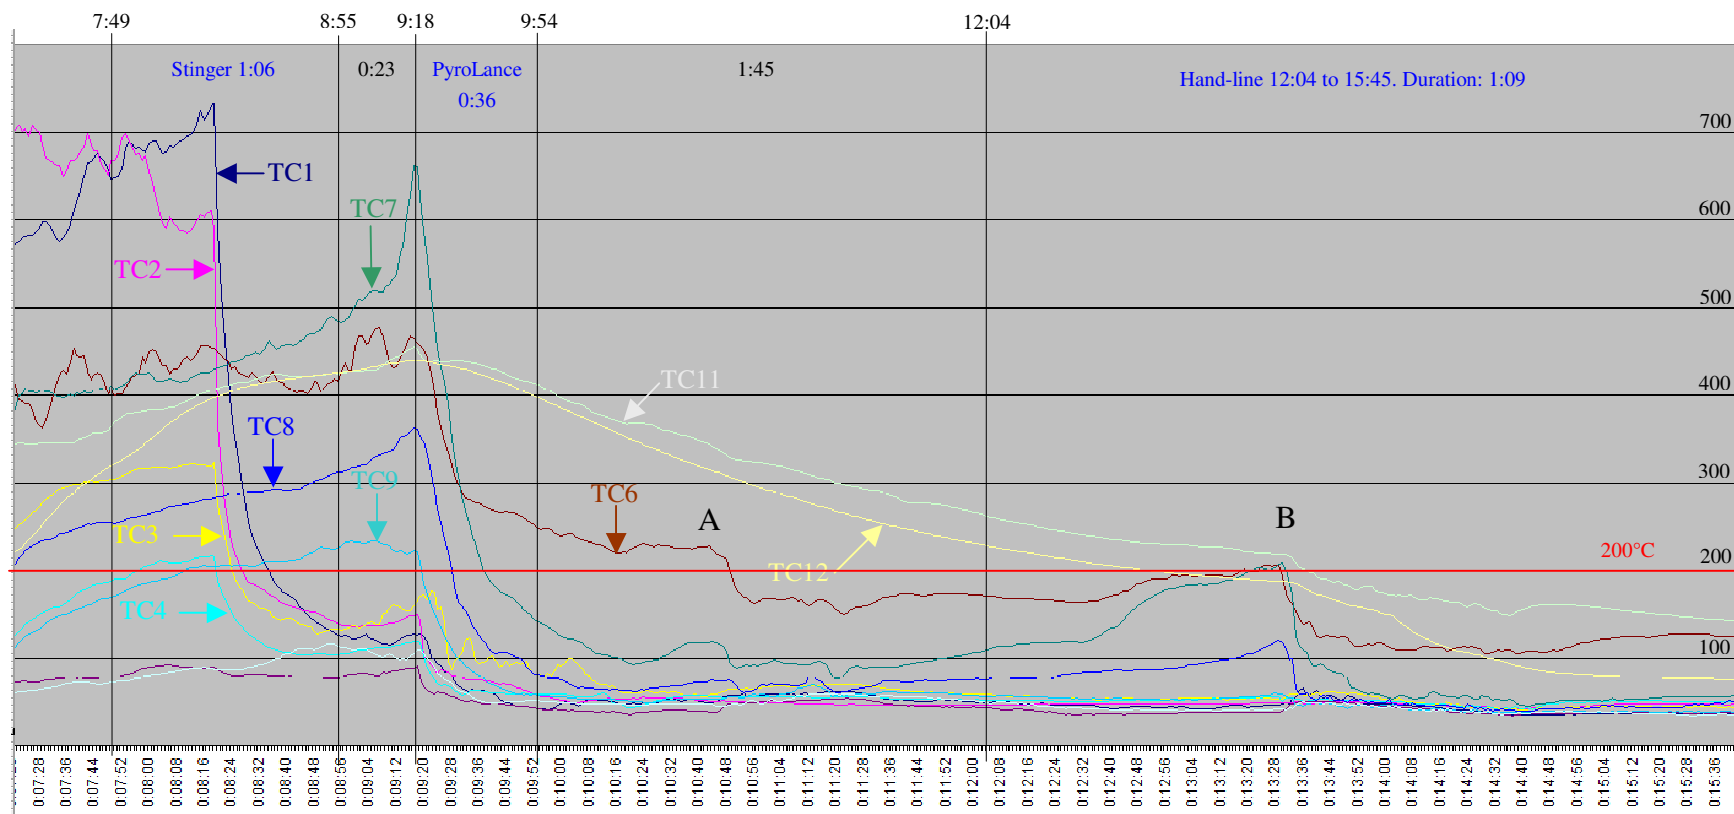
Figure 45. Test 2 temperature data during initial fire extinguishments.

In Figure 45 the period of the Stinger, PyroLance and over-wing hand-line extinguishments have been marked by vertical lines with the duration of the water sprays and intervals between marked. The Stinger spray was centred on the fuel stack and did not appear to cool above S8R. Its effect was initially between the STBD fuselage sidewall and the fire and had little immediate effect on the two thermocouple trees but it did eventually cause the thermocouple tree #1 temperatures to drop (TC#1 through #4). TC#6 was also affected but TCs 7 through 9 of thermocouple tree #2 continued to rise until the PyroLance was applied. The PyroLance spray likely passed between the two thermocouple trees based on the position and angle it was operated at and almost all TCs show a drop caused by this extinguishment. The two exterior thermocouples slow their rise during the Stinger event and begin to decline during the PyroLance extinguishment but this is likely a cumulative effect as all of the interior thermocouples registered rapid declines in temperature at about the same time.

There is a sharp fall in the TC tree 2 temperatures measured by TC#6, 7 and 8 (marked 'A'). During the hand-line water spray event TC#6, 7 and 8 all see a temperature rise but they then all drop off similarly (marked 'B'). The audio record from inside the aircraft along with the external and internal video, have been scrutinized to confirm that no water spray events caused the temperature drops at "A". This temperature drop may be the result of the collapse of the fuel stack and, for "B", its disruption or direct water contact with the TCs by the hand-line water spray.

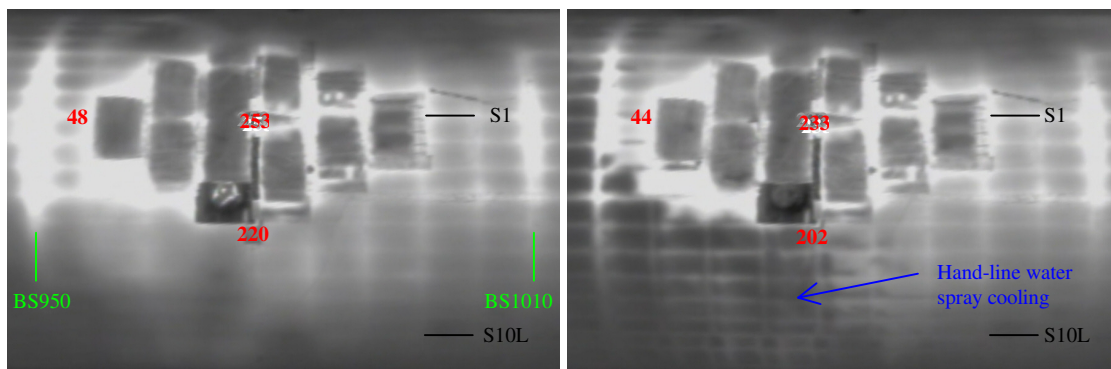
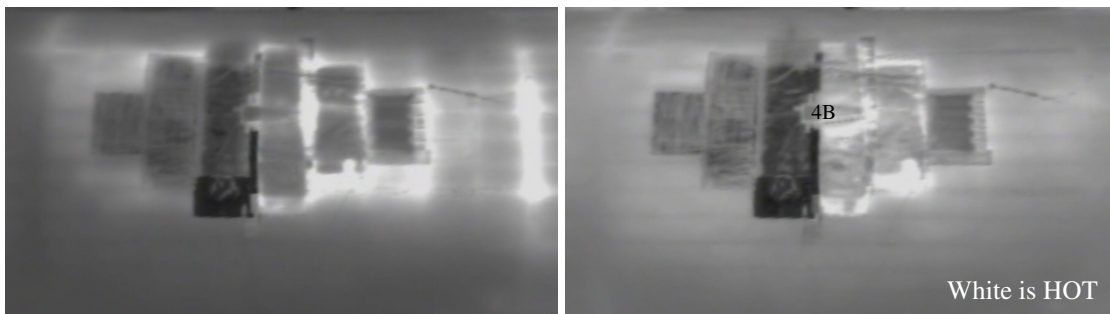
Figure 46. Selected overhead TIC views of composite skin panels from 11:44 to 27:44.

The thermocouple temperature recordings ended at 15:11, 34 seconds before the end of the hand-line attack. The firefighters were instructed not to apply water directly onto the composite panels in the crown. At 12:14 the effects of the initial water spray can be seen on the aluminium structure but this fades throughout the remaining attack indicating that water was being directed down onto the debris on the floor for the remainder of the extinguishment.

By 17:44 the heat has dissipated from the skin and the frame at BS950. Note that the frames at BS950 and 1010 are heavy forgings. Ten minutes later, at 27:44 the heat has almost completely dissipated at BS1010 yet the CFRP panels 4 & 5 remain hotter than their surroundings. It may be that where the CFRP panels are lapped over a second layer (CFRP or aluminium) they were protected from extinguishments and the decrease in cabin temperature and they continue to smoulder between the plies. This continued combustion of the adhesive is evidently heating the aluminium at the perimeter of the CFRP panels. Panel 4B is also hotter than its surroundings and this may also be evidence of heat from internal combustion emitting from the free edges of the panel.

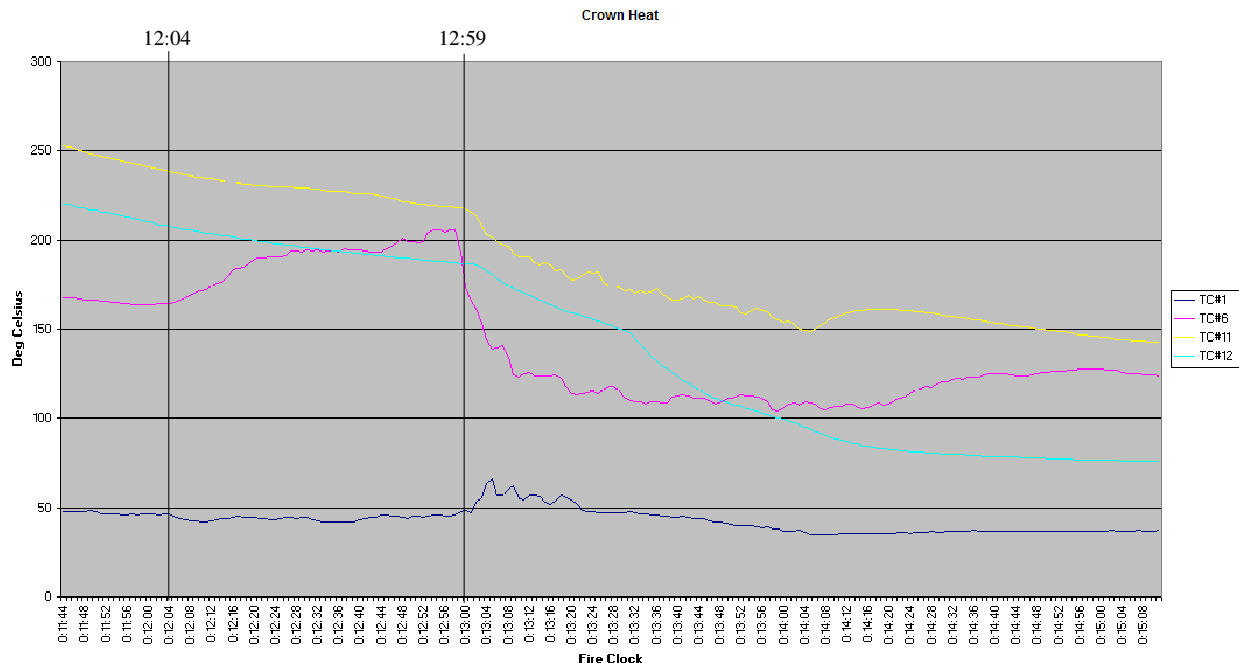
Figure 47. Crown (TC#1 &amp; 6) and exterior skin (TC#11 &amp; 12) temperatures.

Although the hand-line extinguishment starts at 12:04 the effect on the thermocouples is not seen to be an influence until 12:59 (Figure 47). TC#11 and #12 drop at the same rate initially but TC#11 levels off at around 300°F (150°C) while TC#12, on aluminium, decreases to level off just above 167°F (76°C). The persistent higher temperature recorded by TC#11 is most likely due to continued smouldering. TC#1 is hovering around 122°F (50°C) and then gets down to around 95°F (35°C). TC#6, far away at the top of thermocouple tree #2, sees a temperature rise during the extinguishment as heat is pushed away from the seat of the fire and up towards the crown.

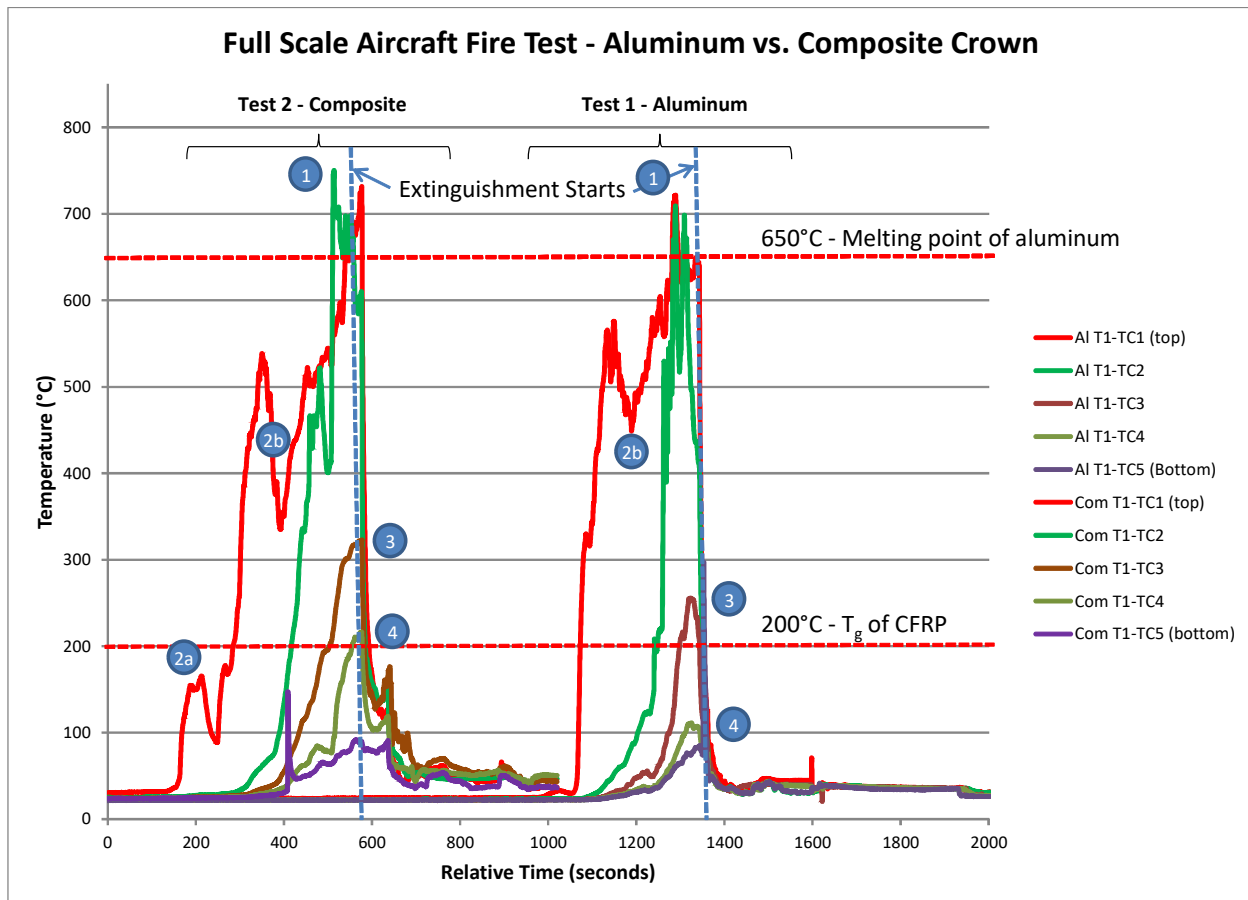
Figure 49. Test 1 versus Test 2 TC Tree 1 Temperatures.

Point 1: Test 1 and Test 2 were remarkably similar in their peak TC#1 temperatures of 1330°F and 1348°F respectively (721°C and 731°C). Also, both fires ran at temperatures over 750°F (400°C) in the upper half of the cabin for 4 minutes (Figure 49 and Figure 50). The composite fire (Test 2) was hotter for a longer period of time lower down in the cabin which may explain why a much larger area is heat damaged as evidenced by the blackened paint on the exterior.

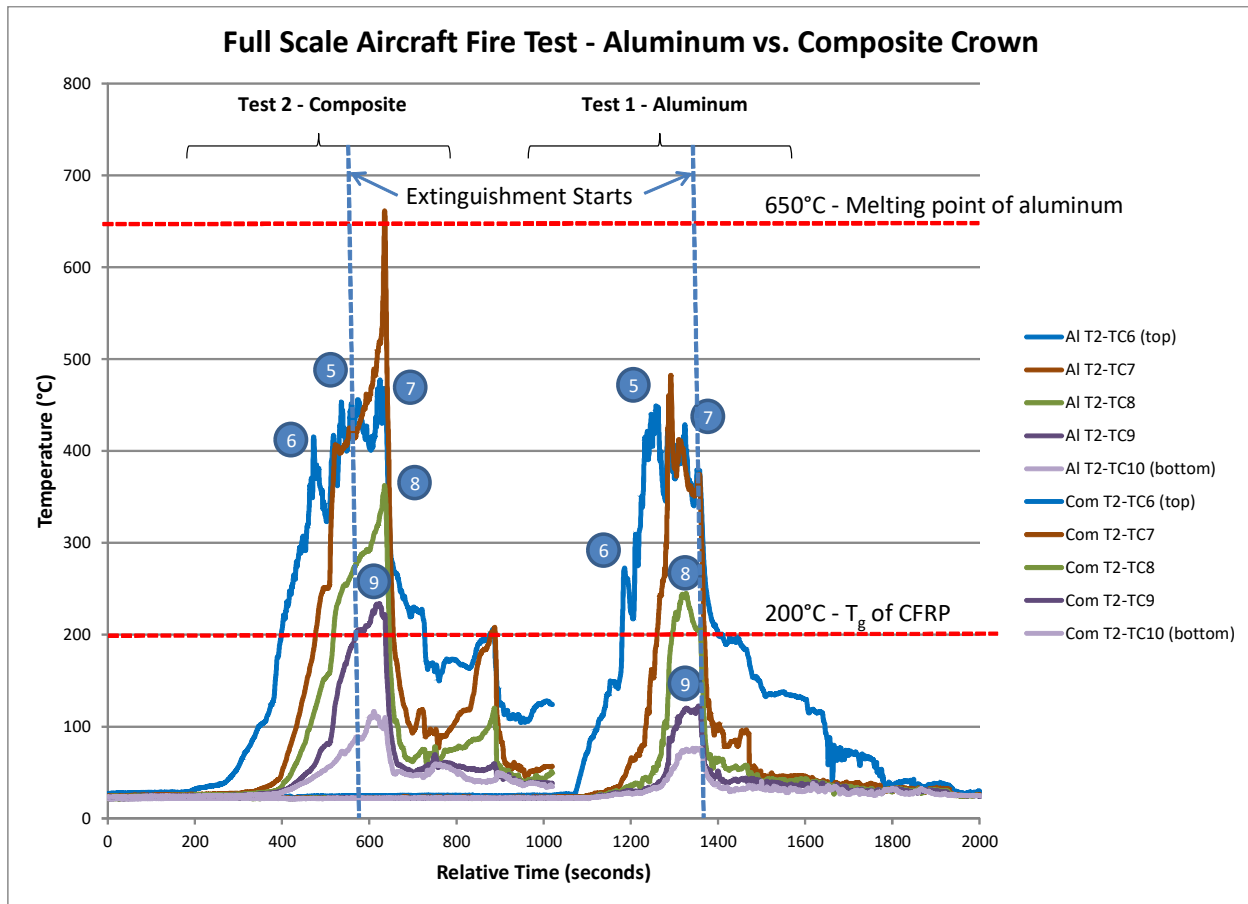
Figure 50. Test 1 versus Test 2 TC Tree 2 Temperatures.

TC#9 positions are further from the base of the fire and lower to the deck compared to the similar TC#3 and TC#4 comparison made previously. Again in Figure 50 the re-ignition of the Test 2 Composite fire is seen. No such secondary ignition is reported for the Test 1 Aluminium fire.

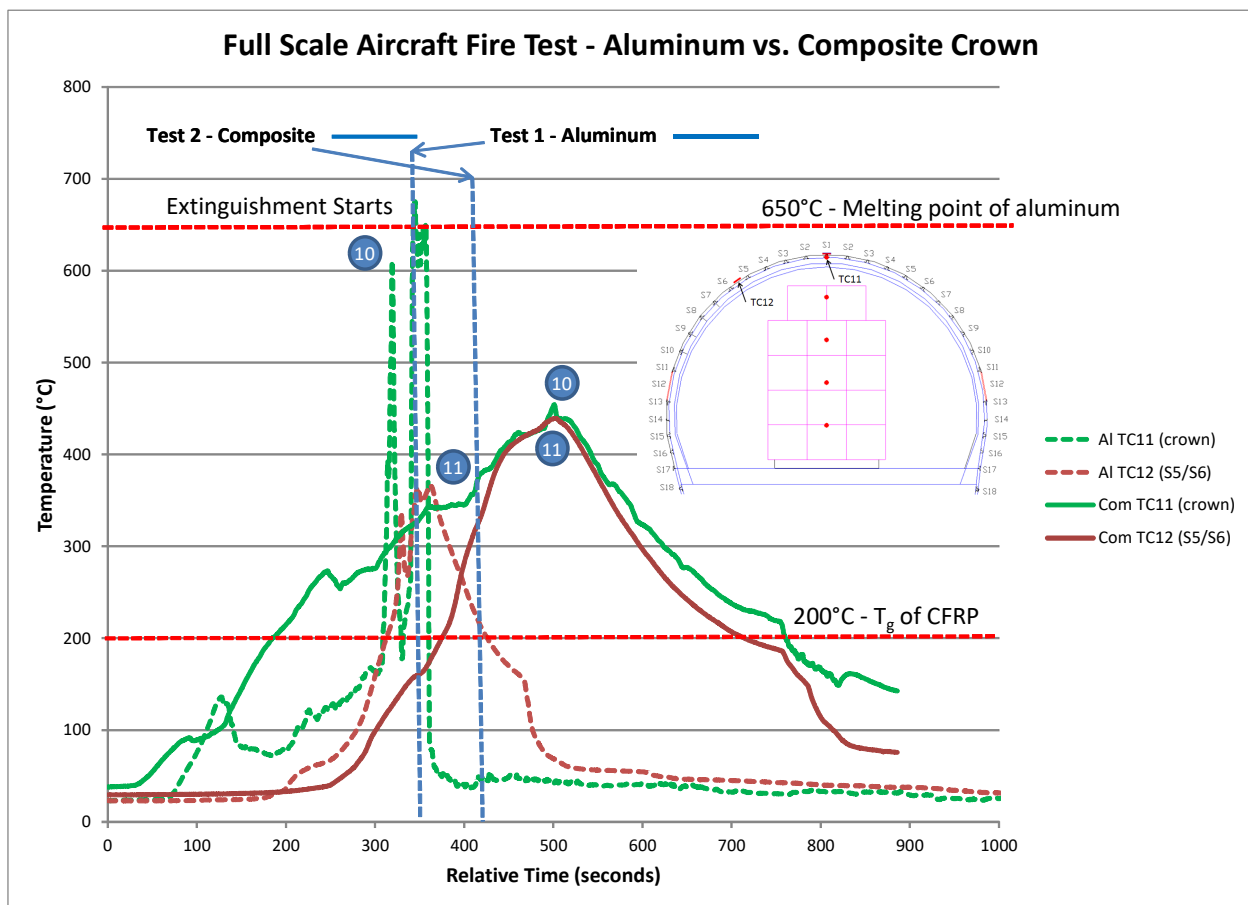
Figure 51. Test 1 versus Test 2 Exterior TC Measurements.

aluminium sheets melting away from the GLARE panels, they remained largely intact with respect to not allowing the Test 2 fire smoke and heat to vent. The fact that the aluminium sheets within the GLARE melted also indicates that the fire temperature was above the melting temperature of aluminium, approximately 1202°F (650°C).

Point 11: The much smaller difference between TC#11 and TC#12 for Test 2 compared to Test 1, almost zero compared to 441°F (245°C), respectively can most likely be attributed to the lower thermal conductivity of CFRP (approximately 0.87 Btu/hr·ft·°F (1.5 W/m°C) versus 69.3 Btu/hr·ft·°F (120 W/m°C) for aluminium) or could have been a result of the insulating properties of the burning laminate construction where the inner plies separated, creating separate insulating char layers.

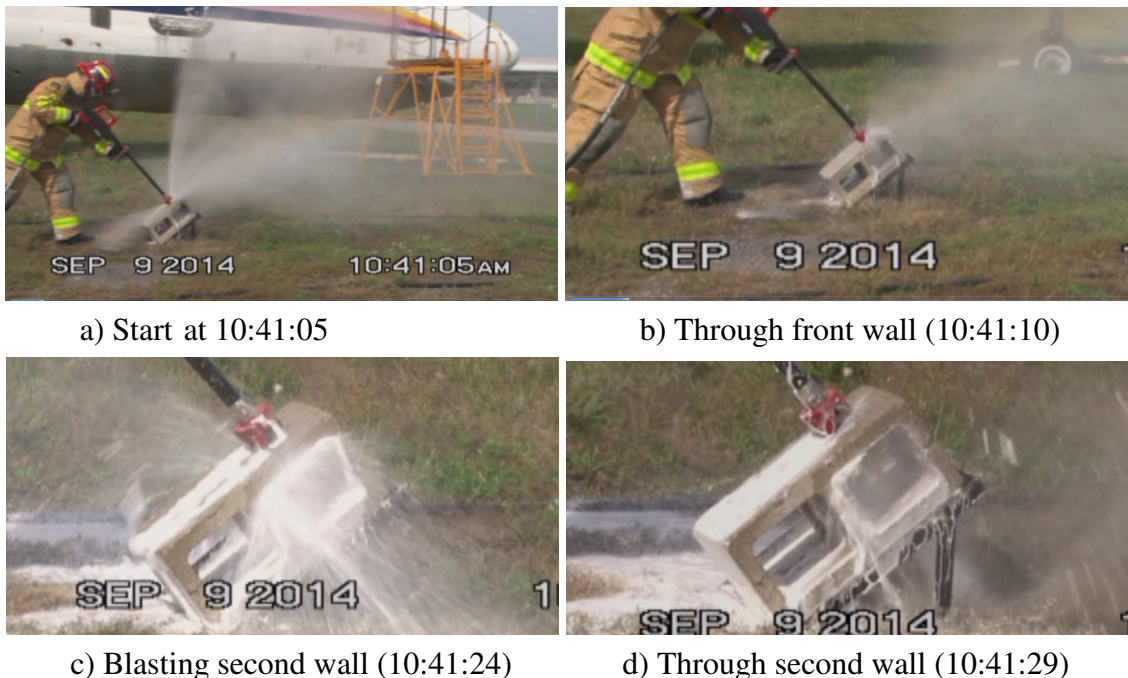
Fig. A.II-1. Concrete block. Water jet only. Duration:0:24.
