# **Full-Scale Aircraft Fire Tests - A Comparison of Aluminium and Composite Burn-Through**

Report No: LTR-SMM-2015-0414

Date: May 2015

<b>Classification :</b>	Unclassified	<b>Distribution :</b>	Limited
<b>For:</b>	Ottawa International Airport Authority, Emergency Rescue Services		
<b>Reference:</b>			
<b>Submitted by:</b>	S. Beland, Director R&D (Aerospace - SMM)		
<b>Approved by:</b>	J. Komorowski, Director General (IAR)

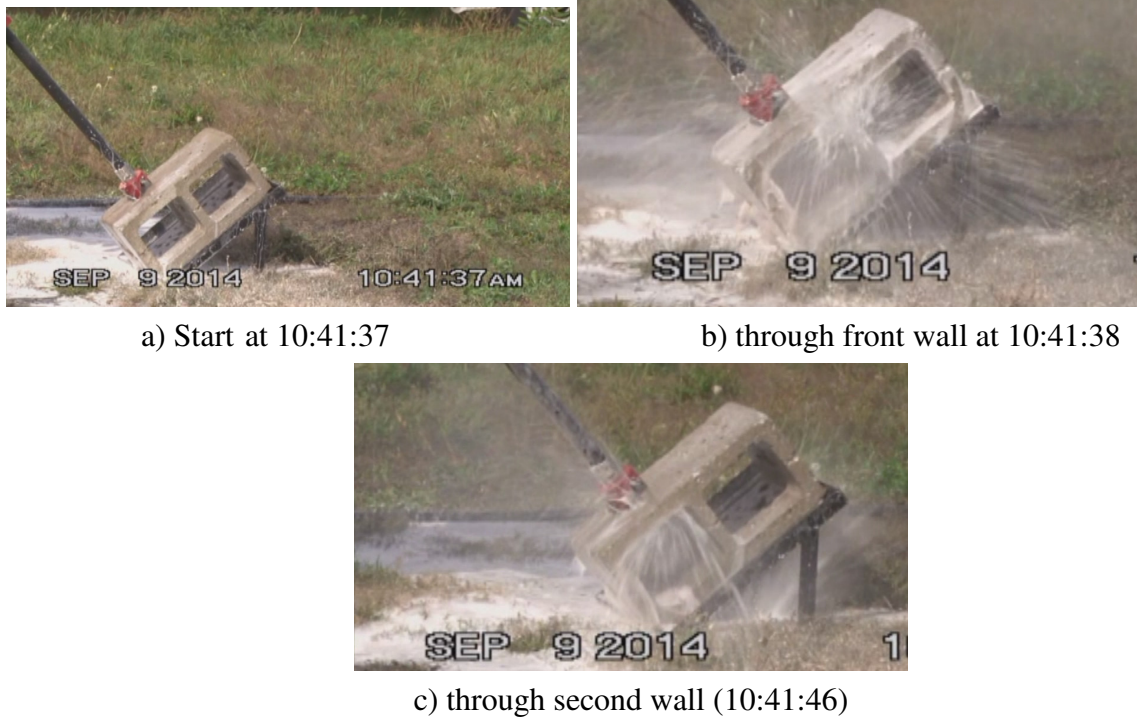
With abrasive media in the water flow for the second demonstration on the concrete block the jet pierced the first wall in one second and went completely through the block in nine seconds (Fig. A.II-2.).

Fig. A.II-2. Concrete block. Abrasive media & water jet. Duration: 0:09.

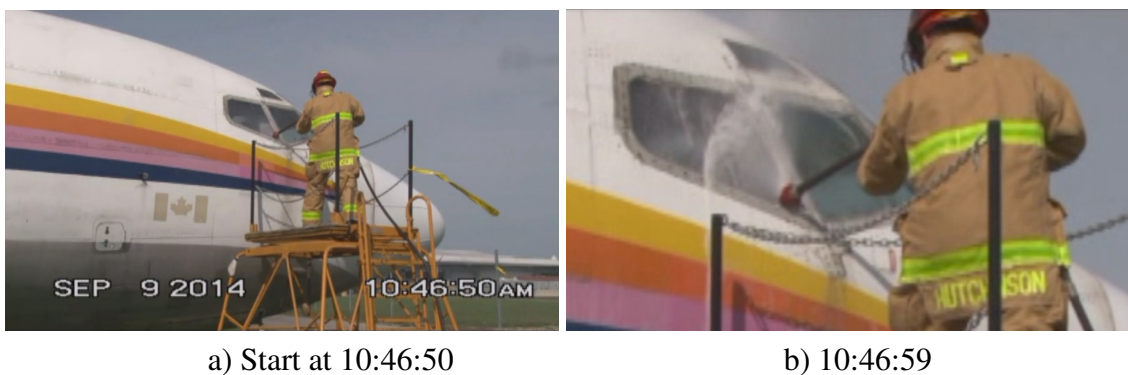
c) Quit without full penetration at 10:47:04. Plies were delaminated and water filled cavity.

Fig. A.II-3. STBD DV cockpit window (laminated stretched acrylic). Duration: 0:14.

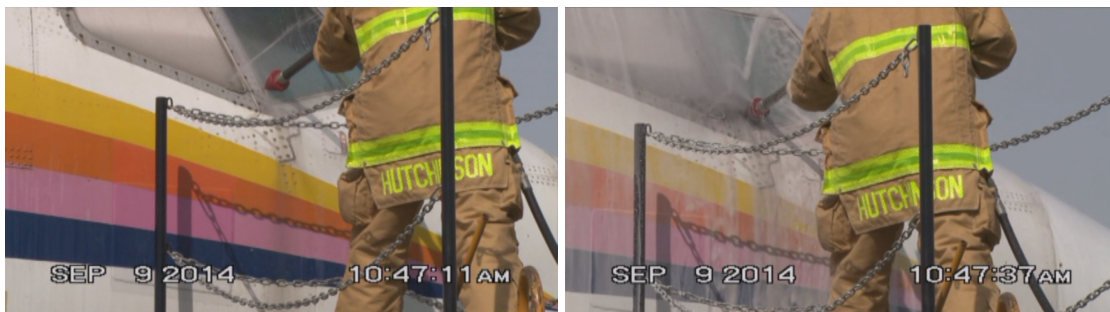
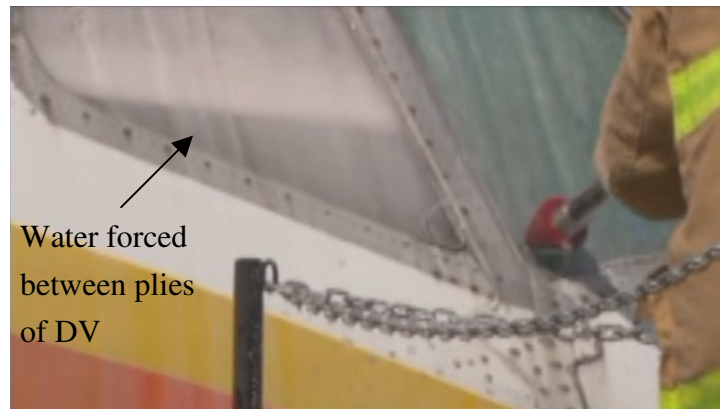
The front cockpit windshields are constructed as a glass panel laminate. These are very difficult to cut due to the multiple glass layers or punch through as they have a bird impact rating. The water jet abrasive media shattered the glass plies as expected (they are tempered) and pierced through the laminate thickness in 32 seconds (Fig. A.II-5.). Thus a rapid method of introducing firefighting agent into the cockpit was demonstrated.

c) End at 10:47:43. Window was fully penetrated.

Fig. A.II-5. STBD cockpit window (laminated glass). Duration: 0:32.

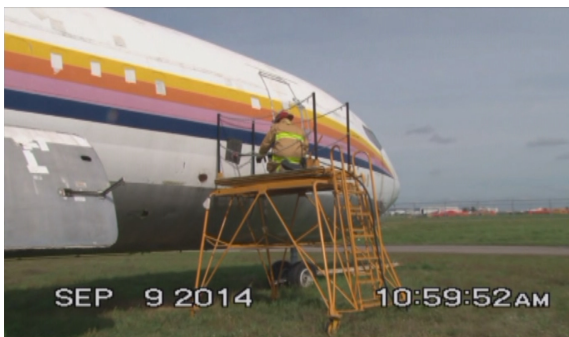
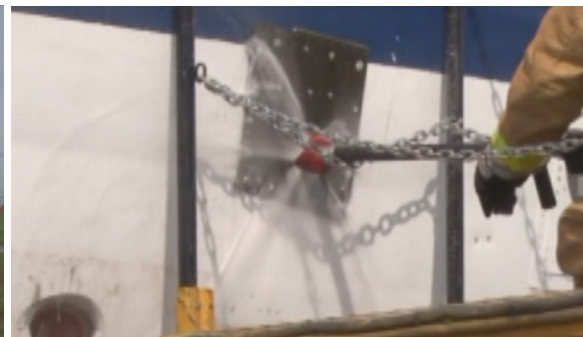
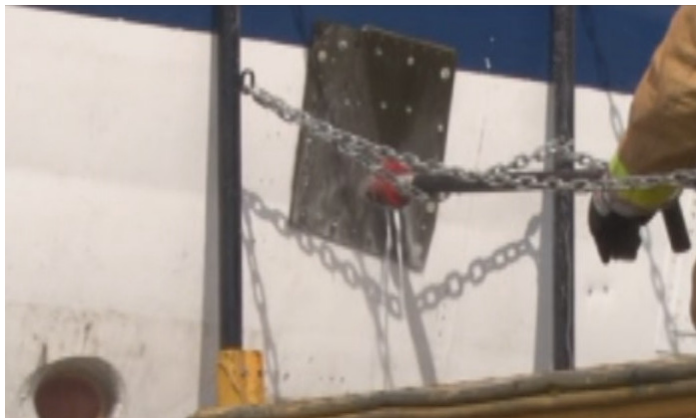
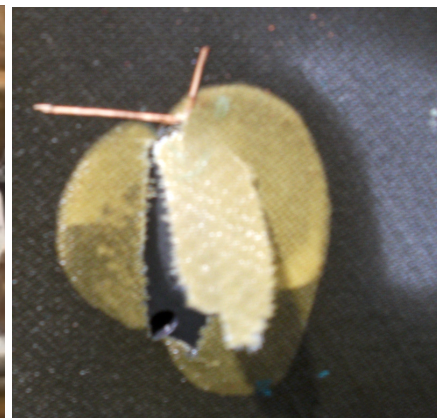
A panel of CFRP had been attached to the fuselage of the aircraft for Pyrolance demonstration. The aluminium skin behind the panel had been removed. The composite panel was nominally 0.3 inches thick. It was pierced and the stream of firefighting agent was introduced into the main deck area of the forward fuselage within approximately 6 seconds. The result was a very clean hole and only the inner fibreglass (anti-corrosion) ply was delaminated (Fig. A.II-6).

c) End at 10:59:59 with full penetration

d) delamination of fibreglass ply

Fig. A.II-6. CFRP panel (0.030 inch thick). Duration: 0:06.

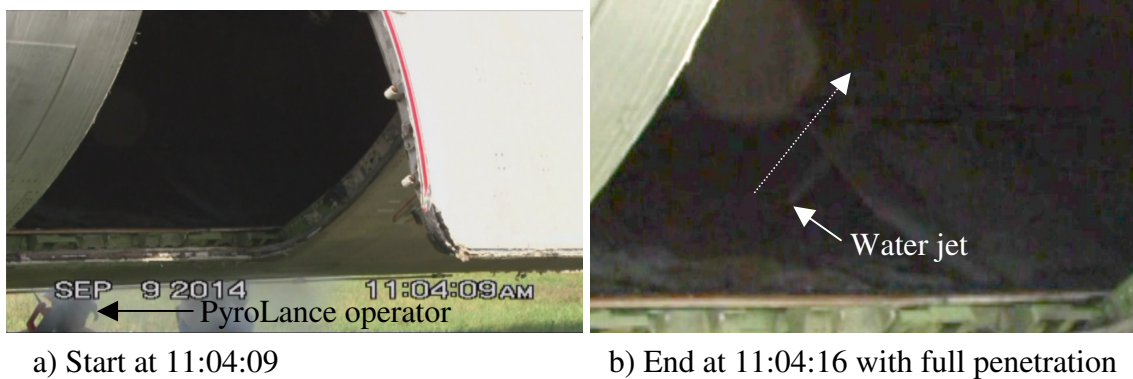
The PORT side of the FWD fuselage has an extra 0.1 inch thick (2.54mm) skin installed that surrounds the main-deck cargo door. This external skin doubler was installed over the existing fuselage skins and so a combined thickness of 0.145 inch (3.68mm) had to be pierced to accomplish penetration into the cargo hold, just above the floor and below the sidewall cheek area. Between the outer skins and the hold there exists only a thin fibreglass liner. The PyroLance succeeded in piercing completely and introducing a stream of firefighting agent into and across the width of the hold in seven seconds (Fig. A.II-7). This location is too low on smaller aircraft to permit a HRET Stinger piercing and too high on larger aircraft for expeditious manual piercing.

Fig. A.II-7. FWD Cargo hold. PORT side. Skins are 0.1" + 0.045" tk. Duration: 0:07.

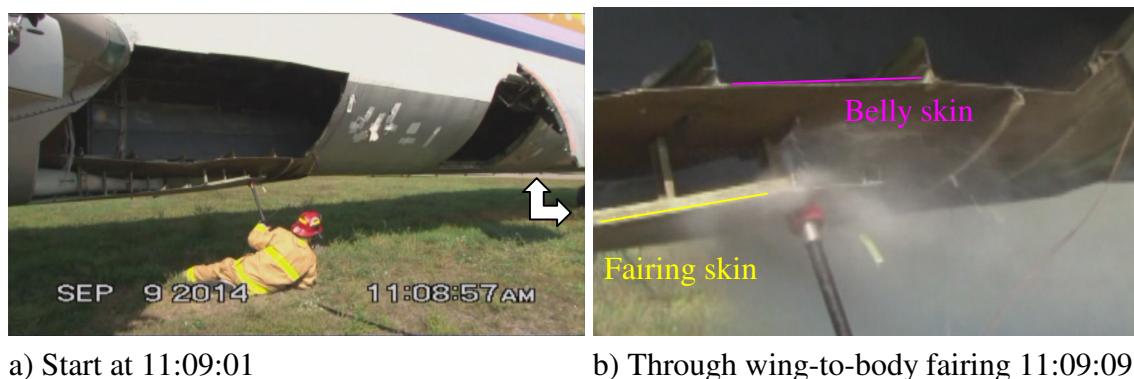
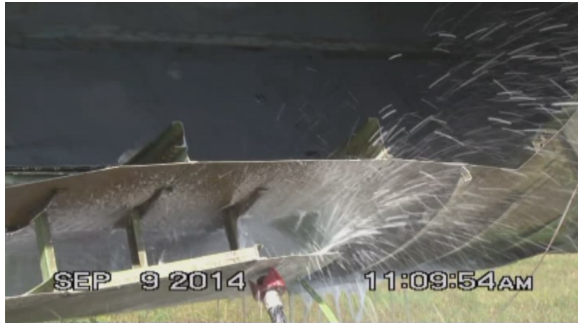
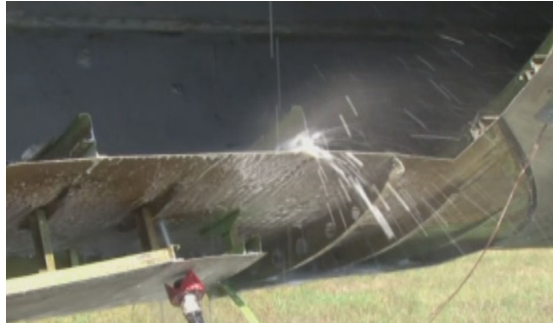
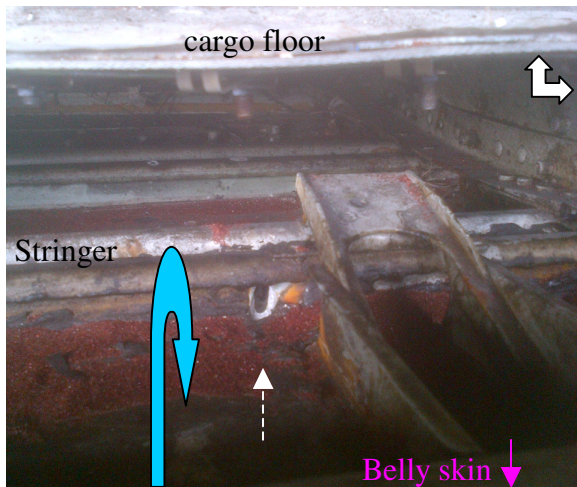
External access to the aft end of the FWD cargo hold (or FWD end of the AFT cargo hold) is obstructed by the wing-to-body fairing. A portion of the fuselage sidewall and fairing had previously been removed giving access to view the action of the water jet stream through the structural elements. The Pyrolance succeeded in piercing both the fairing (8 seconds) and fuselage skin within 53 seconds but the stream then encountered the side of a longitudinal stringer whose shape appeared to redirect the water stream although some erosion was accomplished. Piercing multiple layers at a distance from each other may have diffused the water stream and degraded its effectiveness. The trial was halted after 1:36 without piercing the cargo bay floor, Fig. A.II-8.

c) Through cargo belly skin at 11:09:54.

d) End after no progress (11:10:37)

e) Water jet deflected by curvature of stringer flange. Did not penetrate flange or cargo floor.

Fig. A.II-8. Rear of FWD Cargo hold. STBD side. Floor skin not penetrated. Duration: 1:36.
