ARFF Special Projects

2005 to 2017

Ron Gould, NRC Aerospace (Retired)
Chief François Jacquet, OIAA ERS
Simon Hind, NRC Aerospace

*ARFF Working Group
Future Aviation Safety – A Global Conference
June 1-2, 2017. Copenhagen, Denmark*

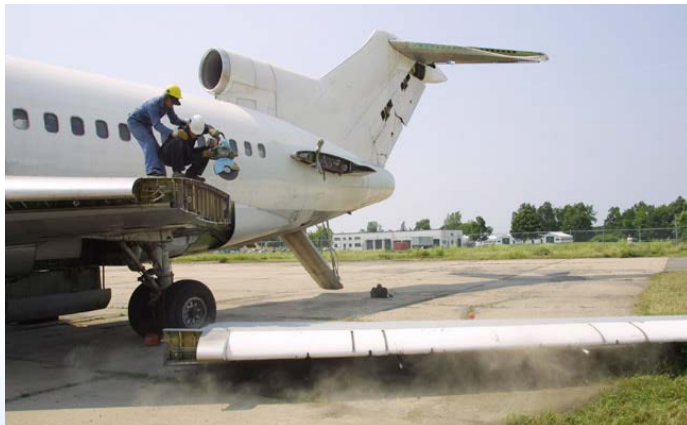
Fuel tanks were sniffed for explosive vapours before cutting

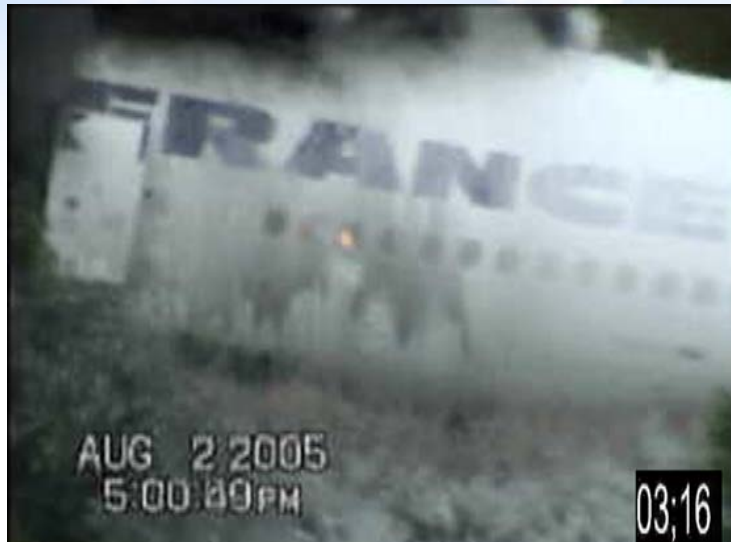
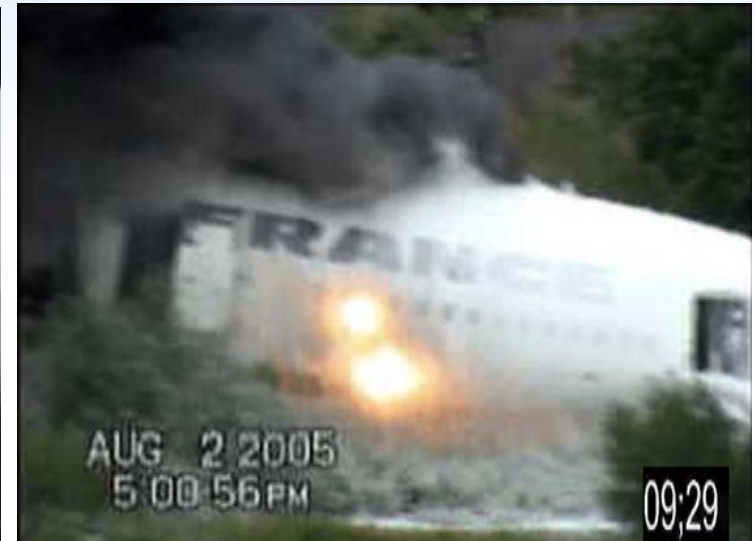
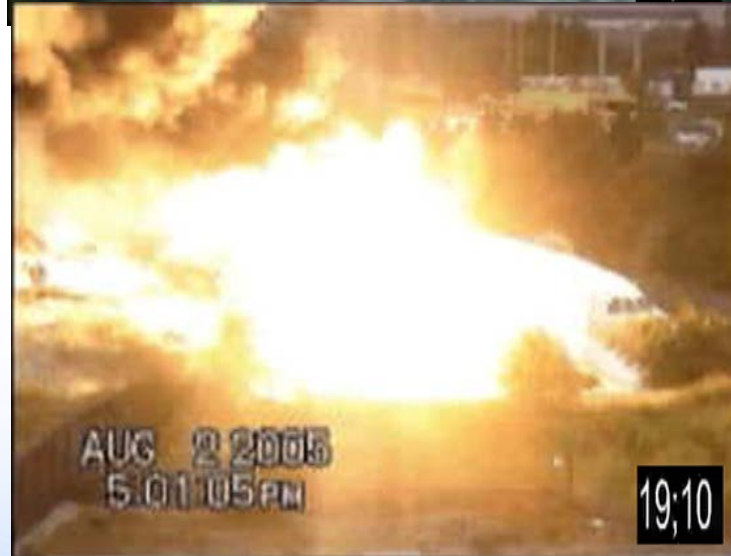
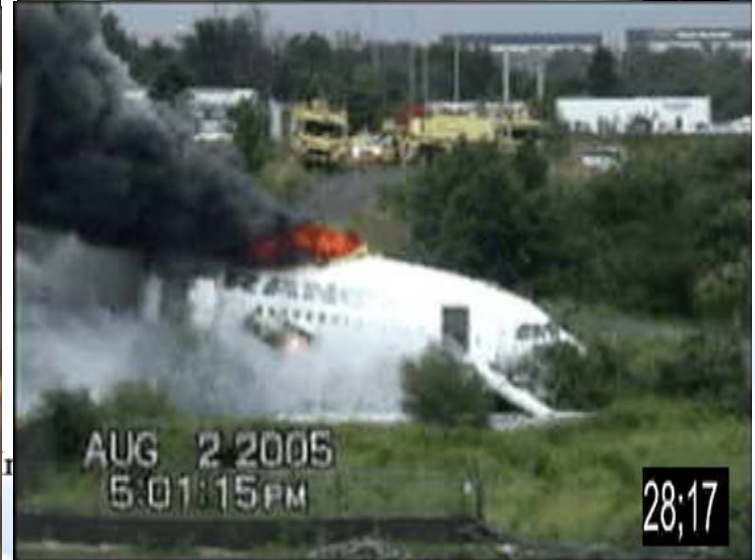
On the Crash Chart, only 4 pressurized oxygen bottles are shown in the FWD hold cheek area. There were 6 bottles and #5 exploded.

Time in RH corner (@29.97 frames/sec) is from first appearance of fire in cabin window.

Approx 19 seconds to explosion of breathing oxygen bottle.

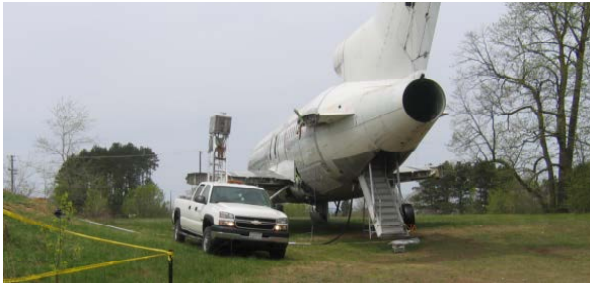
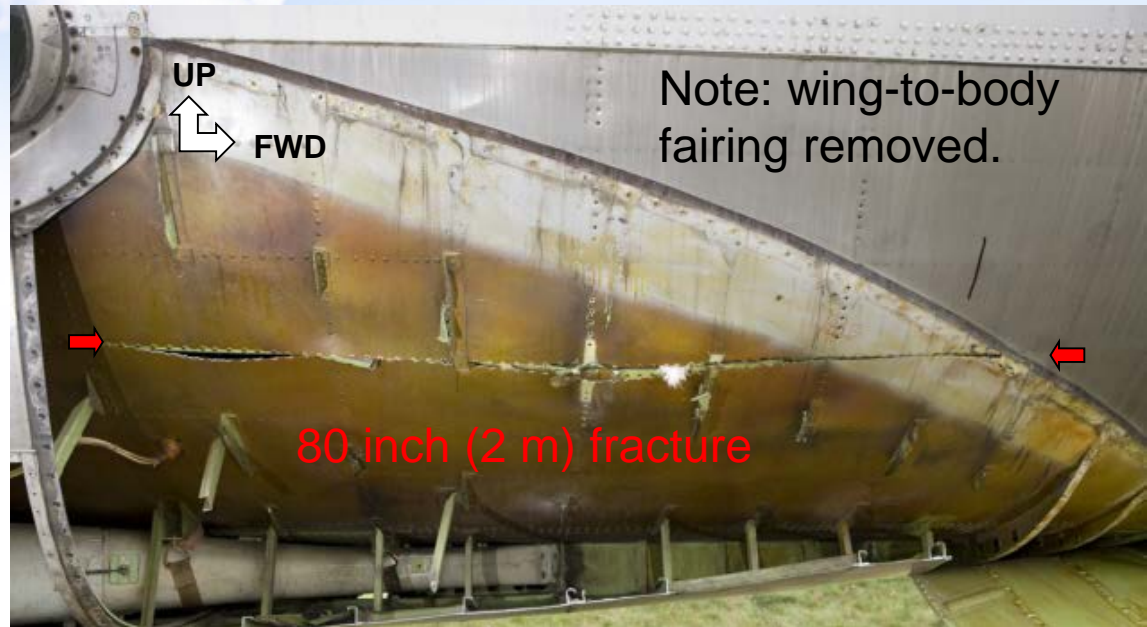
Kaboom 2

Blast created “critical length” fracture in the skin and broke 4 frames in 7 places.

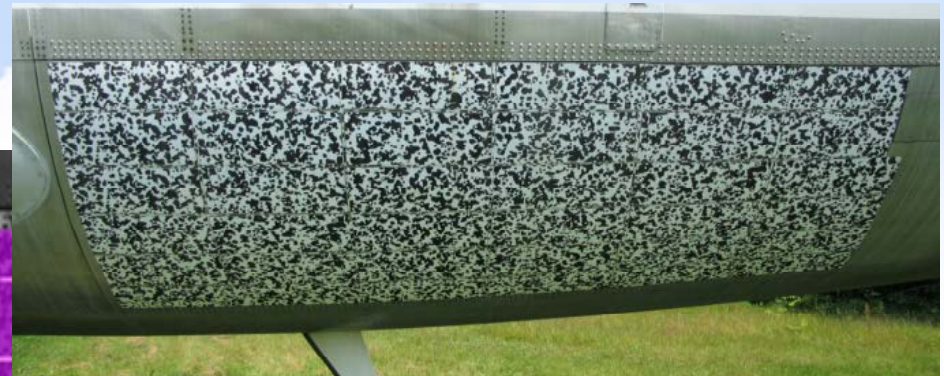
Blast Measurements

LIDAR mapping of aircraft was done pre- and post-blast.

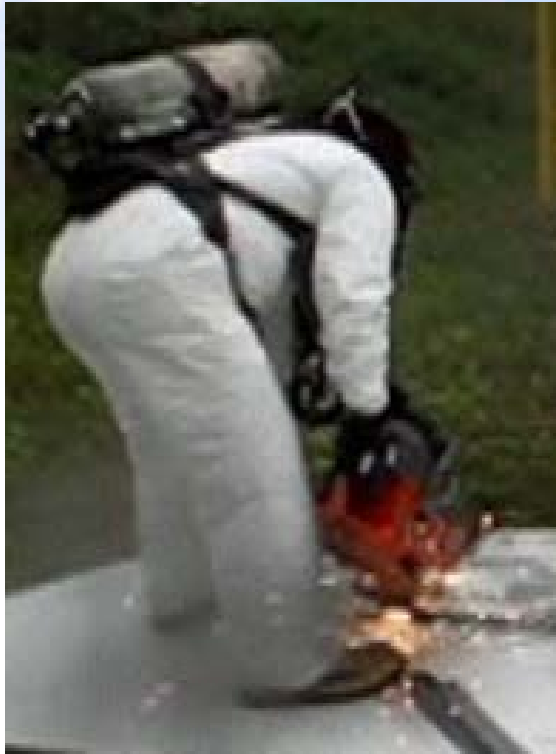
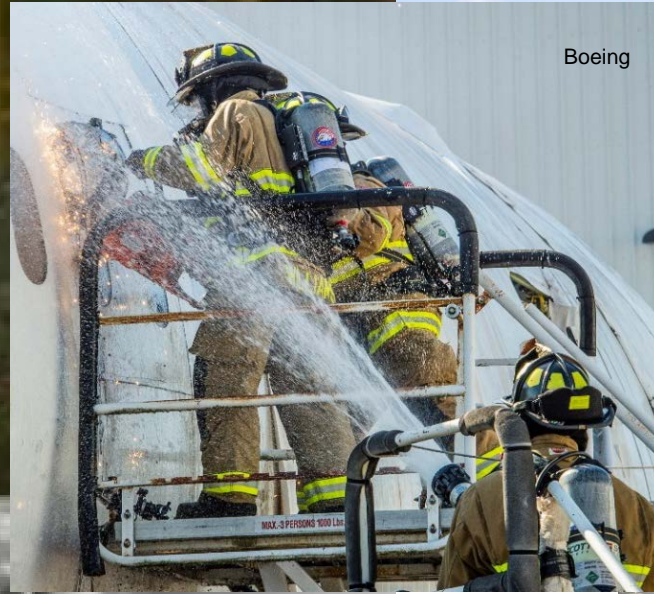
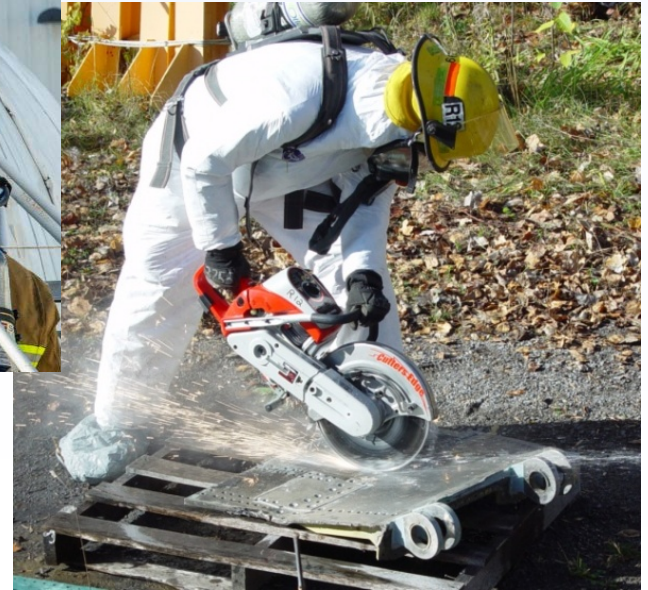
Cutting Composites

Water spray not just for dust abatement.

Cutting through metal fasteners in composite structures can start a smouldering fire.

F-18 wing root has titanium fir tree core. Composite skin easy to cut but molten Ti is sufficient to set your pants on fire.

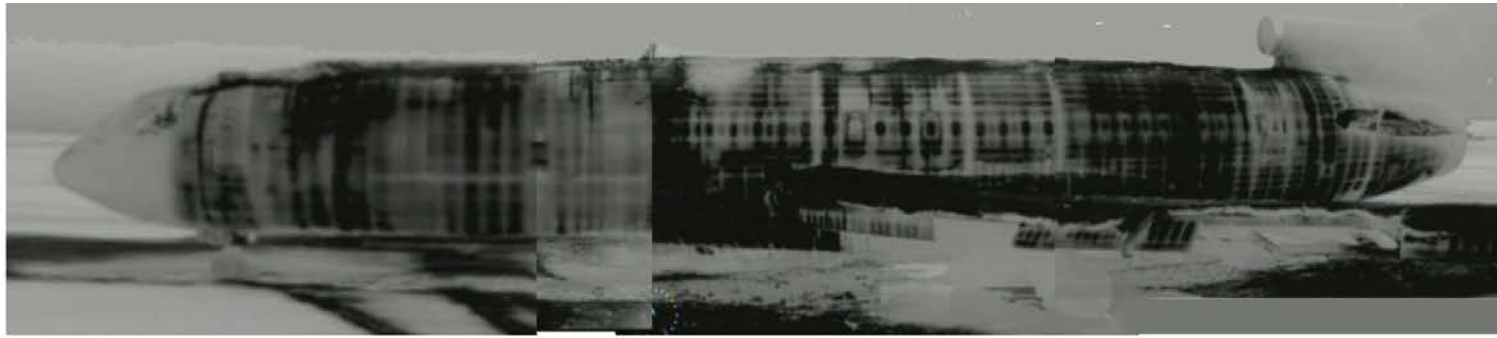
Stinger Piercing Maps

We have only one HRET piercing tool so we don't want to break it or trap it in a confined space.

B727 piercing map

Other than windows and doors – there are no landmarks for piercing on a fuselage.
Too much effort to generate a piercing map - even for one aircraft type.
Too much to ask a firefighter to flip through a database to find where to pierce.

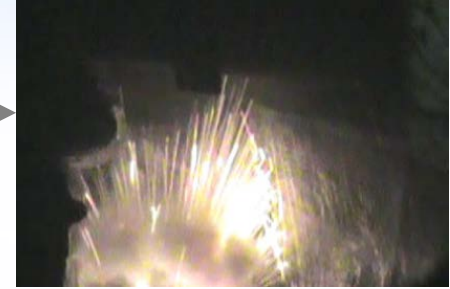
Cargo Hold Battery Fire

Military 10 D-cell Li/MnO₂ primary battery pack
2.87 lb (1.3 kg)

Molten Lithium →

Flame jet, 90 sec
each cell

Battery
case
trajectory

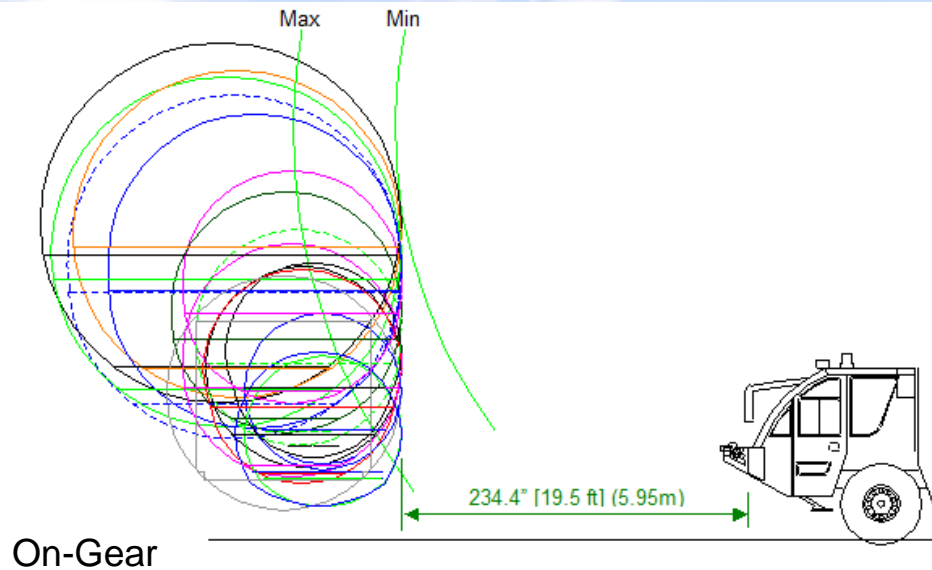
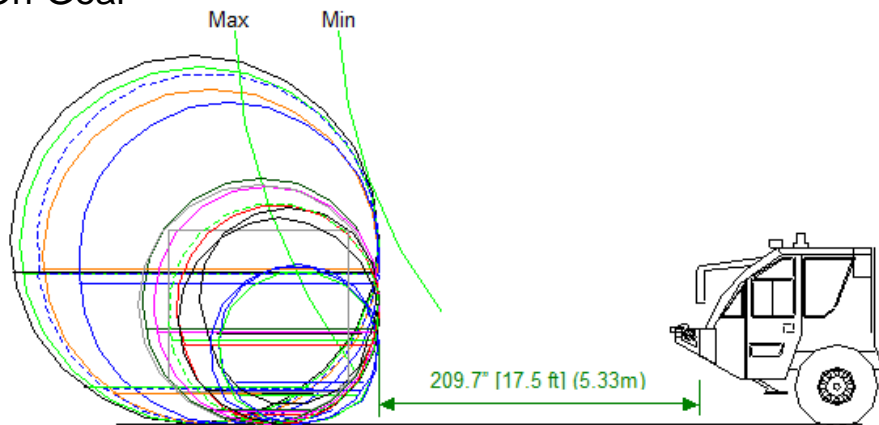
Stand-off Modeling for Optimum HRET positioning for Piercing.

On-Gear

Off-Gear

Combined Small and Large Aircraft groups.

Optimum standoff distances were developed for 18 aircraft types.

These were grouped to establish one common distance.

The difficulty remains – how to measure/display the distance as the truck approaches the aircraft.

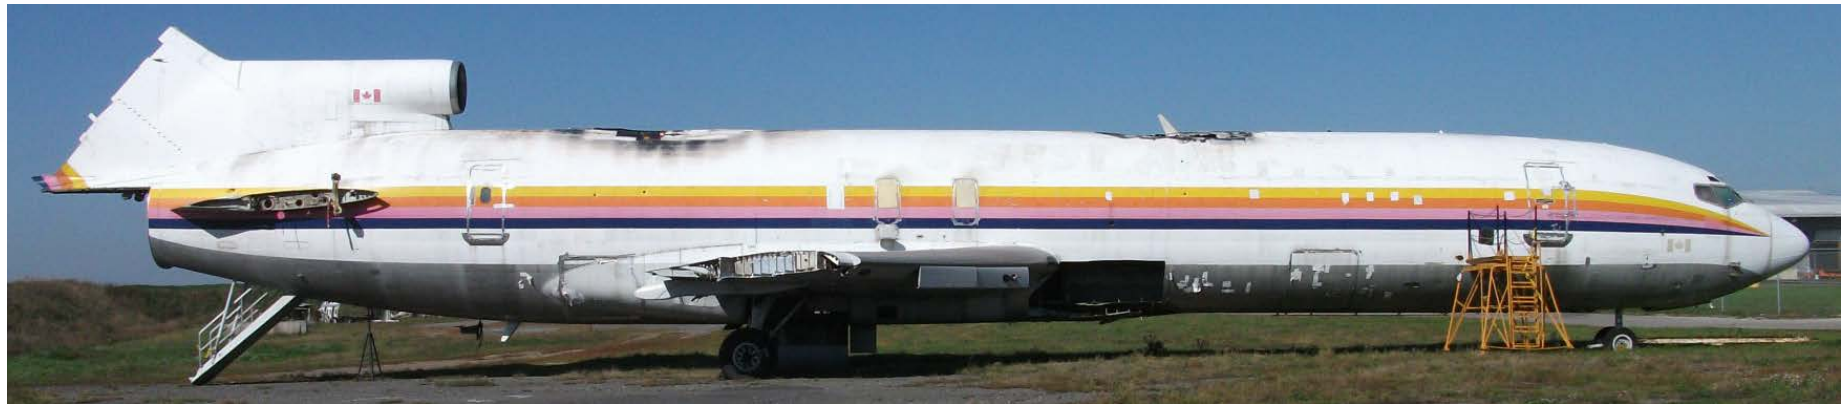
The Big Burn

Sufficient fuel on aft main deck and in cargo hold to burn the tail off behind the wing.

Fuel Load (shredded paper)

← Main Deck 250 boxes

← Cargo Hold 100 boxes

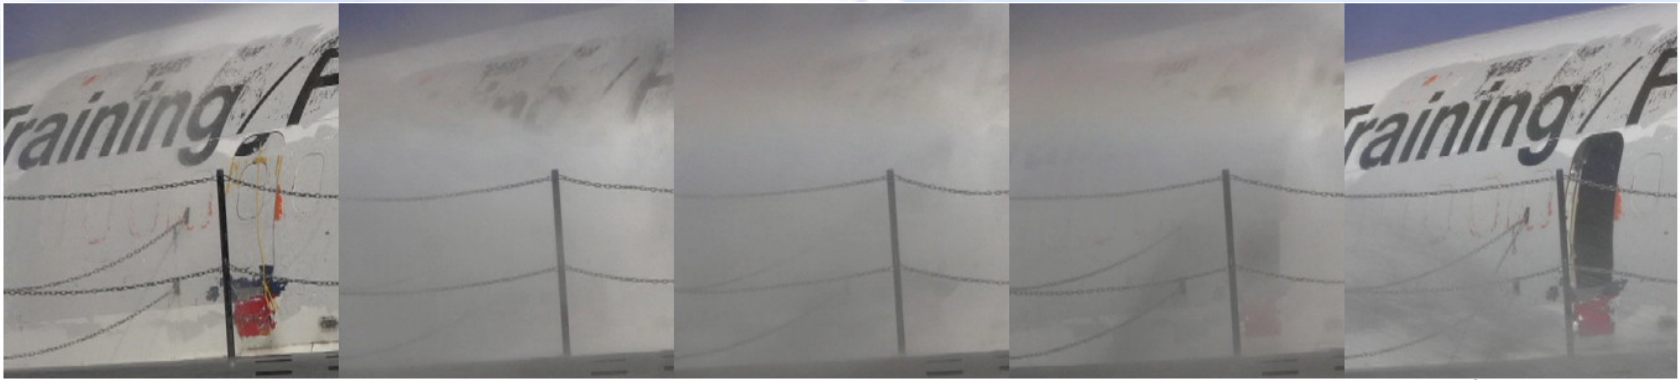
Straight stream on OWE exterior release panel for <0.5 sec

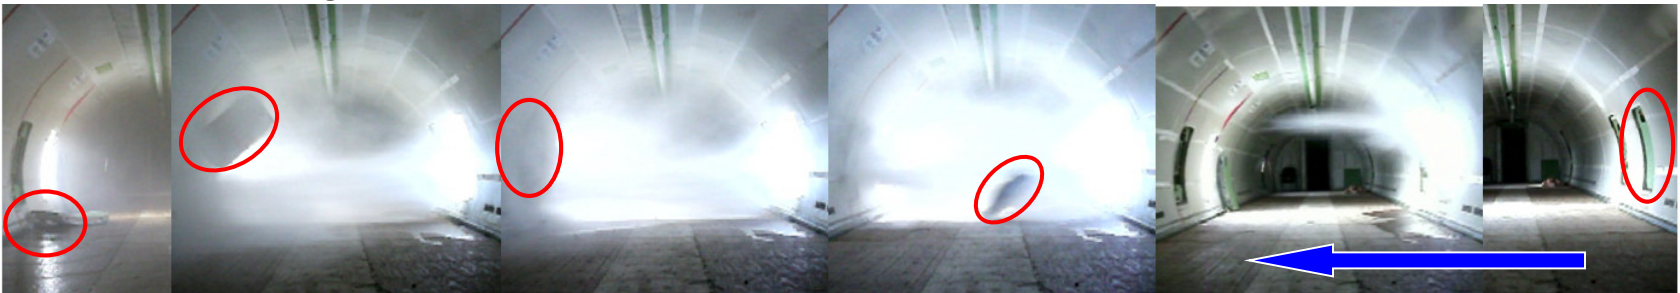
45 lb (20 kg) OWE was in motion for 2.75 sec.
Speed while crossing fuselage: 18 mph (29 km/h).

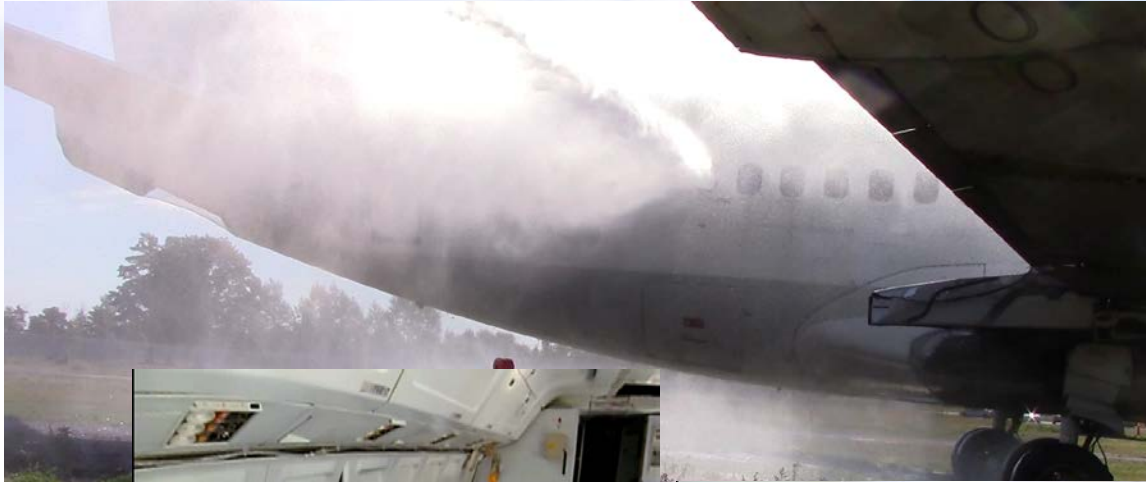
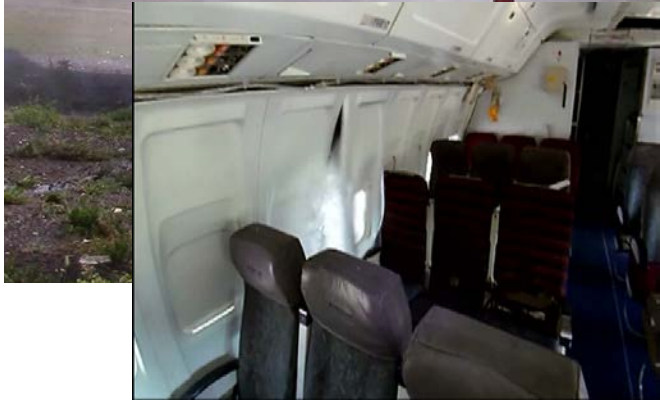
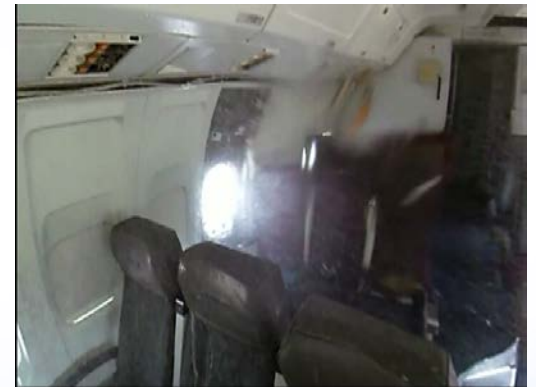
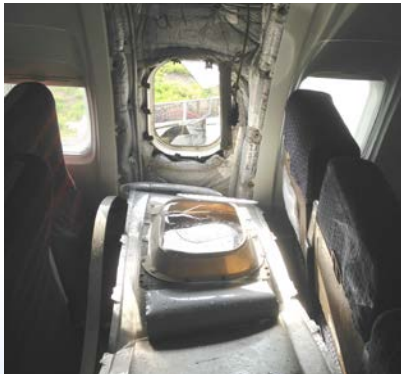
Some cabin windows are located by metal spring clips. Firefighters are aware that they can be pushed in with a hand tool. But we can do it with water in a few seconds from beyond the wing tip.
