# *ARFF Special Projects*

2005 to 2017

*ARFF Working Group  
Future Aviation Safety – A Global Conference  
June 1-2, 2017. Copenhagen, Denmark*

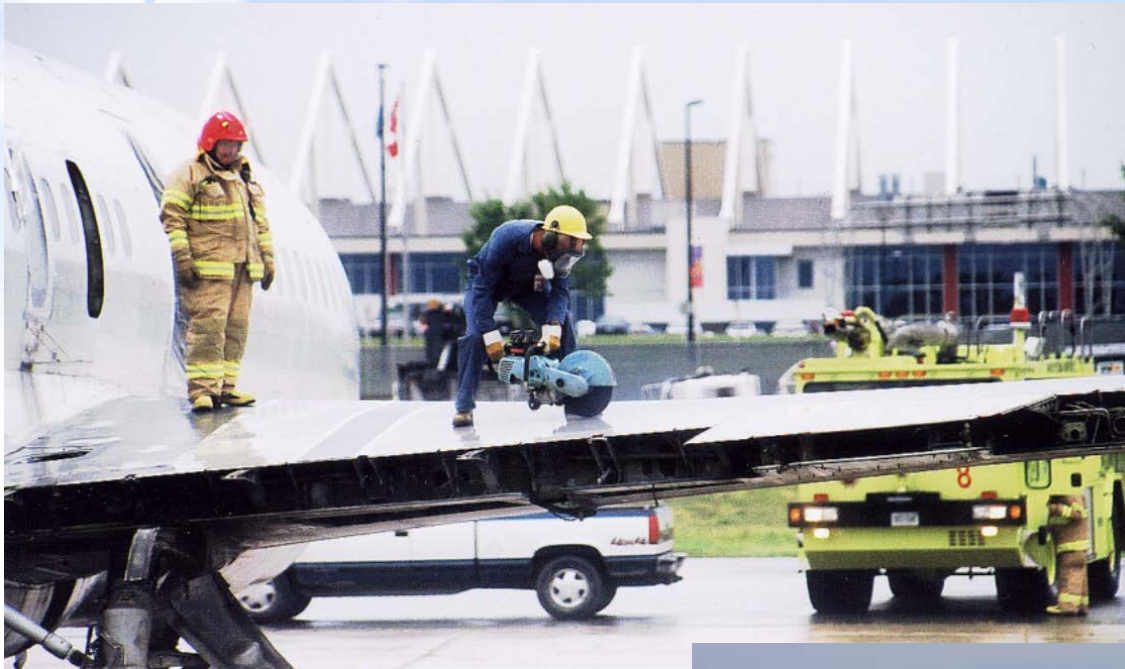
OIAA ERS supported the wing clipping of NRC's first B727. The wings had to be cut so that the aircraft could be moved through the airport perimeter fence. No gate is wide enough.

Fuel tanks were sniffed for explosive vapours before cutting

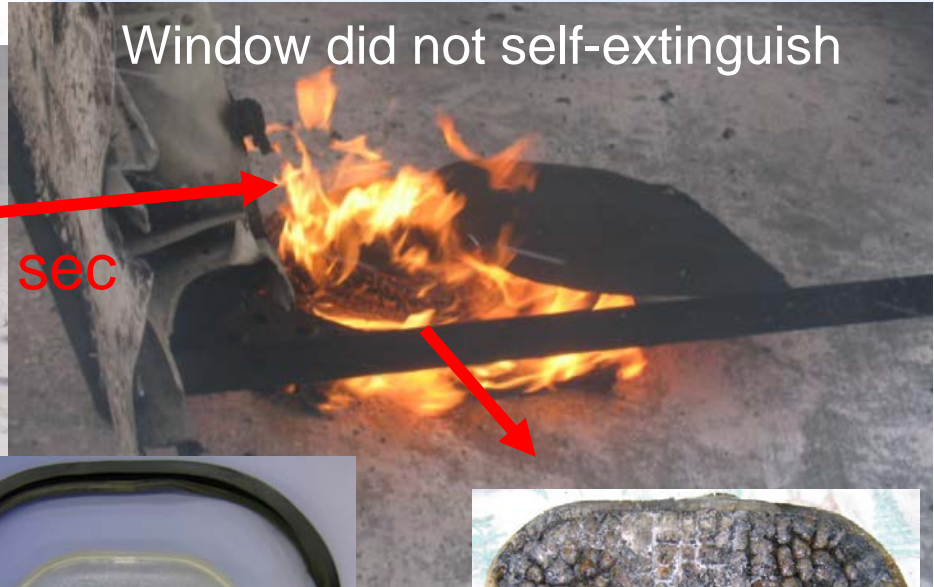
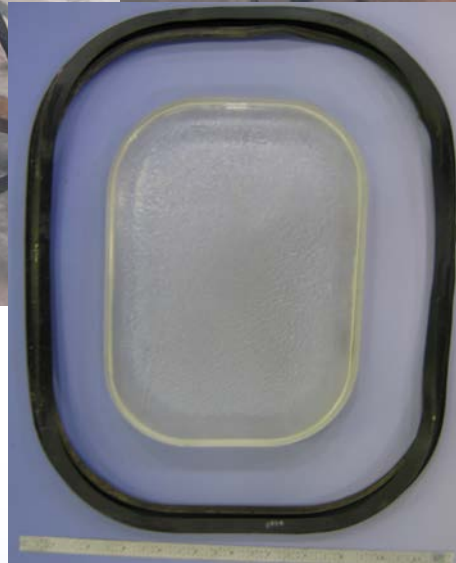
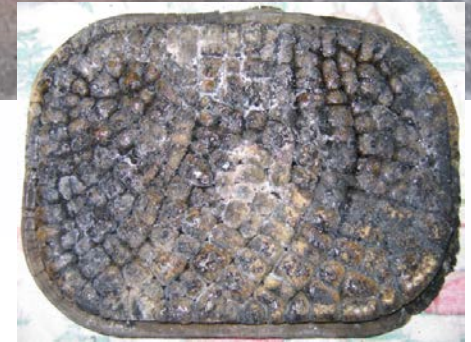
Adjacent gasoline pool fire caused outer surface self-ignition.

Heat causes 40% shrinkage

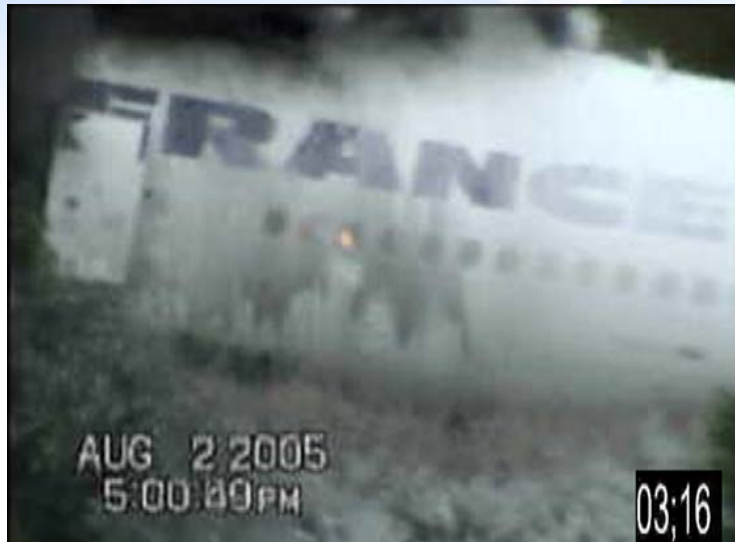
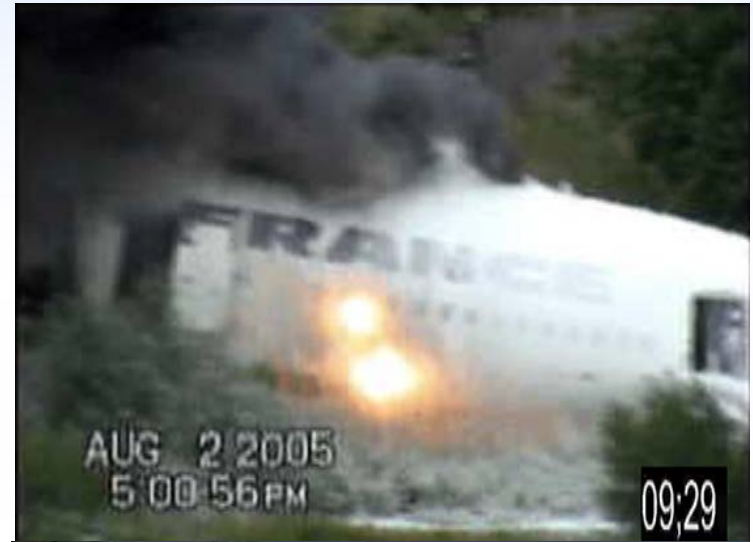
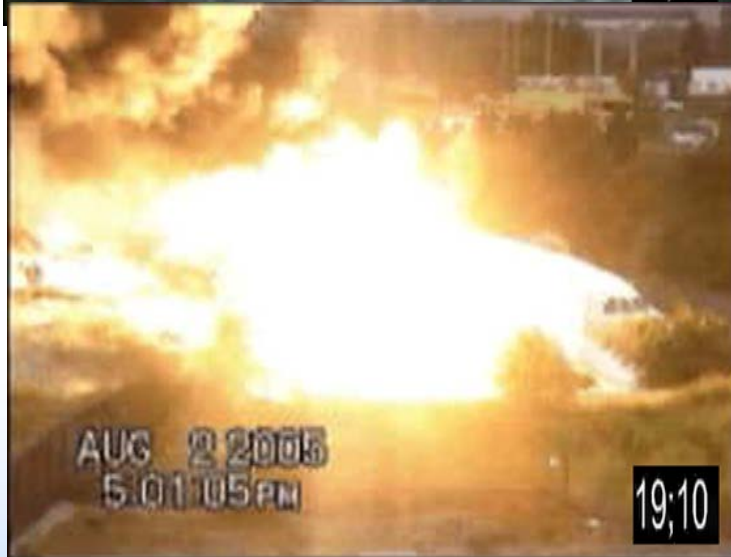
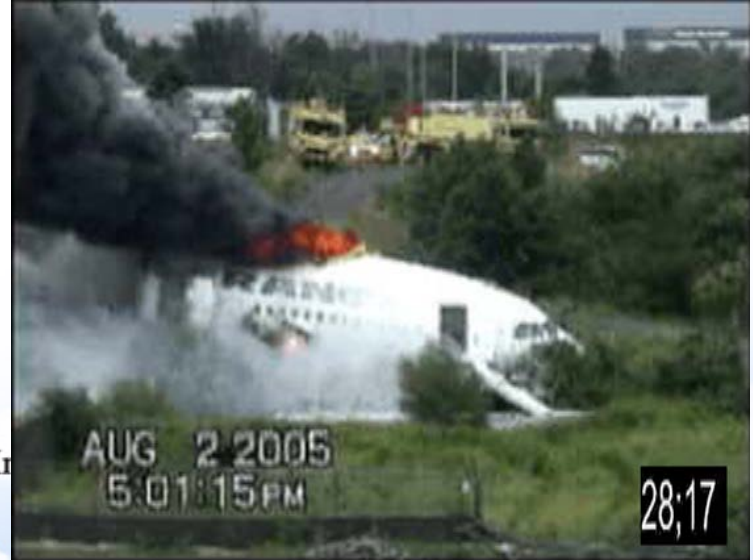
On the Crash Chart, only 4 pressurized oxygen bottles are shown in the FWD hold cheek area. There were 6 bottles and #5 exploded.

Time in RH corner (@29.97 frames/sec) is from first appearance of fire in cabin window.

Approx 19 seconds to explosion of breathing oxygen bottle.

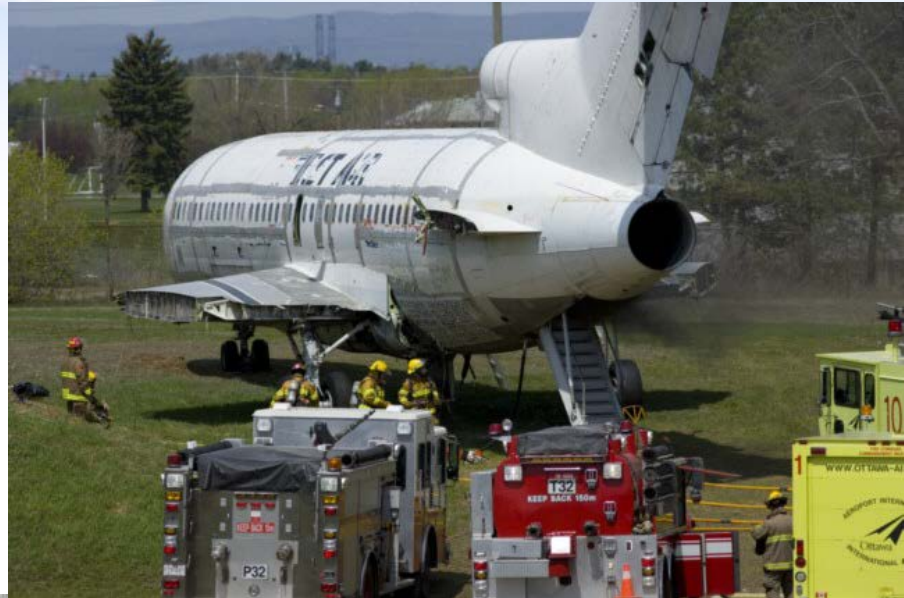
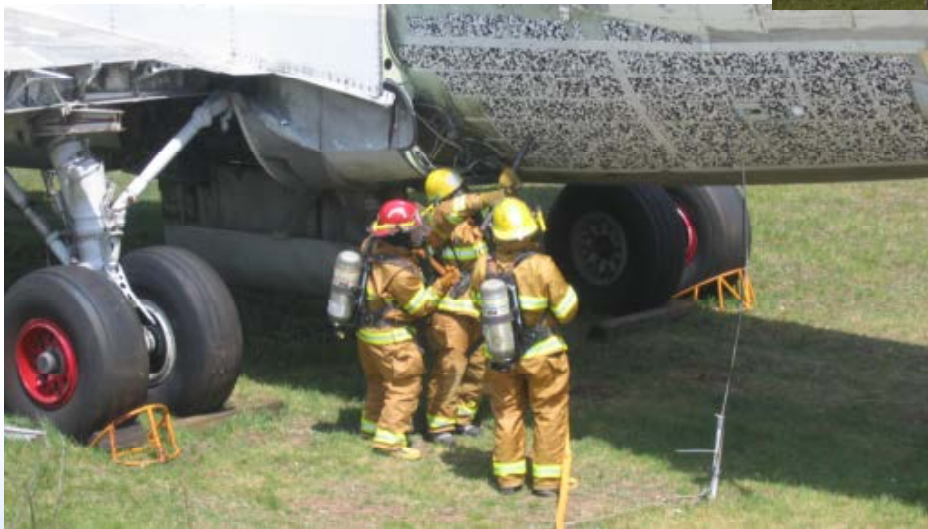
1 bomb + real luggage  
produced a toxic fire.

Manual piercing to access  
aft cargo hold fire.

Too much foam.

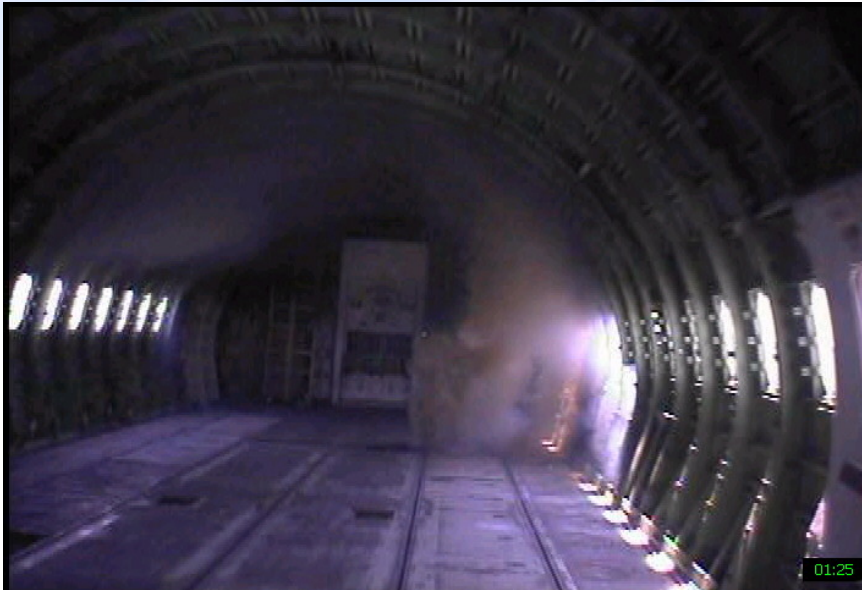
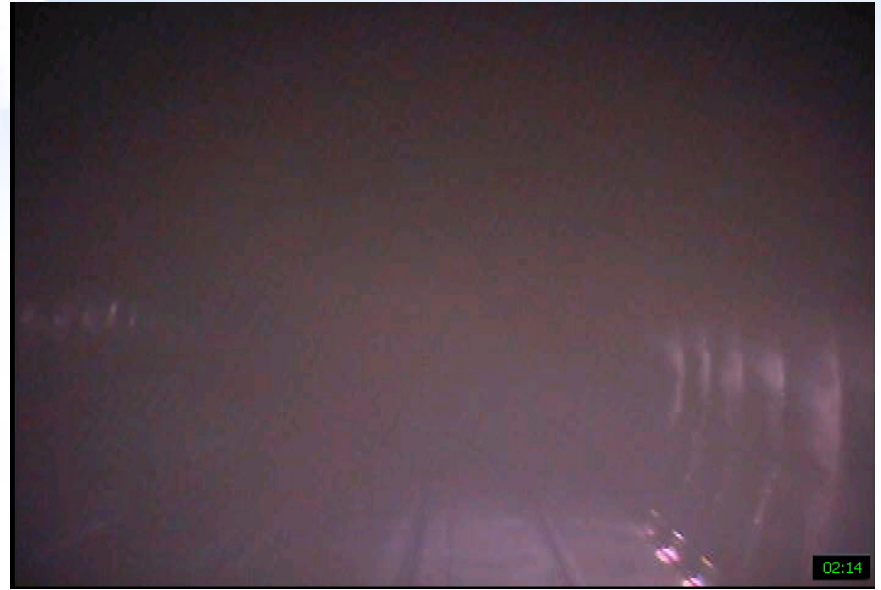
80 seconds elapsed time

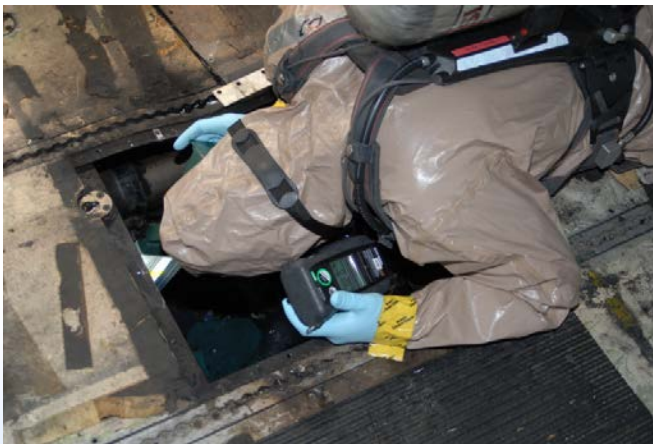
Cargo hold environment still too toxic  
1 day after fire ( $\text{CO}_2 > 200 \text{ ppm}$ )

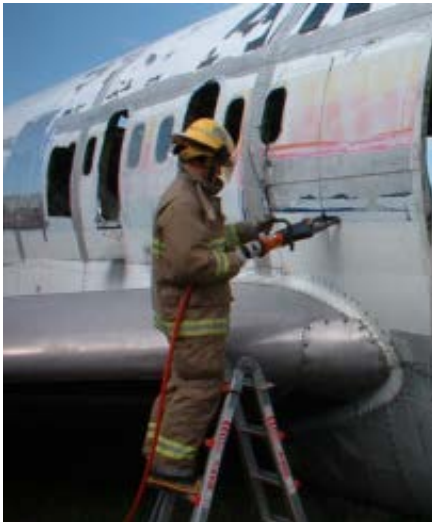
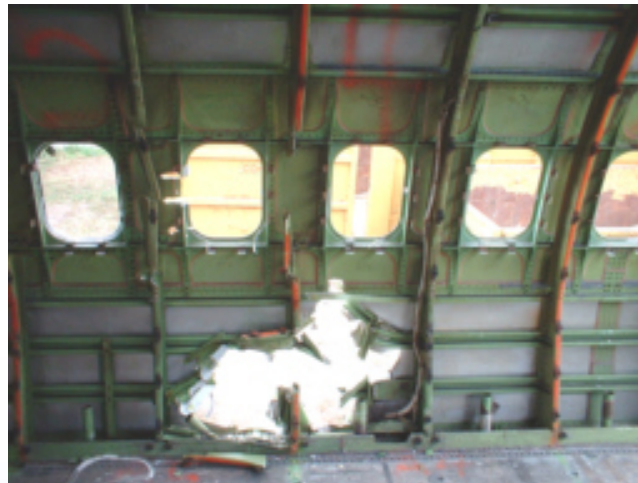
Scrapping an aircraft provides training opportunities for city, airport and military firefighters to try out their forced entry equipment and techniques. Training aids can be cut out too.

Metal cutting chain saws and hydraulic shears/spreaders are useless on an aircraft.

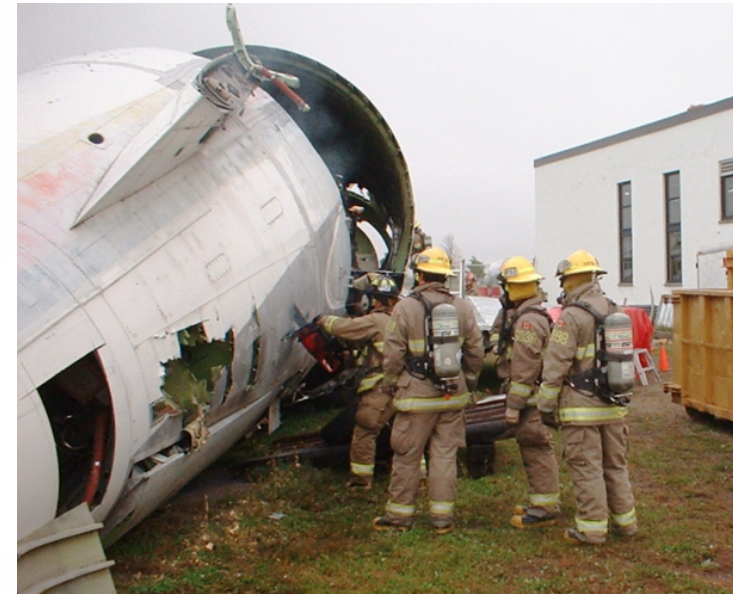
This hole took 15 minutes to make - not counting the time to set-up.

3 chains ruined very quickly.

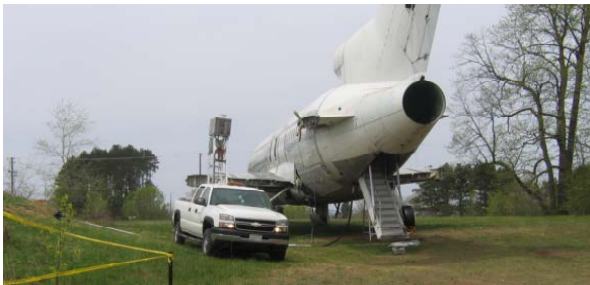
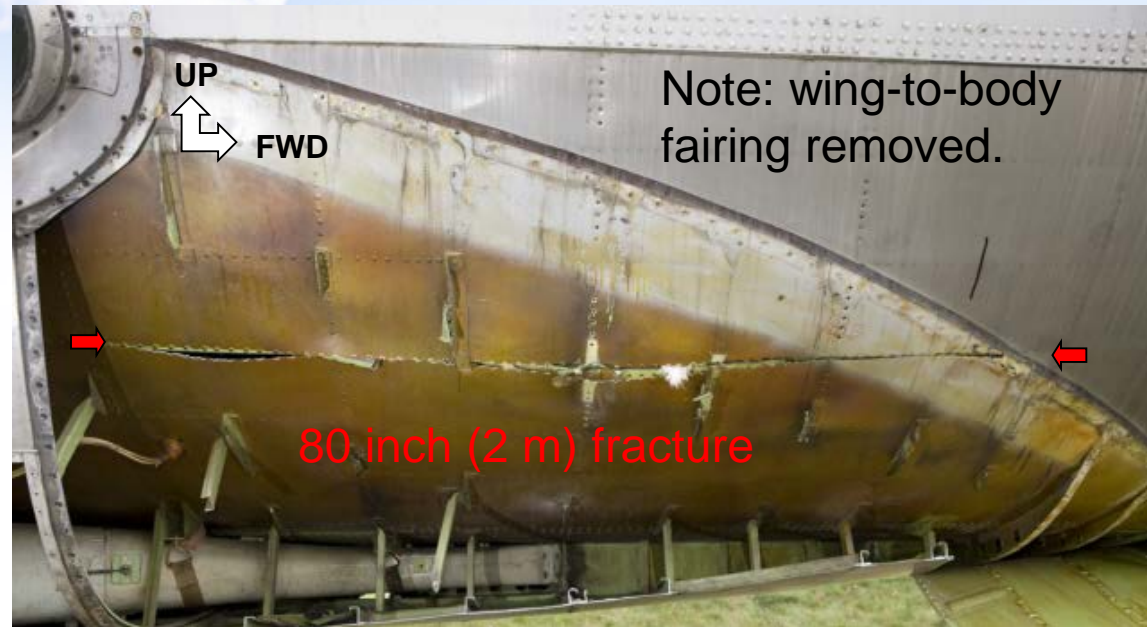
Blast created “critical length” fracture in the skin and broke 4 frames in 7 places.

LIDAR mapping of aircraft was done pre- and post-blast.

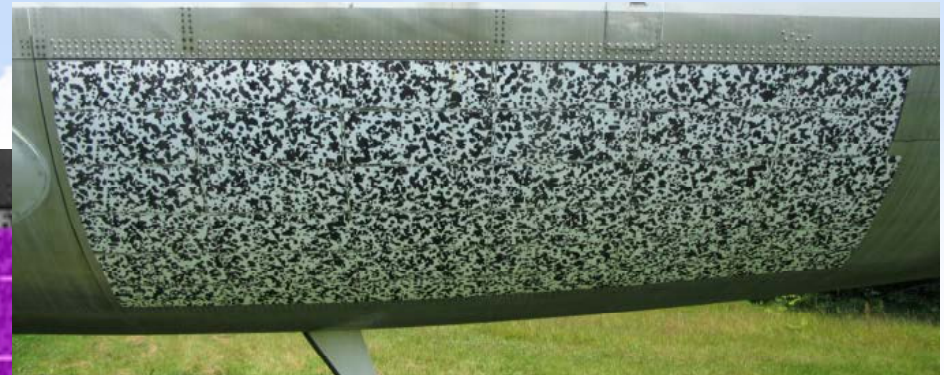
Speckle pattern applied to PORT AFT skin for Digital Image Correlation which provides full-field displacement and strain data during the blast.

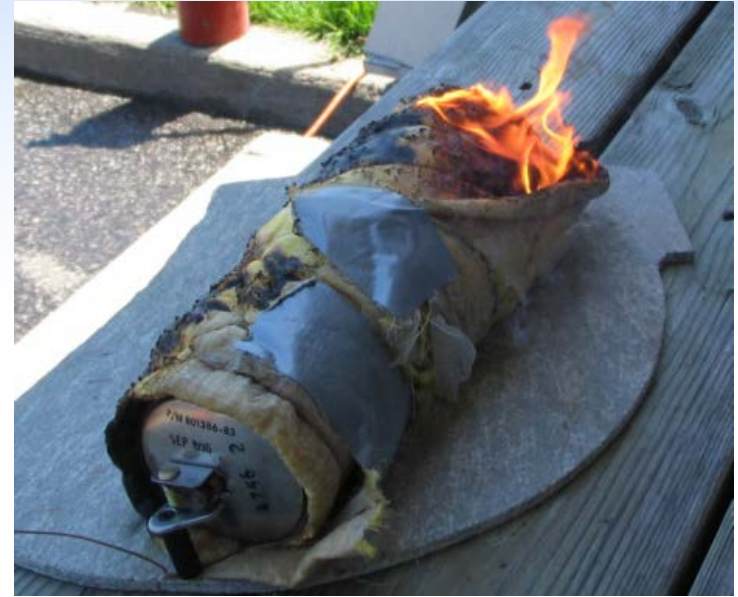
O2 generators may exceed 550°F (288°C) on the outside but they burn at over 1100°F (593°C) internally. So if they are activated and then damaged...

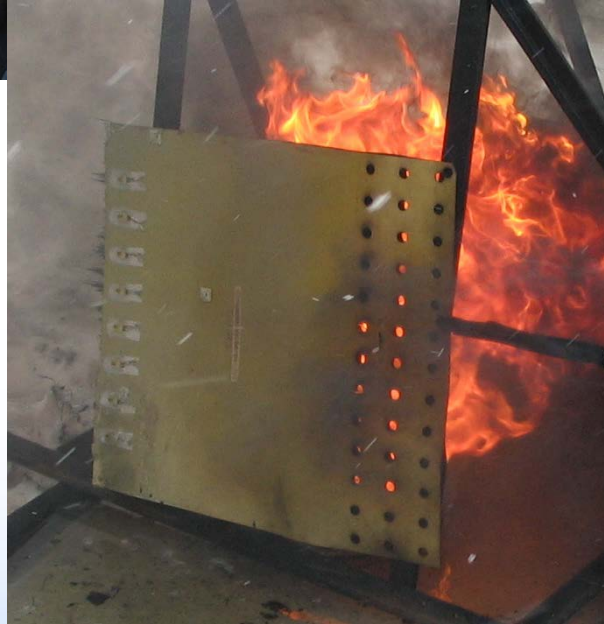
GLARE or FML

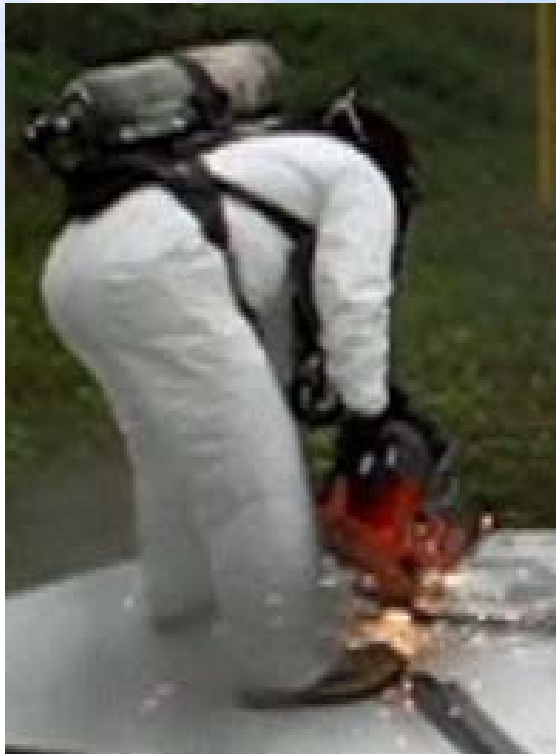
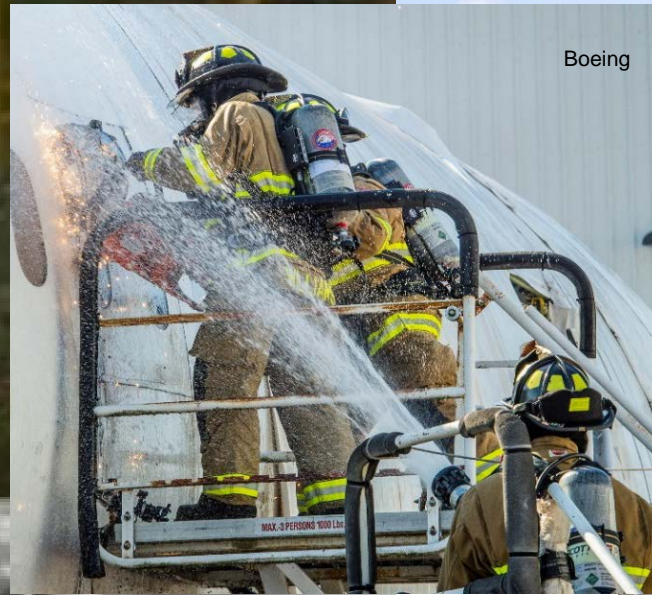
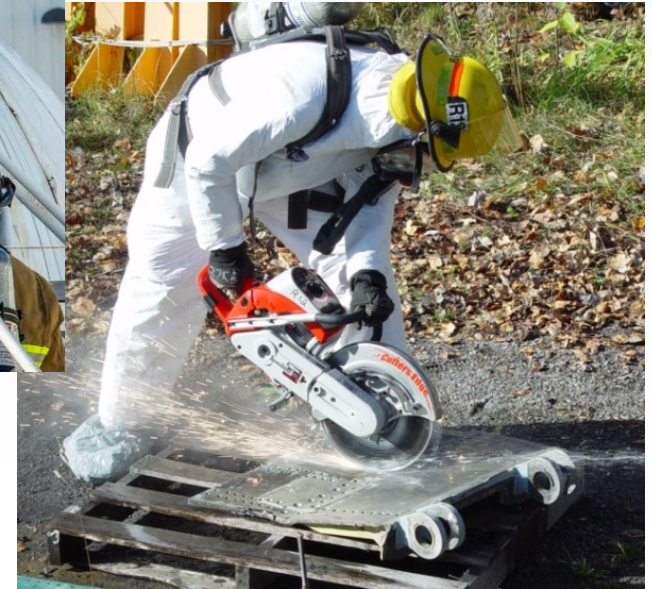
Water spray not just for dust abatement.

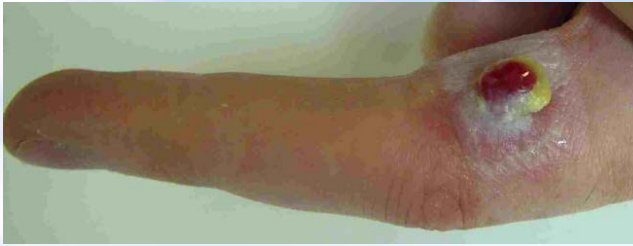
Penetration wound

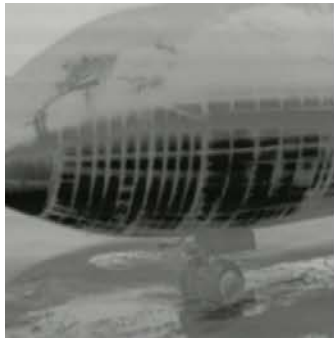
B727 piercing map

Other than windows and doors – there are no landmarks for piercing on a fuselage.  
Too much effort to generate a piercing map - even for one aircraft type.  
Too much to ask a firefighter to flip through a database to find where to pierce.

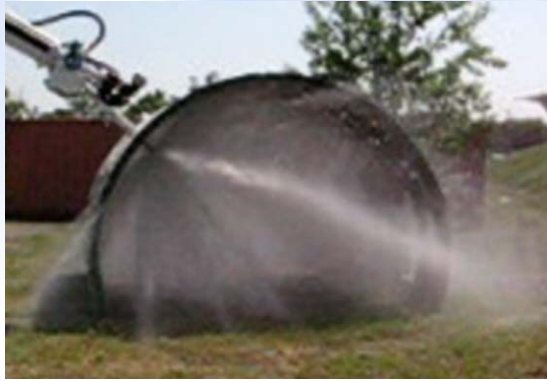
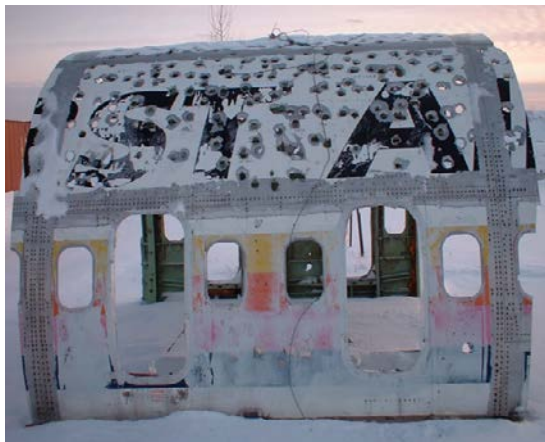
A pool fire in a pan inside our B727 centre section piercing trainer gave us our first example that sub-structure could be detected by the thermal camera and provide the piercing tool operator guidance on where NOT to pierce.

B727 centre section

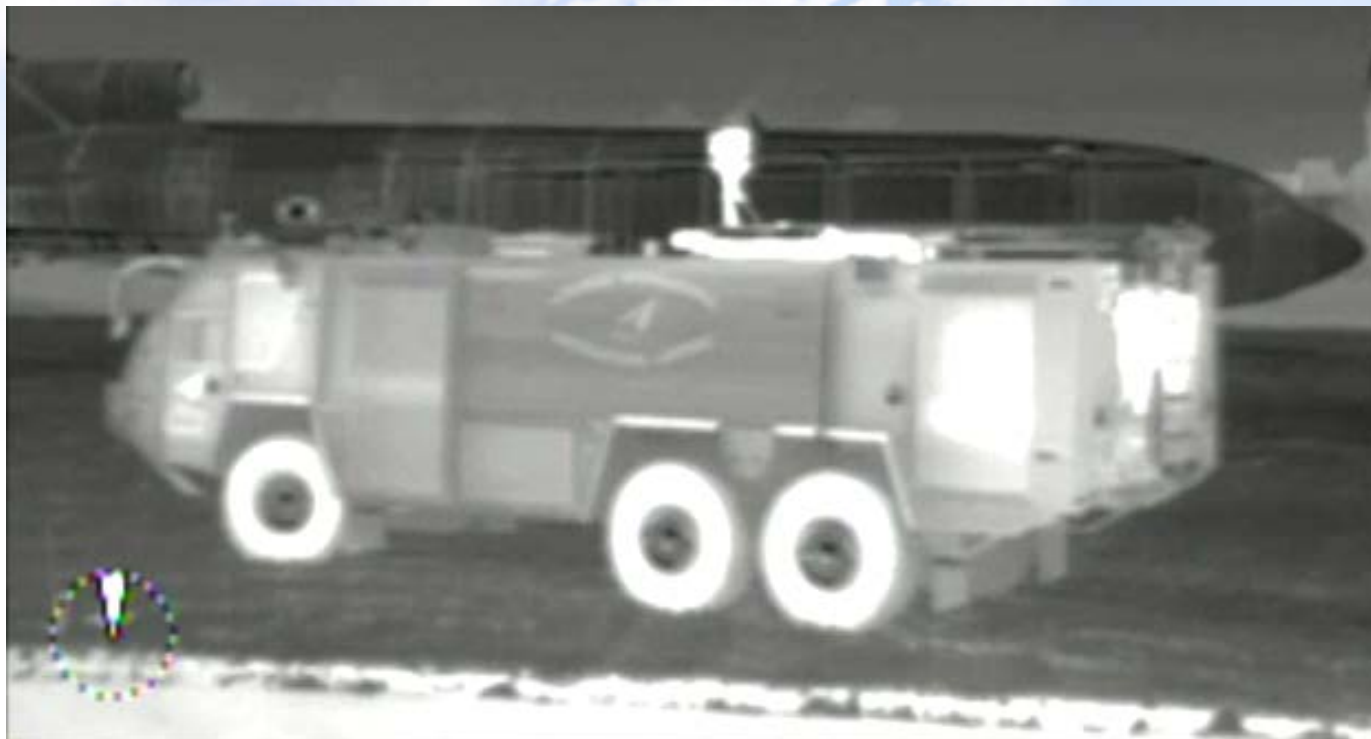
We have two identical Panther 6x6 trucks, Red 8 and Red 9, but we can't tell them apart in a thermal view.

Note the sub-structure read-through on the B727 behind the truck after a CAFS training exercise.

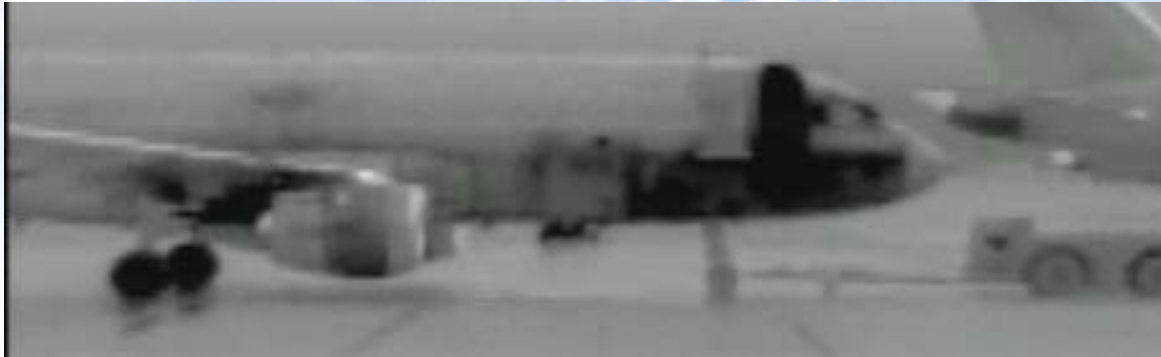
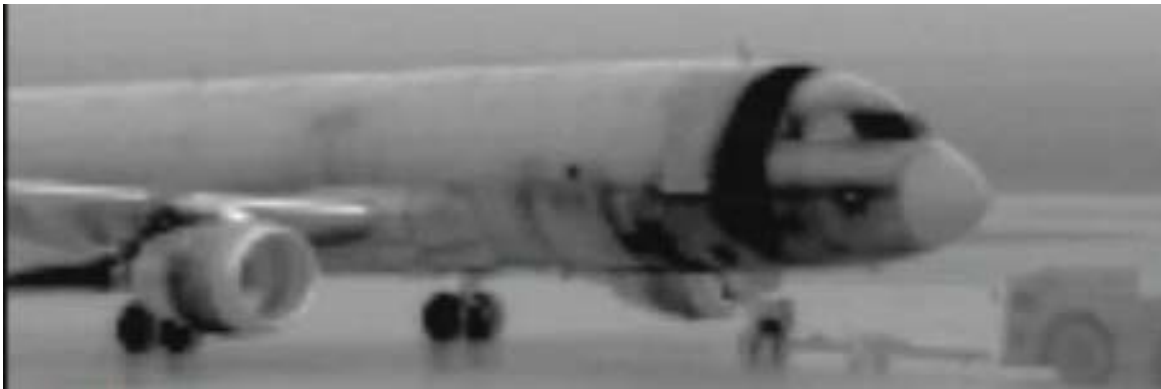
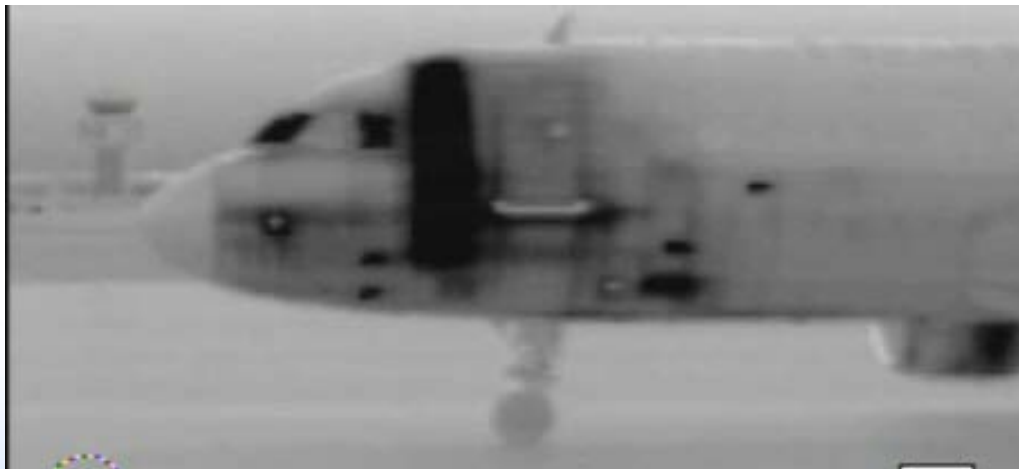
What do aircraft normally look like, thermally, and how does this affect your response to a call of fire/smoke/overheat?

Firefighters need to educate themselves on the normal thermal signatures such as heated windshields, air data probes and, on this A-320, the use of the fuselage skin to dissipate heat from electronics.

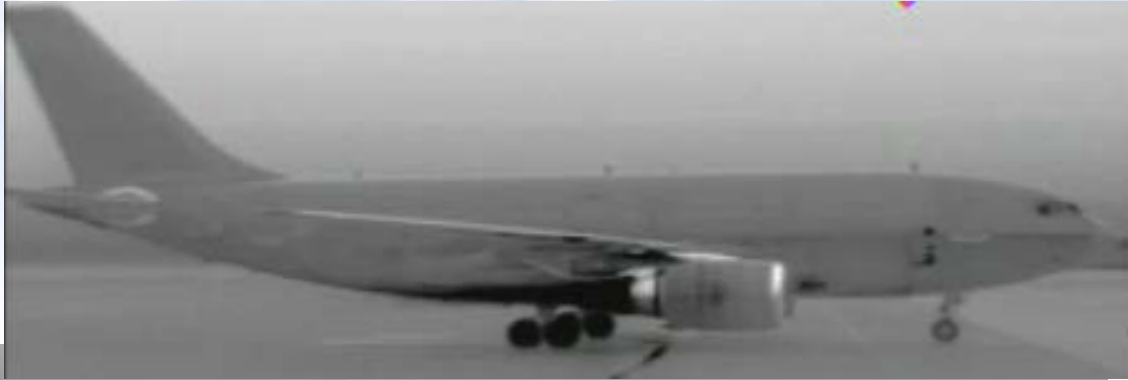
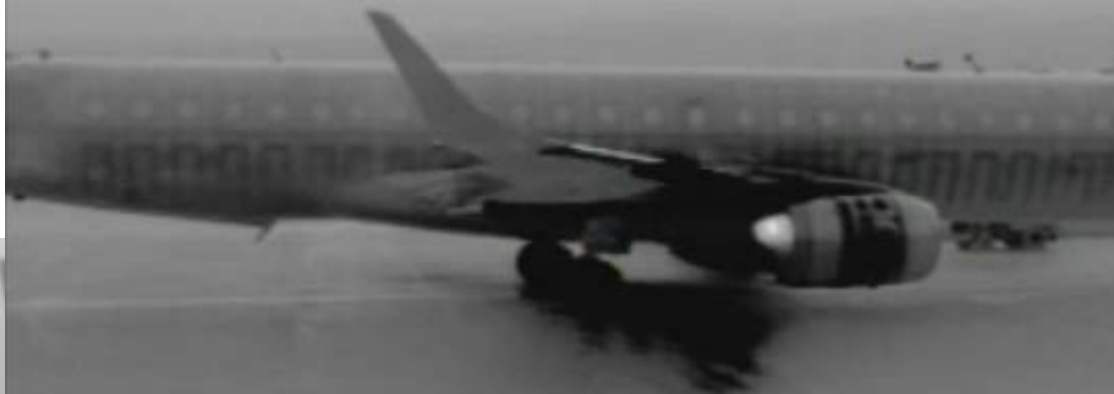
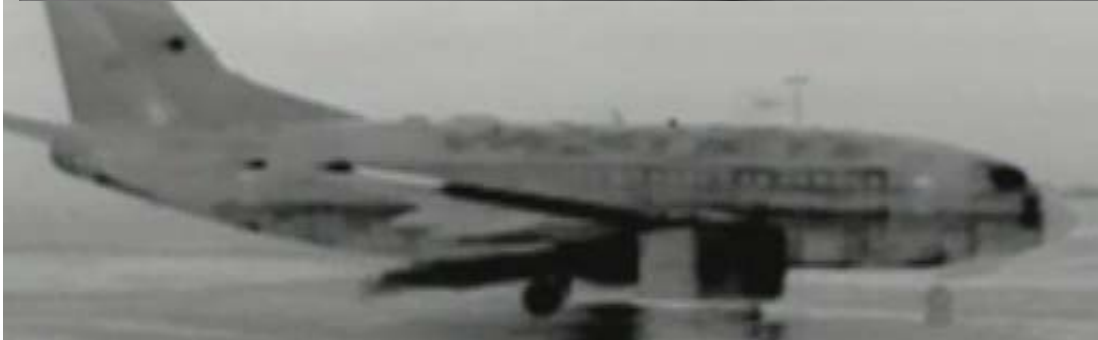
A working group was formed to gather factual information towards developing techniques for fighting fires in engines and nacelles as well as flooding-out run-on engines.

We began imaging the engines on operational aircraft to characterize their normal thermal signatures.

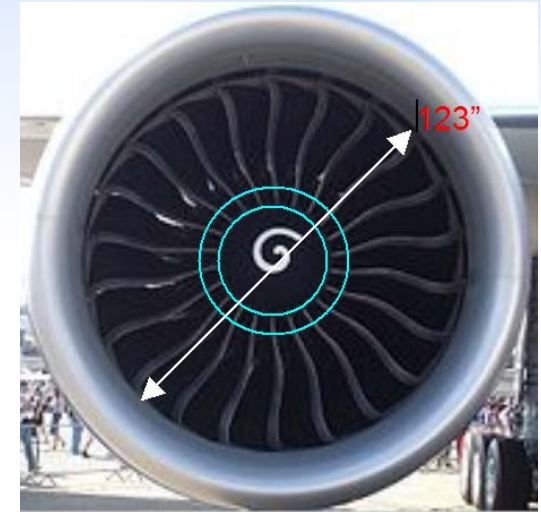
Central ring around fan cone is target for water delivery to terminate engine run-on.

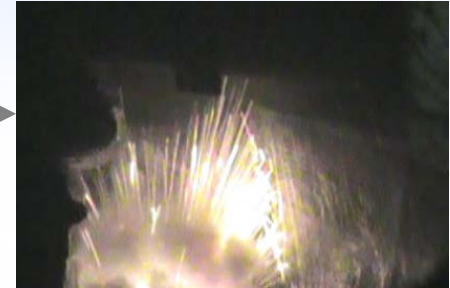
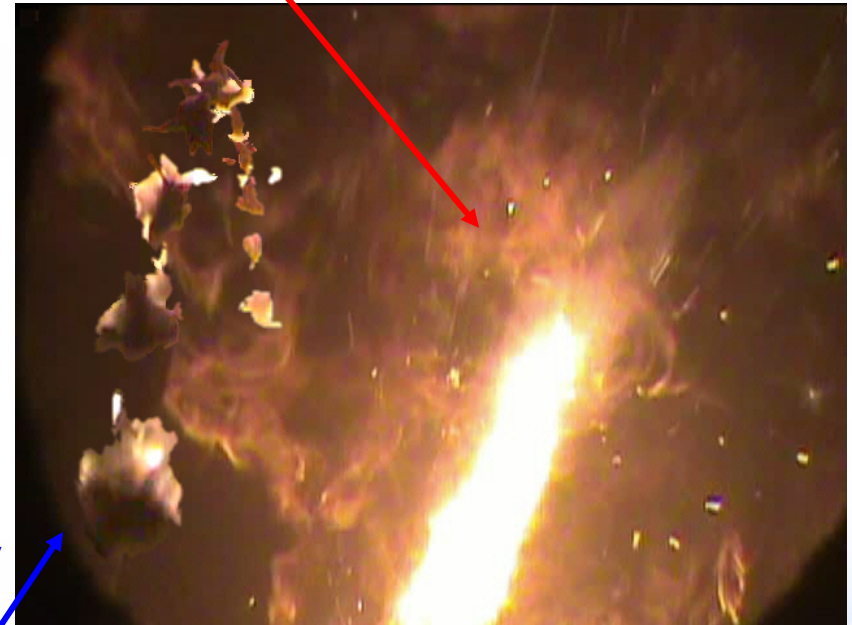
Military 10 D-cell Li/MnO<sub>2</sub> primary battery pack  
2.87 lb (1.3 kg)

Molten Lithium →

Flame jet, 90 sec  
each cell

Battery  
case  
trajectory

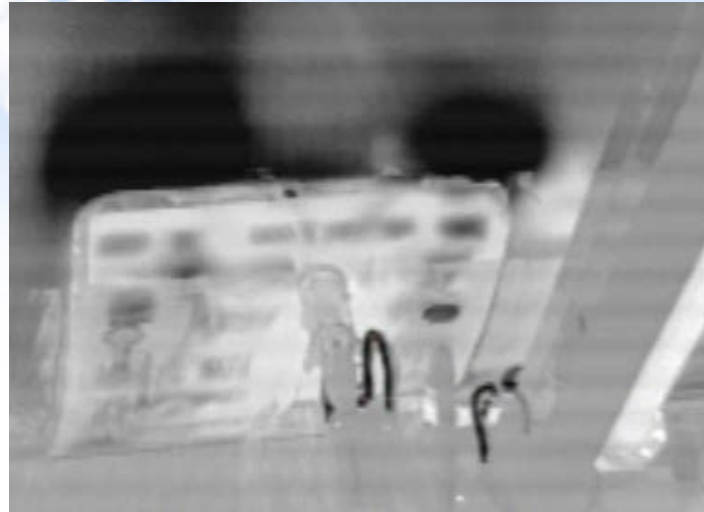
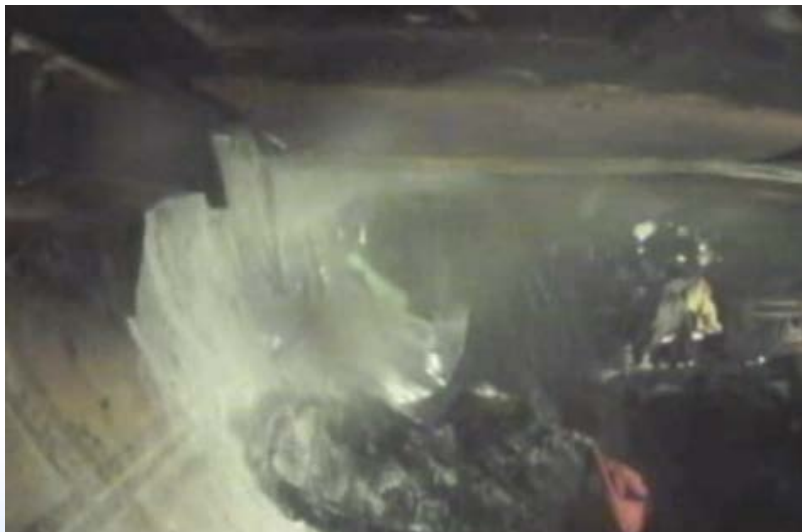
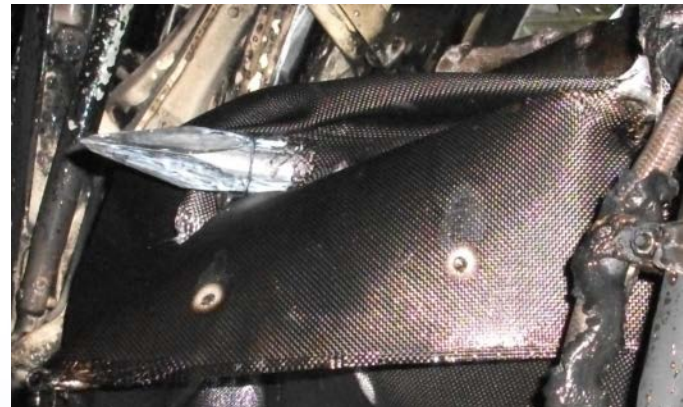
Fire damaged the fibreglass liner on the inside of the cargo door which trapped the Stinger water spray so that only the cargo door was wetted.

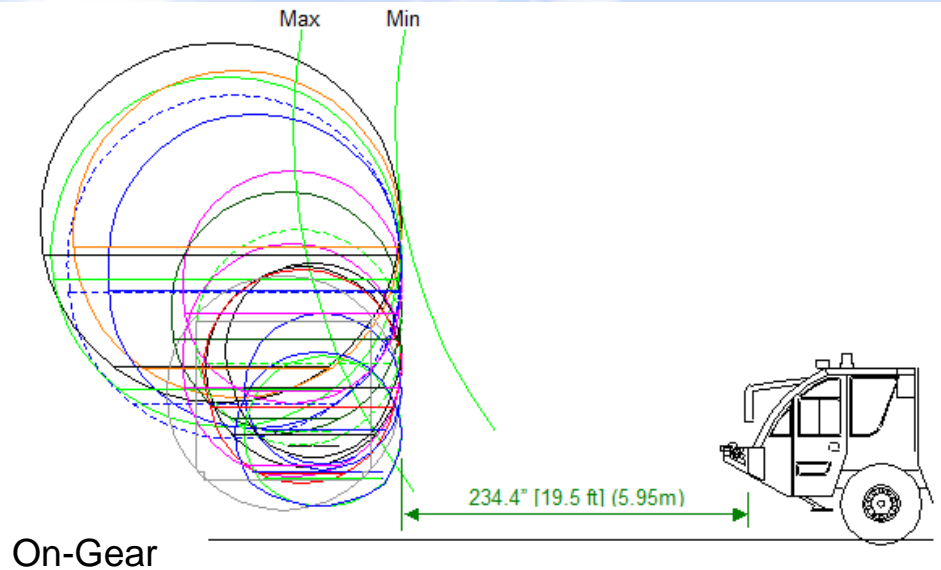
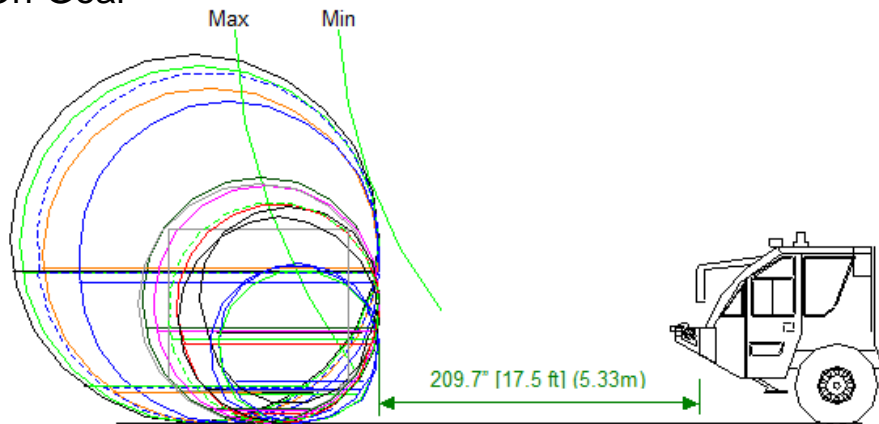
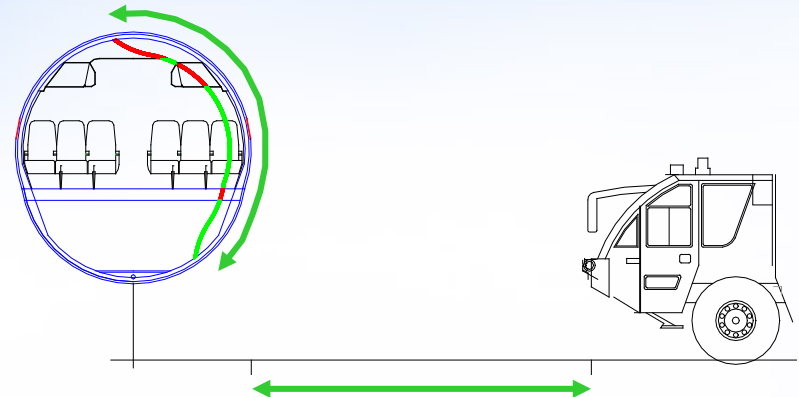
# Stand-off Modeling for Optimum HRET positioning for Piercing.

On-Gear

Off-Gear

Combined Small and Large Aircraft groups.

Optimum standoff distances were developed for 18 aircraft types.

These were grouped to establish one common distance.

The difficulty remains – how to measure/display the distance as the truck approaches the aircraft.

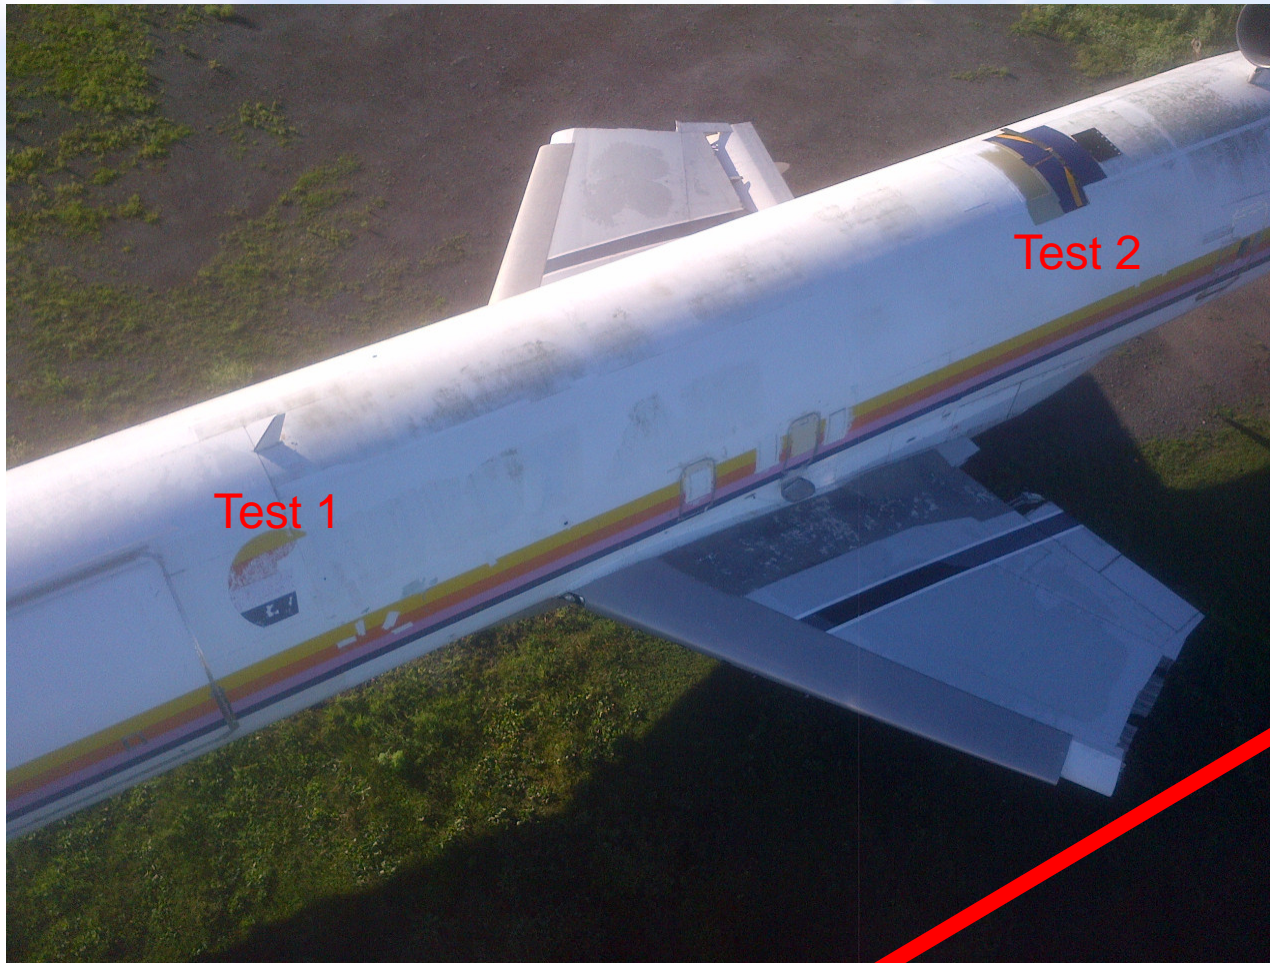
Test 1 – Baseline Aluminium Fire Test  
2 – Advanced Composites Fire

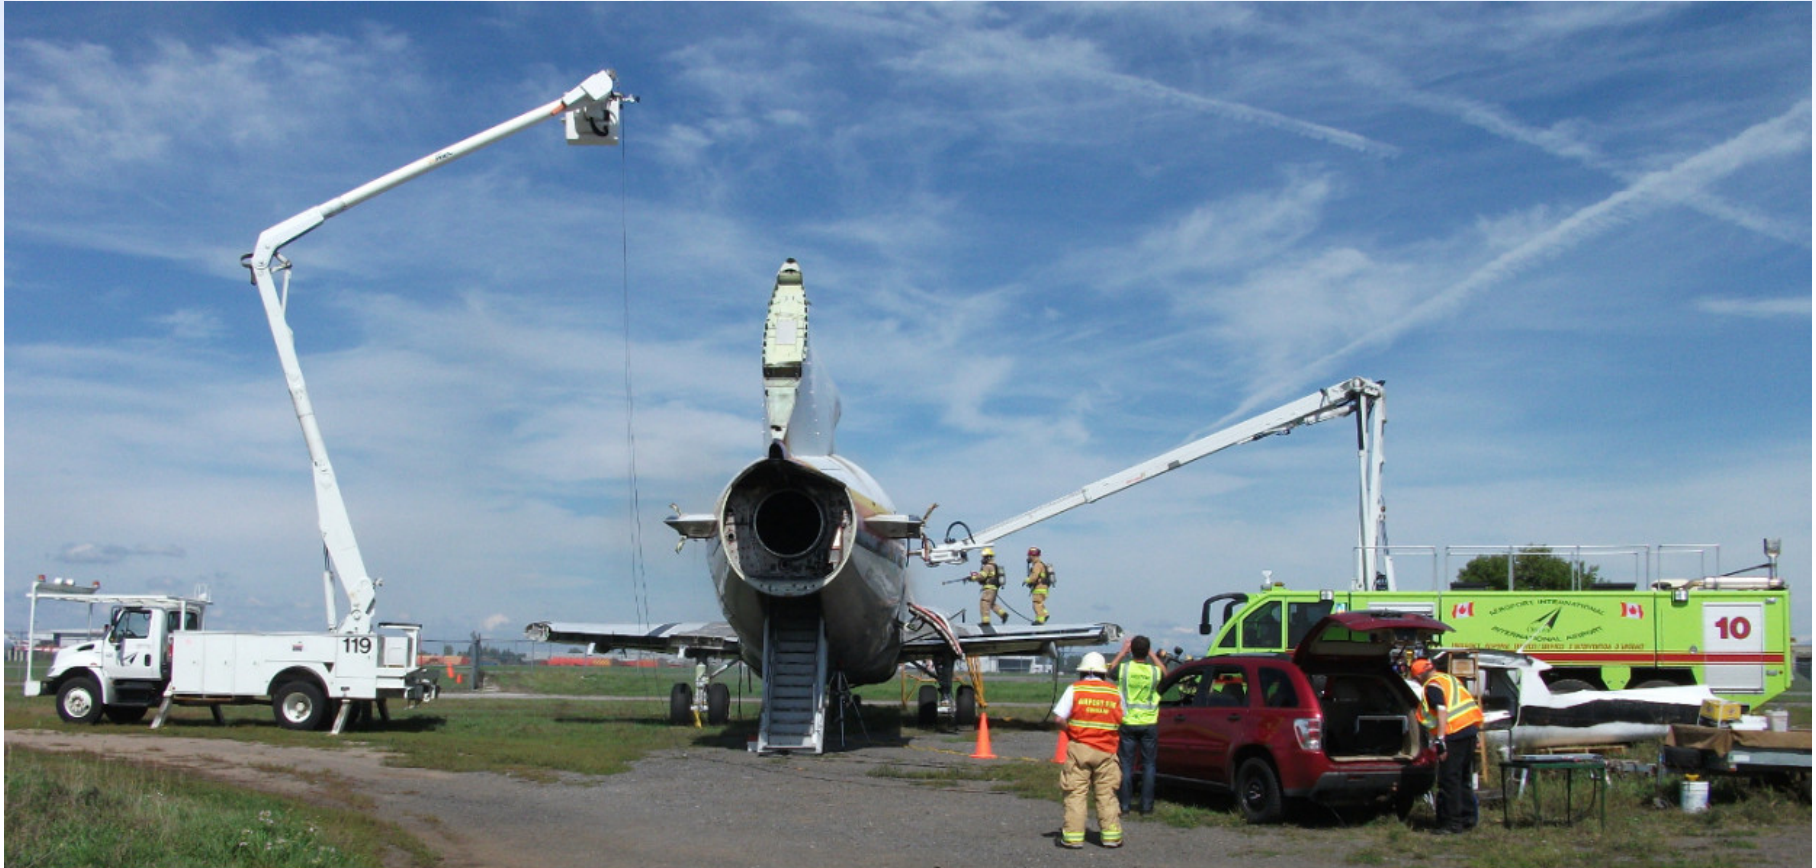
# Composites Burn

Overhead thermal and video camera on boom truck.  
Videos sent to command post (red van).

Pyrolance attacked off STBD wing.

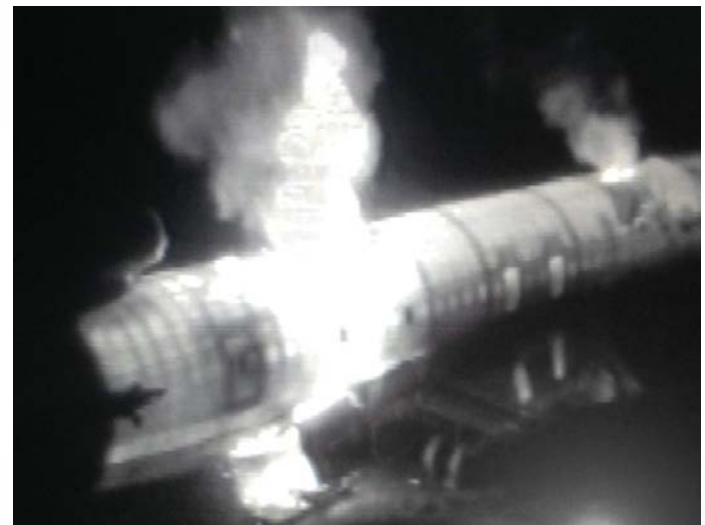
# Burned Twice

Our thermal cameras have no internal memory so we added a laptop to record the boom-truck camera view. The software split the video record into two files but at the end of the test it failed to save the data for the first file.

We had just added the thermal camera to the top of our HRET boom. This is the only image we have - a screen shot off the cab monitor. The video was not recorded on the truck road recorder.

Our trucks have been rewired. If the road recorder is not functioning – we will know - because the cab monitor is blank.

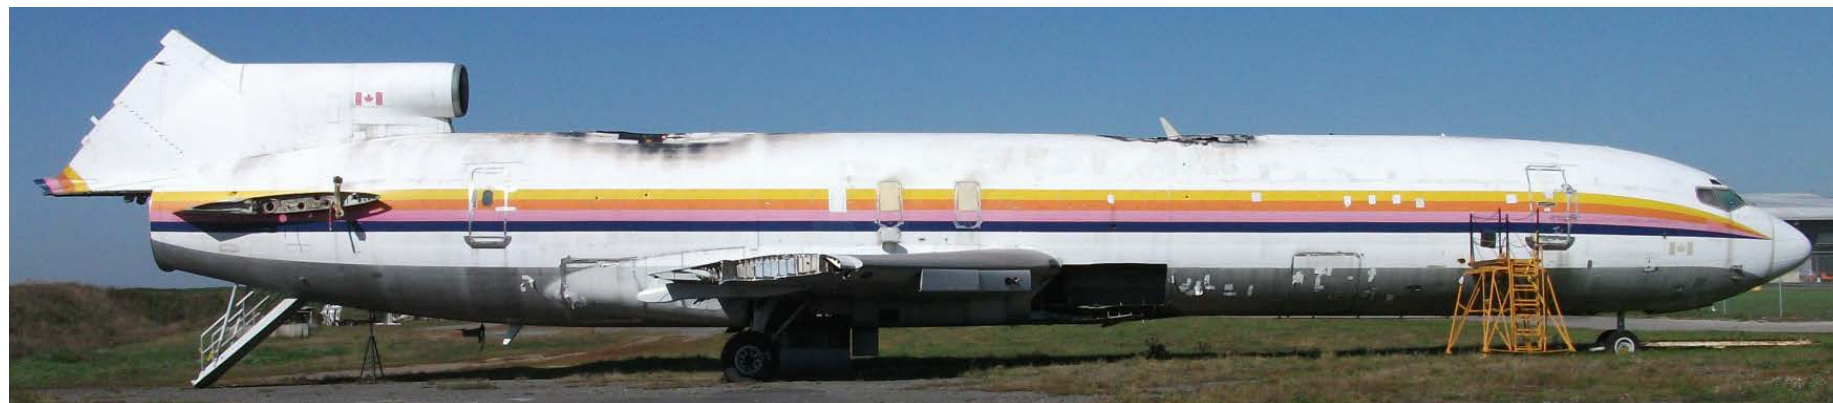
# The Big Burn

Sufficient fuel on aft main deck and in cargo hold to burn the tail off behind the wing.

**Fuel Load (shredded paper)**

← Main Deck 250 boxes

← Cargo Hold 100 boxes
