# *ARFF Special Projects*

2005 to 2017

*ARFF Working Group  
Future Aviation Safety – A Global Conference  
June 1-2, 2017. Copenhagen, Denmark*

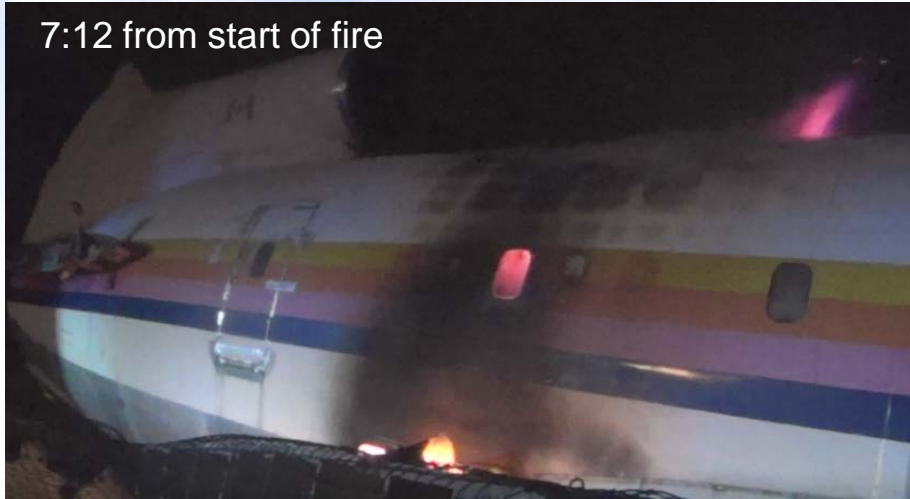
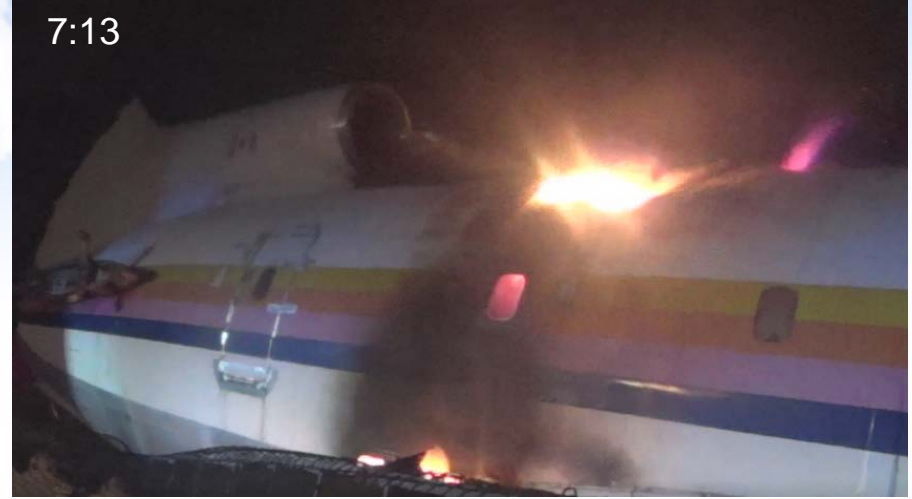
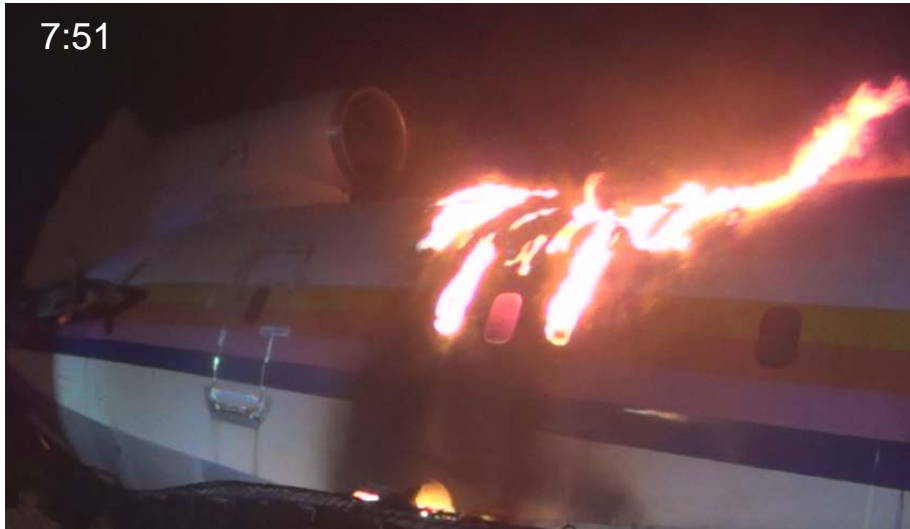
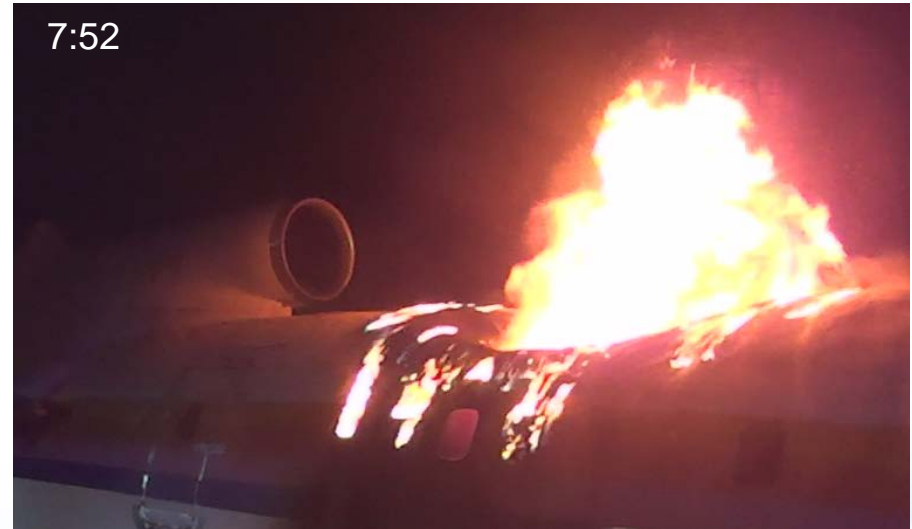
# Burn-through around composite crown.

7:12 from start of fire

7:13

7:51

7:52

This sequence takes place over 40 seconds.

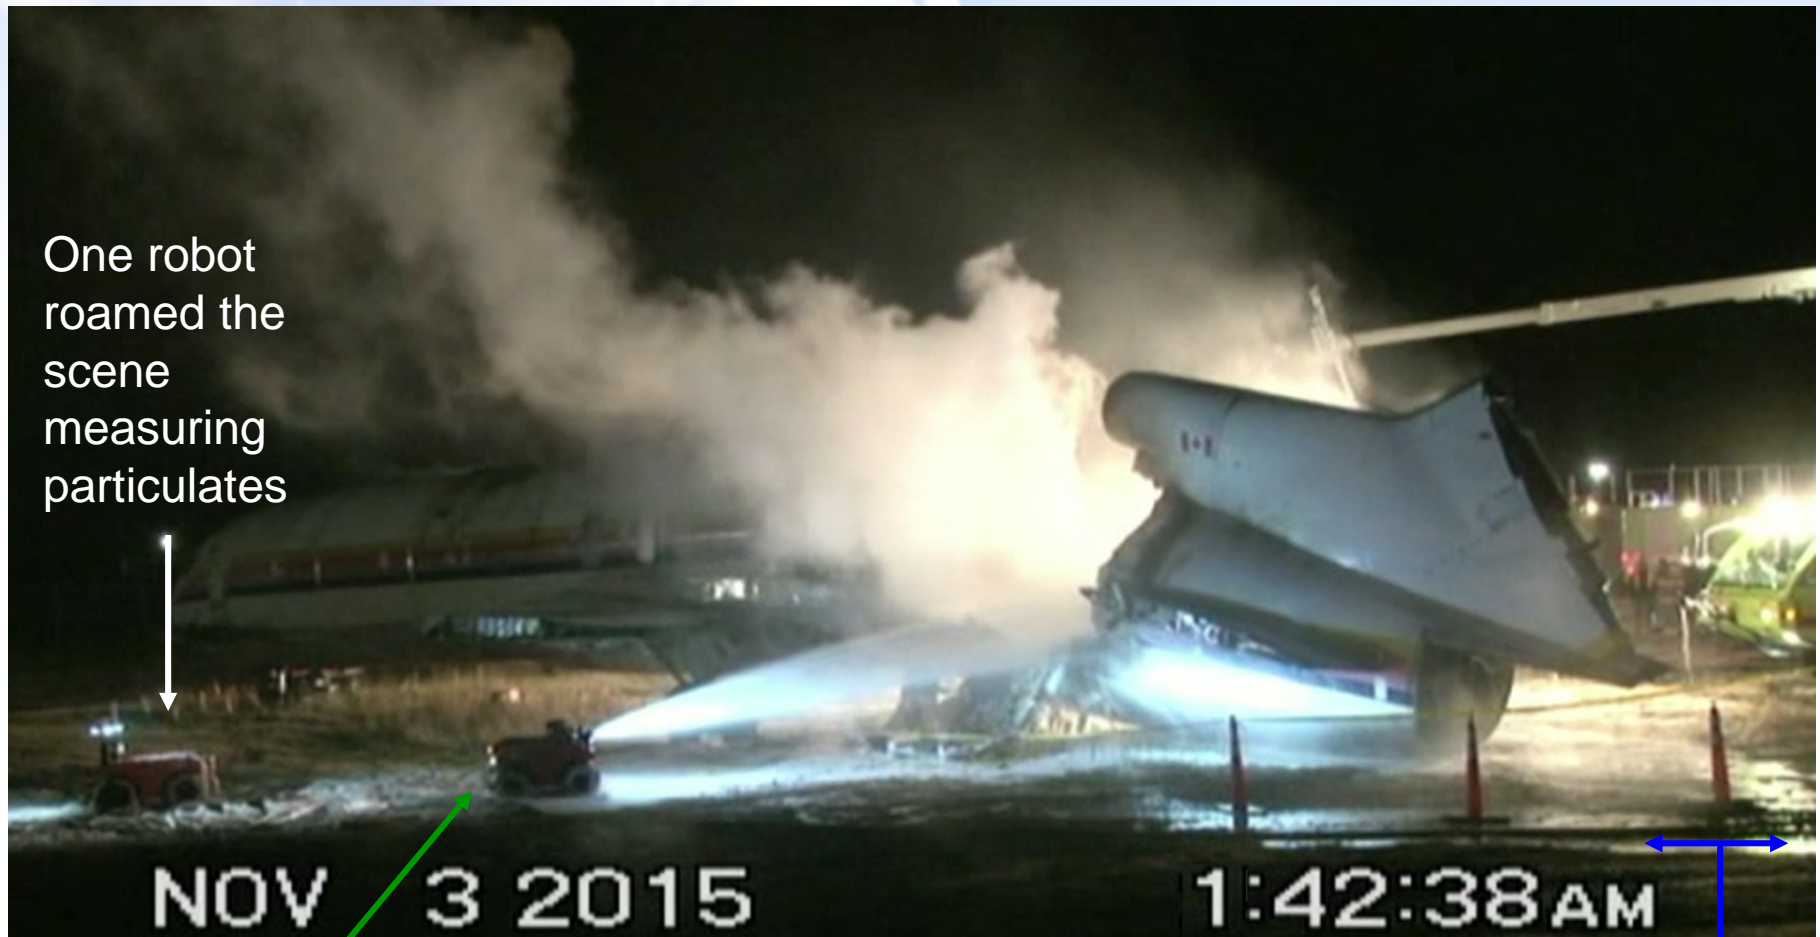
One robot roamed the scene measuring particulates

Demonstration of a new remote-controlled firefighting robot attacking from the down-wind side.

Robot towed a 2.5-inch hose from pumper

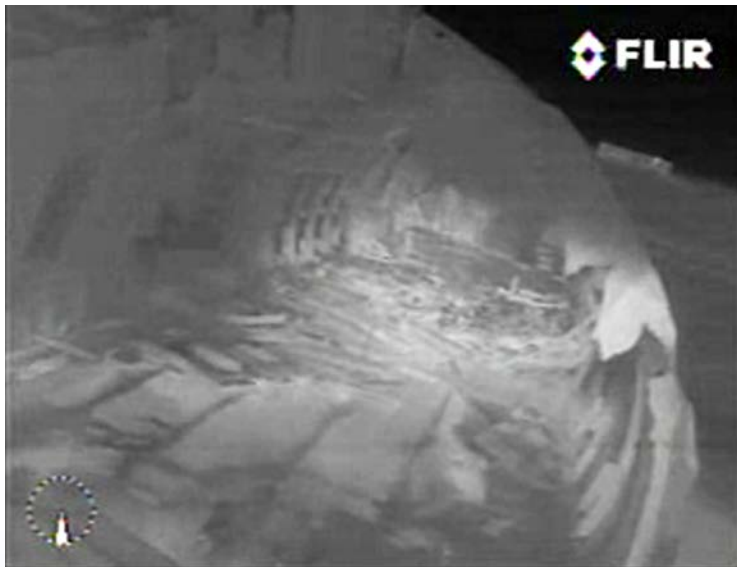
# Wireless HRET Thermal Camera

HRET turret water spray

Looking down fuselage  
through hole in crown

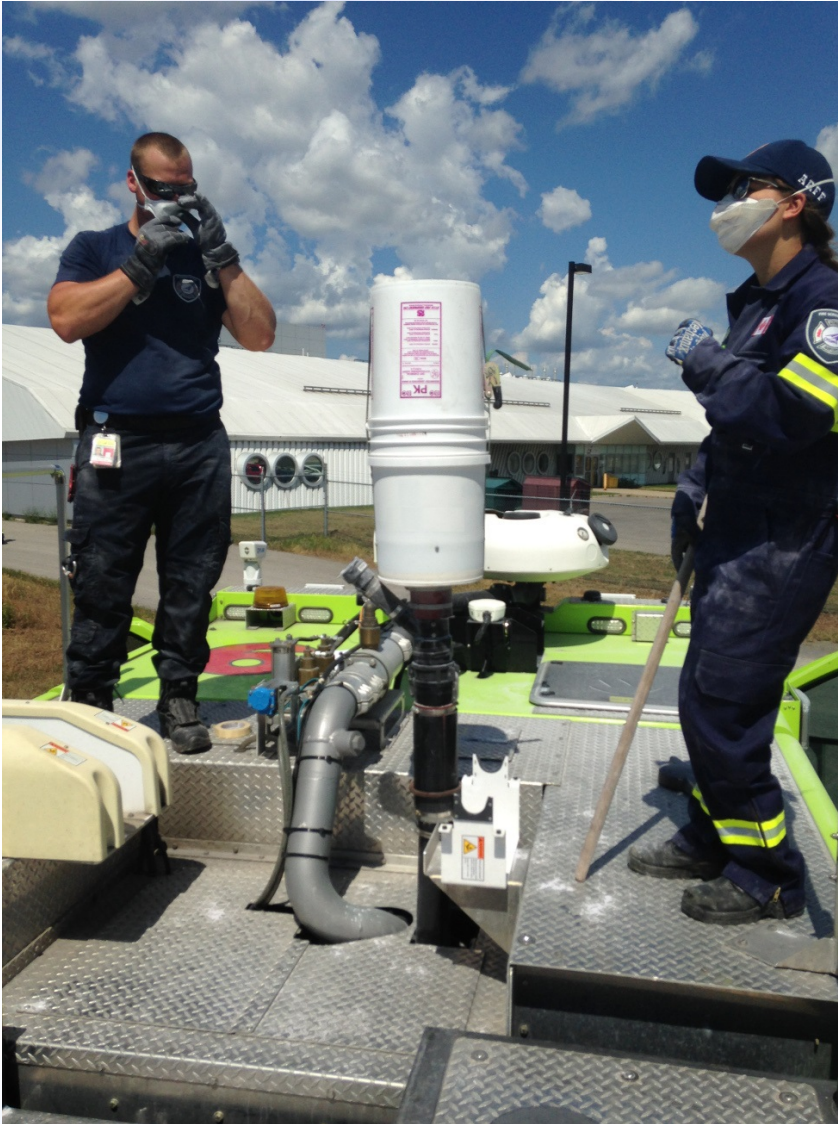
# Dry Chemical Refill Device

The annual dry chemical certification results in a messy refill job that many firefighters do not enjoy.

A prototype device that minimizes the mess and fits three different truck arrangements was built and tested. Seven 50 lb pails of dry chemical have been loaded in 30 minutes.

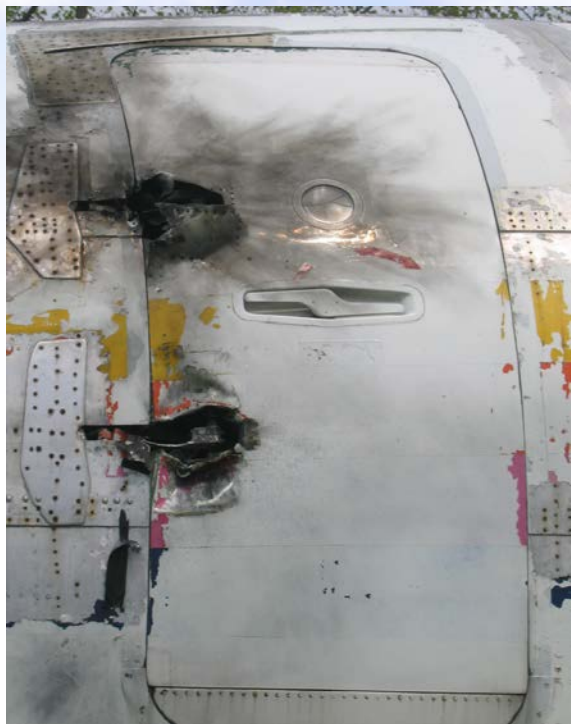
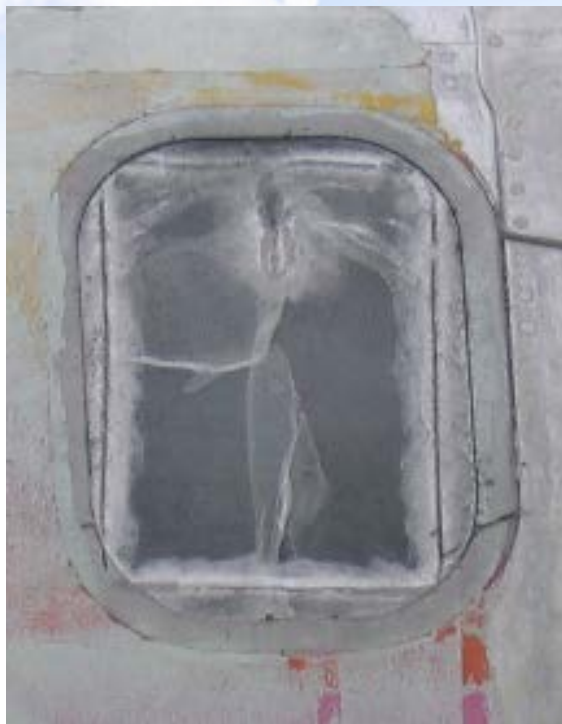
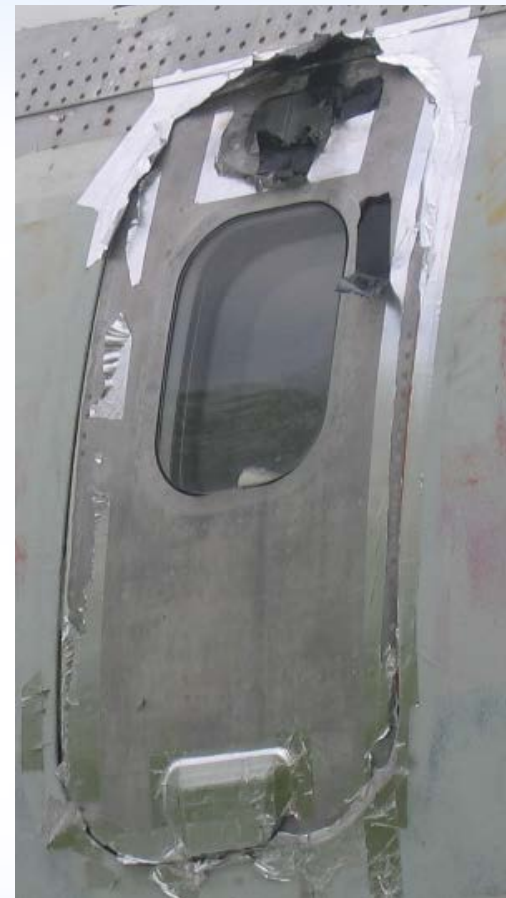
# What were they thinking?

After the Kaboom 1 test, Bad Men came. They were interested in “rapid forced entry”. They used explosives on the L1 door, a cabin window and an OWE.

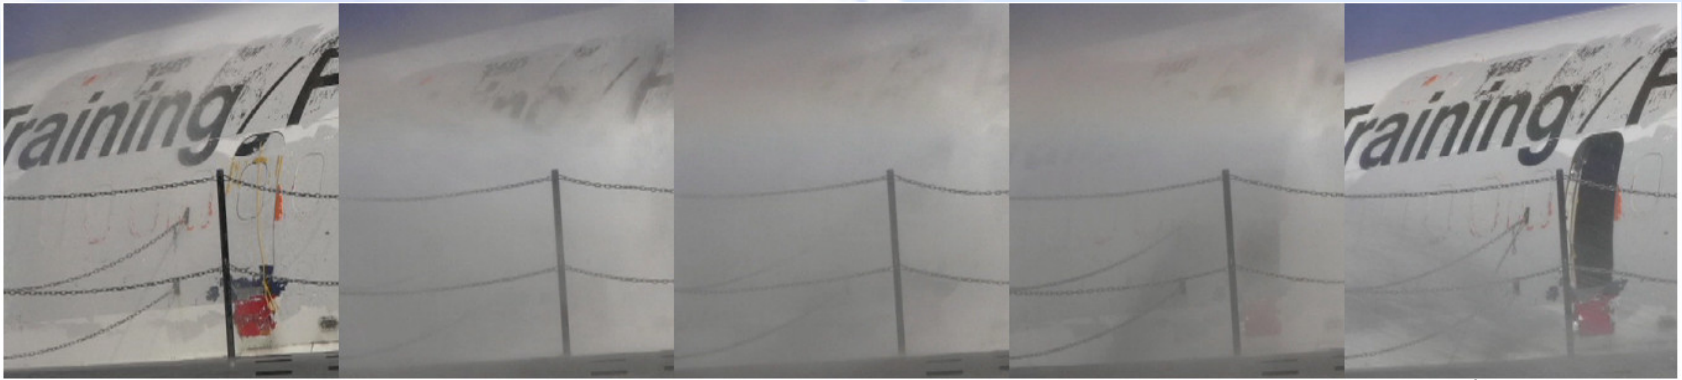
Straight stream on OWE exterior release panel for <0.5 sec

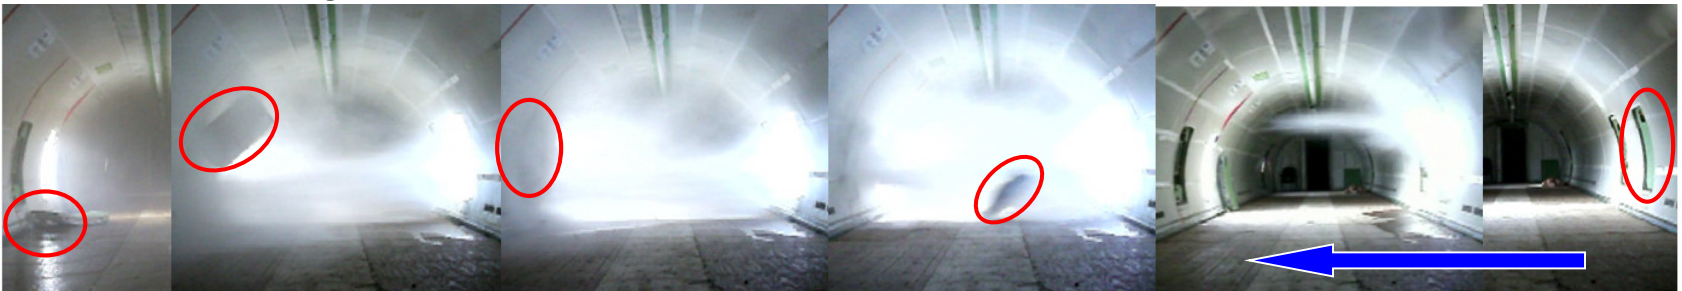
45 lb (20 kg) OWE was in motion for 2.75 sec.  
Speed while crossing fuselage: 18 mph (29 km/h).

When a TYPE III overwing emergency exit door needs to be opened - it may not mean that a firefighter has to be on the wing to do it.

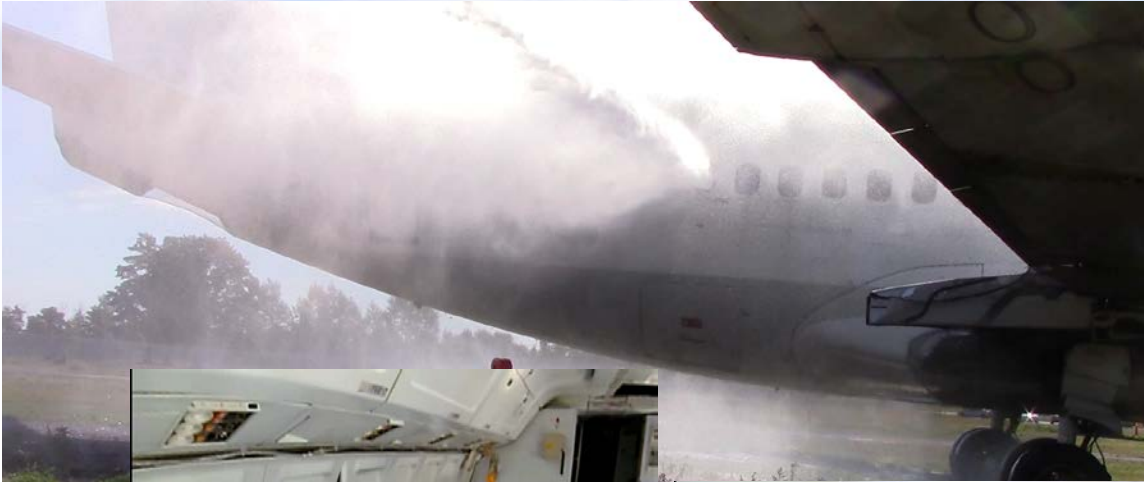
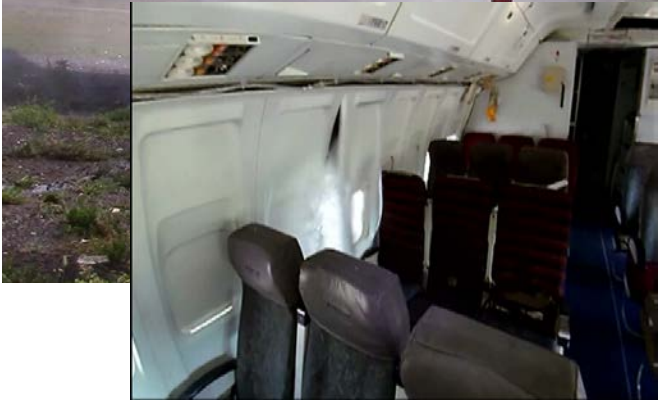
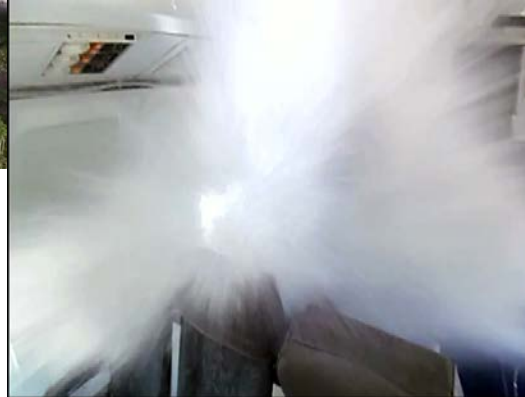
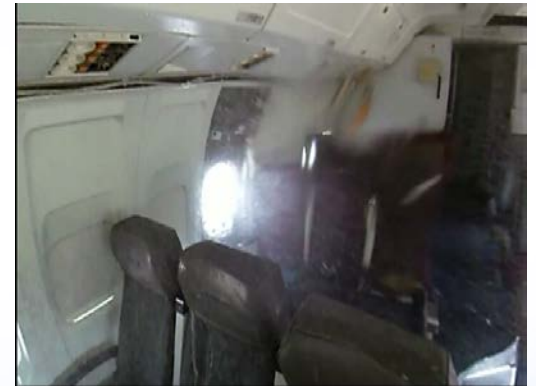
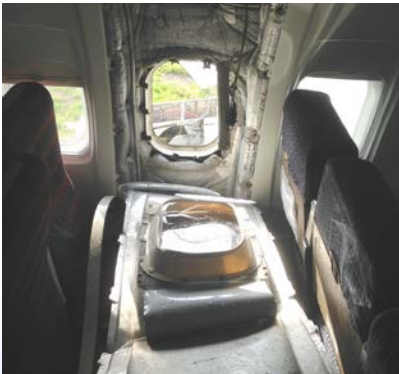
Some cabin windows are located by metal spring clips. Firefighters are aware that they can be pushed in with a hand tool. But we can do it with water in a few seconds from beyond the wing tip.

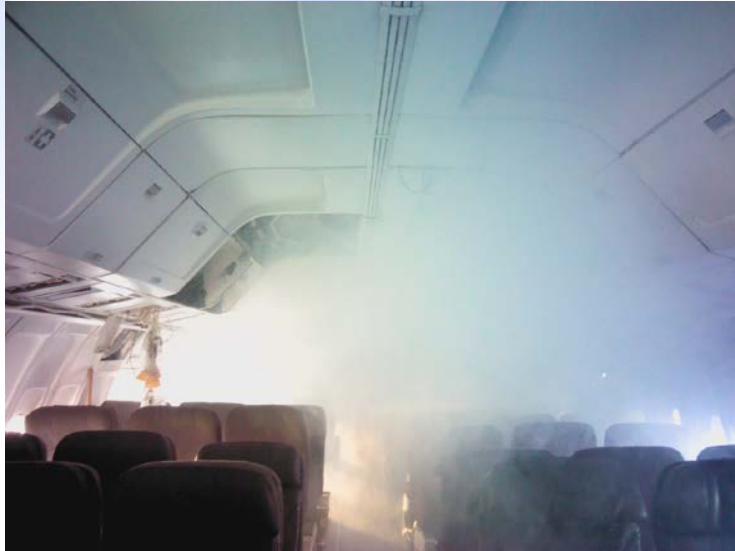
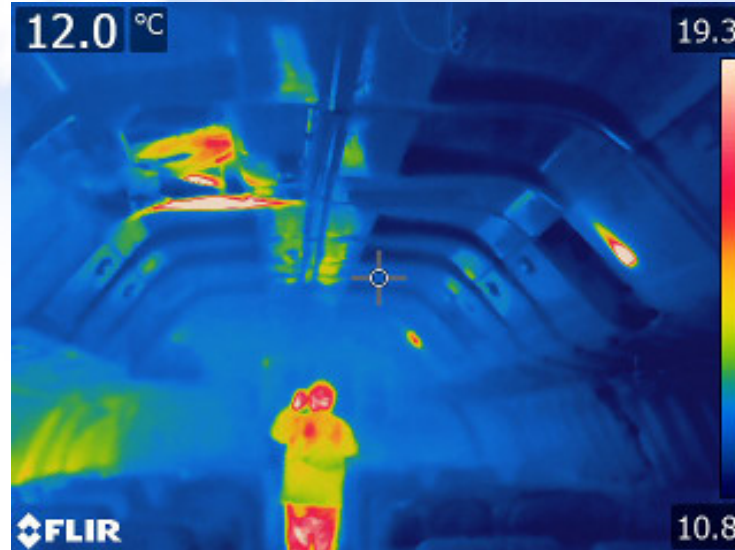
Normal image shows cabin filling with smoke. Thermal image shows three “fires” in the upper cabin and an observer obscured by smoke.

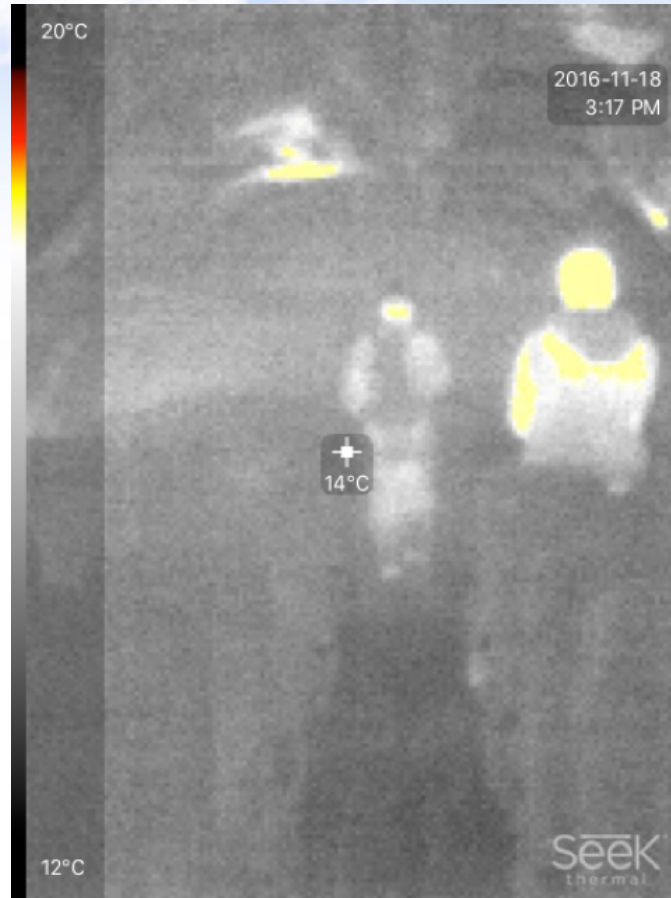
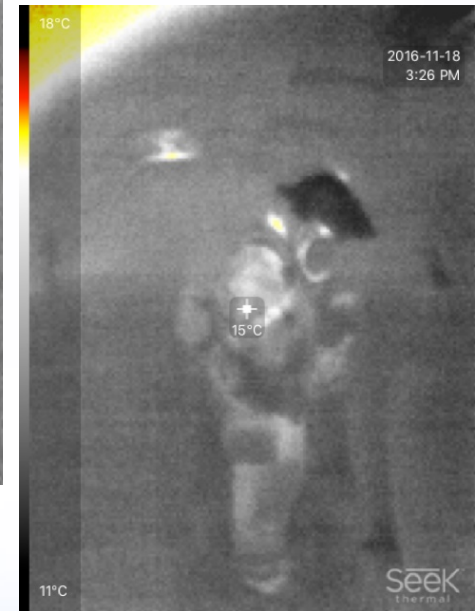
Visual and thermal image pair of firefighter (centre) and test observer, looking aft. Electrical heater strip “fires” behind ceiling liner and over-head luggage bin door.
